LAKE CHILLISQUAQUE

NDS ID NO. PA-815

PHASE I INSPECTION REPORT

NATIONAL DAM INSPECTION PROGRAM

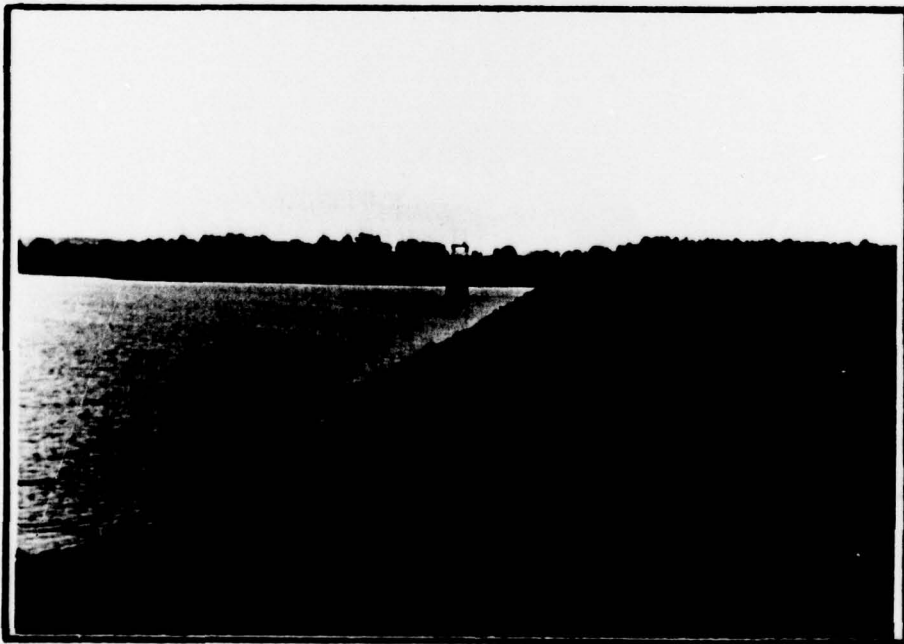
Overview of upstream slope and crest from right abutment.

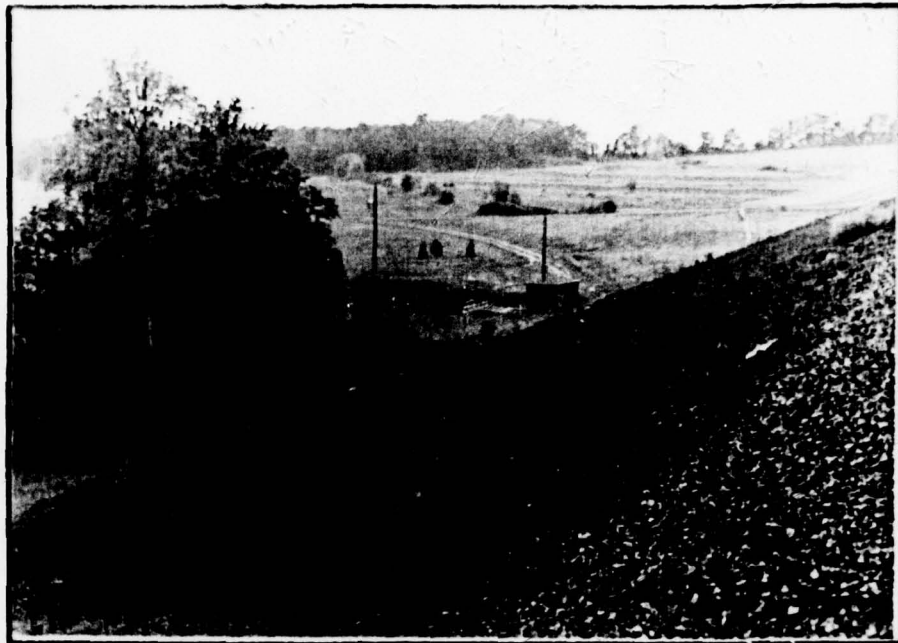
VISUAL EXAMINATION OF	OBSERVATIONS	REMARKS OR RECOMMENDATIONS
VEGETATION	One tree located on downstream slope near left abutment.	
JUNCTION OF EMBANKMENT AND ABUTMENT, SPILLWAY AND DAM	Appear to be good.	
ANY NOTICEABLE SEEPAGE	No seepage noted. Several wet areas noted at toe of dam.	
STAFF GAUGE AND RECORDER	Constant readings at Montour Power Plant of reservoir level and discharges.	
DRAINS	None.

Downstream Slope. Note valve house at toe.

1. Continue to remove all trees from the embankment.
2. The wet areas at the toe of the embankment should be examined during the routine inspections. Drainage from these areas should be provided and flow monitored when it exists.
3. A formal inspection program should be instituted.
4. A warning system should be instituted to warn downstream residents of large spillway discharges or failure of the dam.
5. Valves should be operated and lubricated on a regularly scheduled basis.

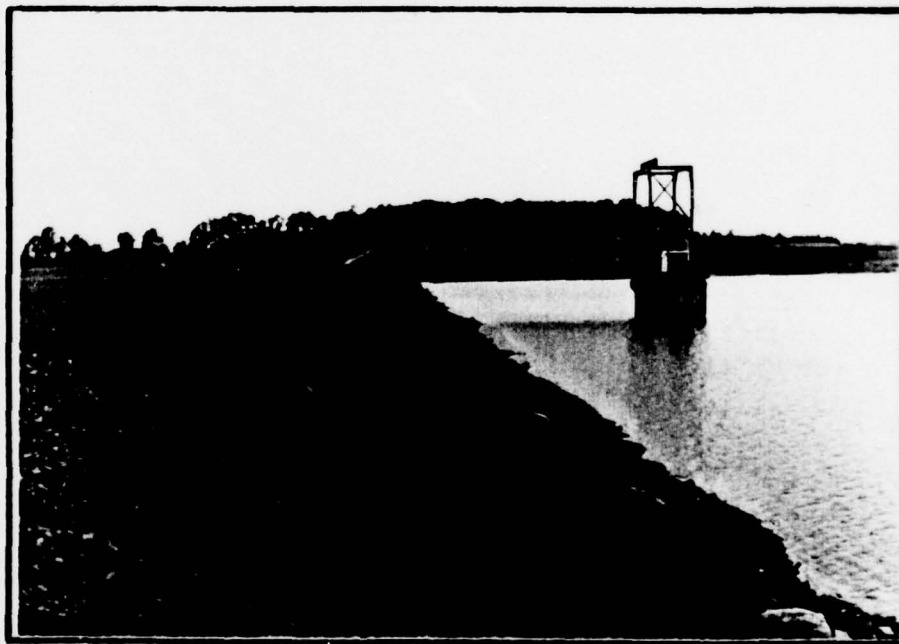
Upstream Slope. Note control tower.

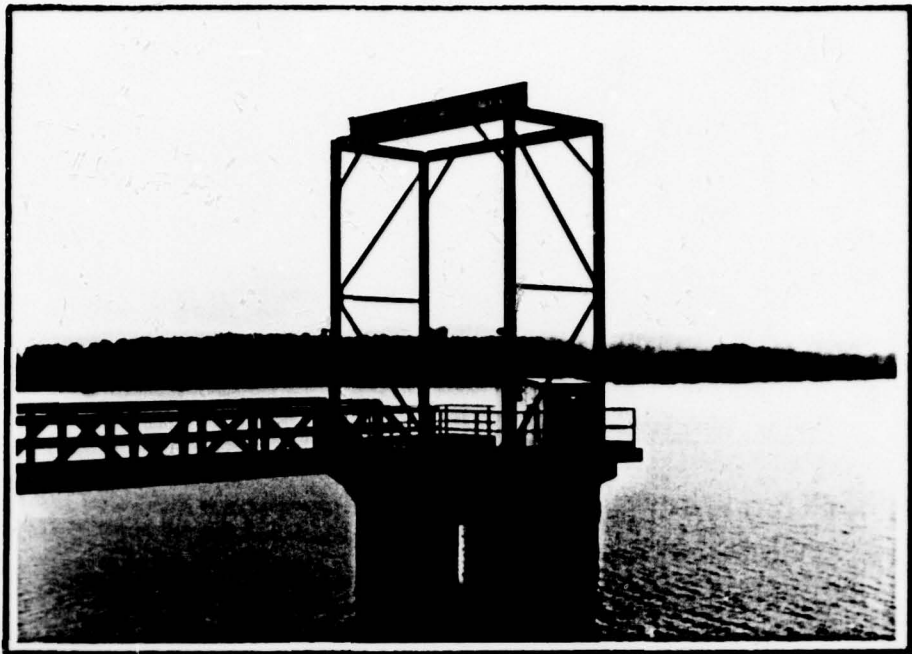
The condition of the two 36" drainlines was unobserved during the inspection. The concrete control tower appeared to be in good condition. The discharge end of the pipes and the valve house appeared to be in good condition. The valve house is kept locked at all times. Operation of the valves is controlled at the power plant, however, the valves can be operated manually in the valve house.

Close-up of control tower.

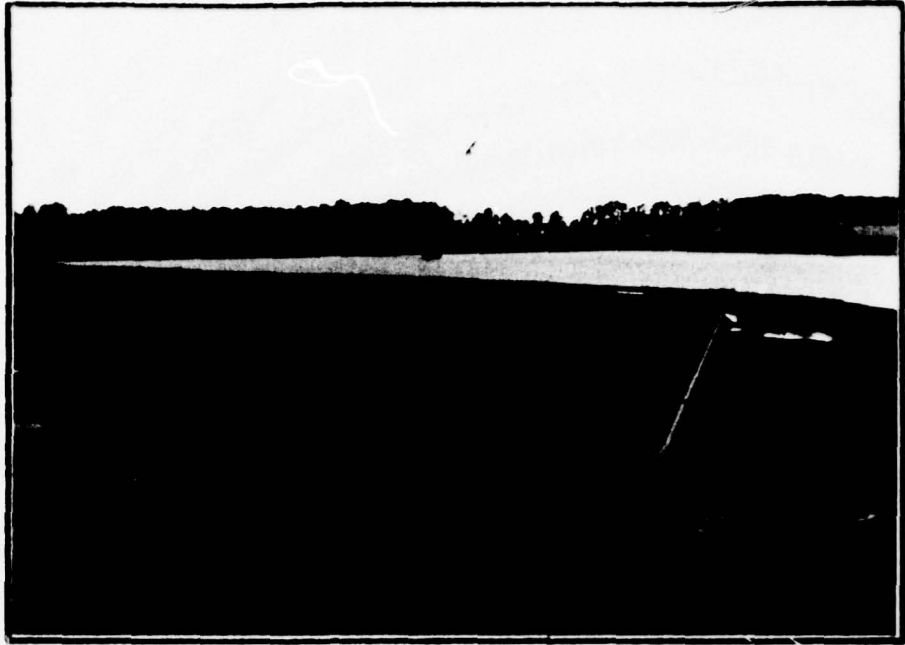
VISUAL EXAMINATION OF	OBSERVATIONS	REMARKS OR RECOMMENDATIONS
CONCRETE WEIR	Concrete weir in good condition.	
APPROACH CHANNEL	Weathered shale appears to be in good condition.	
DISCHARGE CHANNEL	Open cut with grassed bottom and side slopes. Good condition.	
BRIDGE AND PIERS	None.

Spillway weir on left abutment.

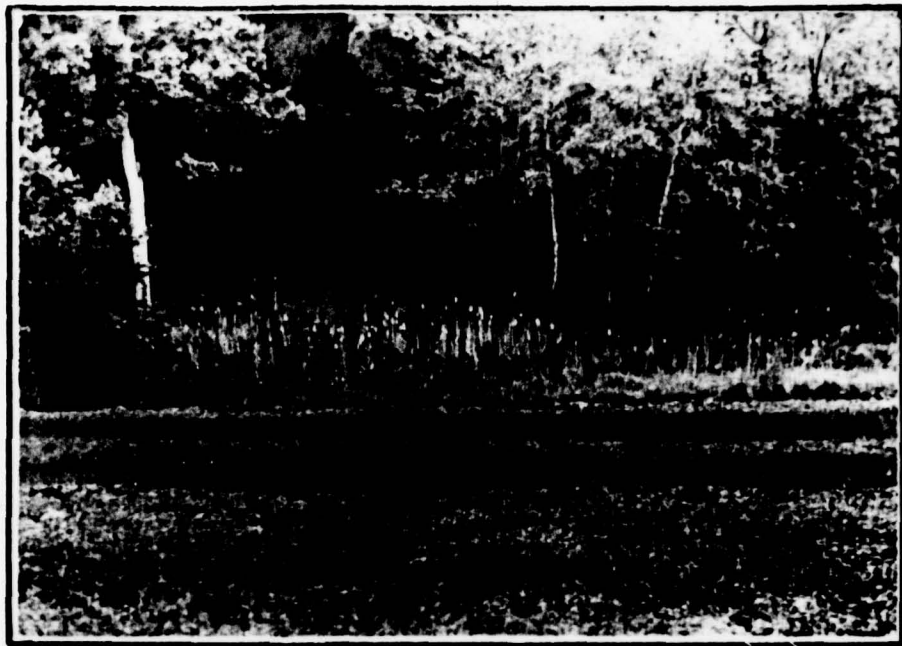
3.2 Evaluation. In general, the embankment and appurtenant structures appear to be in good condition and well maintained. The wet areas at the toe of the dam should be examined during the normal inspections. The tree should be removed from the embankment.

Note: Considerable precipitation occurred prior to and during a portion of the inspection possibly contributing to the wet areas noted at the toe and also possibly obscuring any small volume seeps or isolated wet areas. Dry weather inspections by the owner are encouraged.

a. Visual Observations. No signs of slumping, erosion or instability were noted during the inspection. The wet area at the toe of the dam should be watched for significant changes.

Wet area at downstream toe.
