LITTLE BLUE RUN DAM

NDI I.D. NO: PA-917

PHASE I INSPECTION REPORT
NATIONAL DAM INSPECTION PROGRAM

JUNE 1979

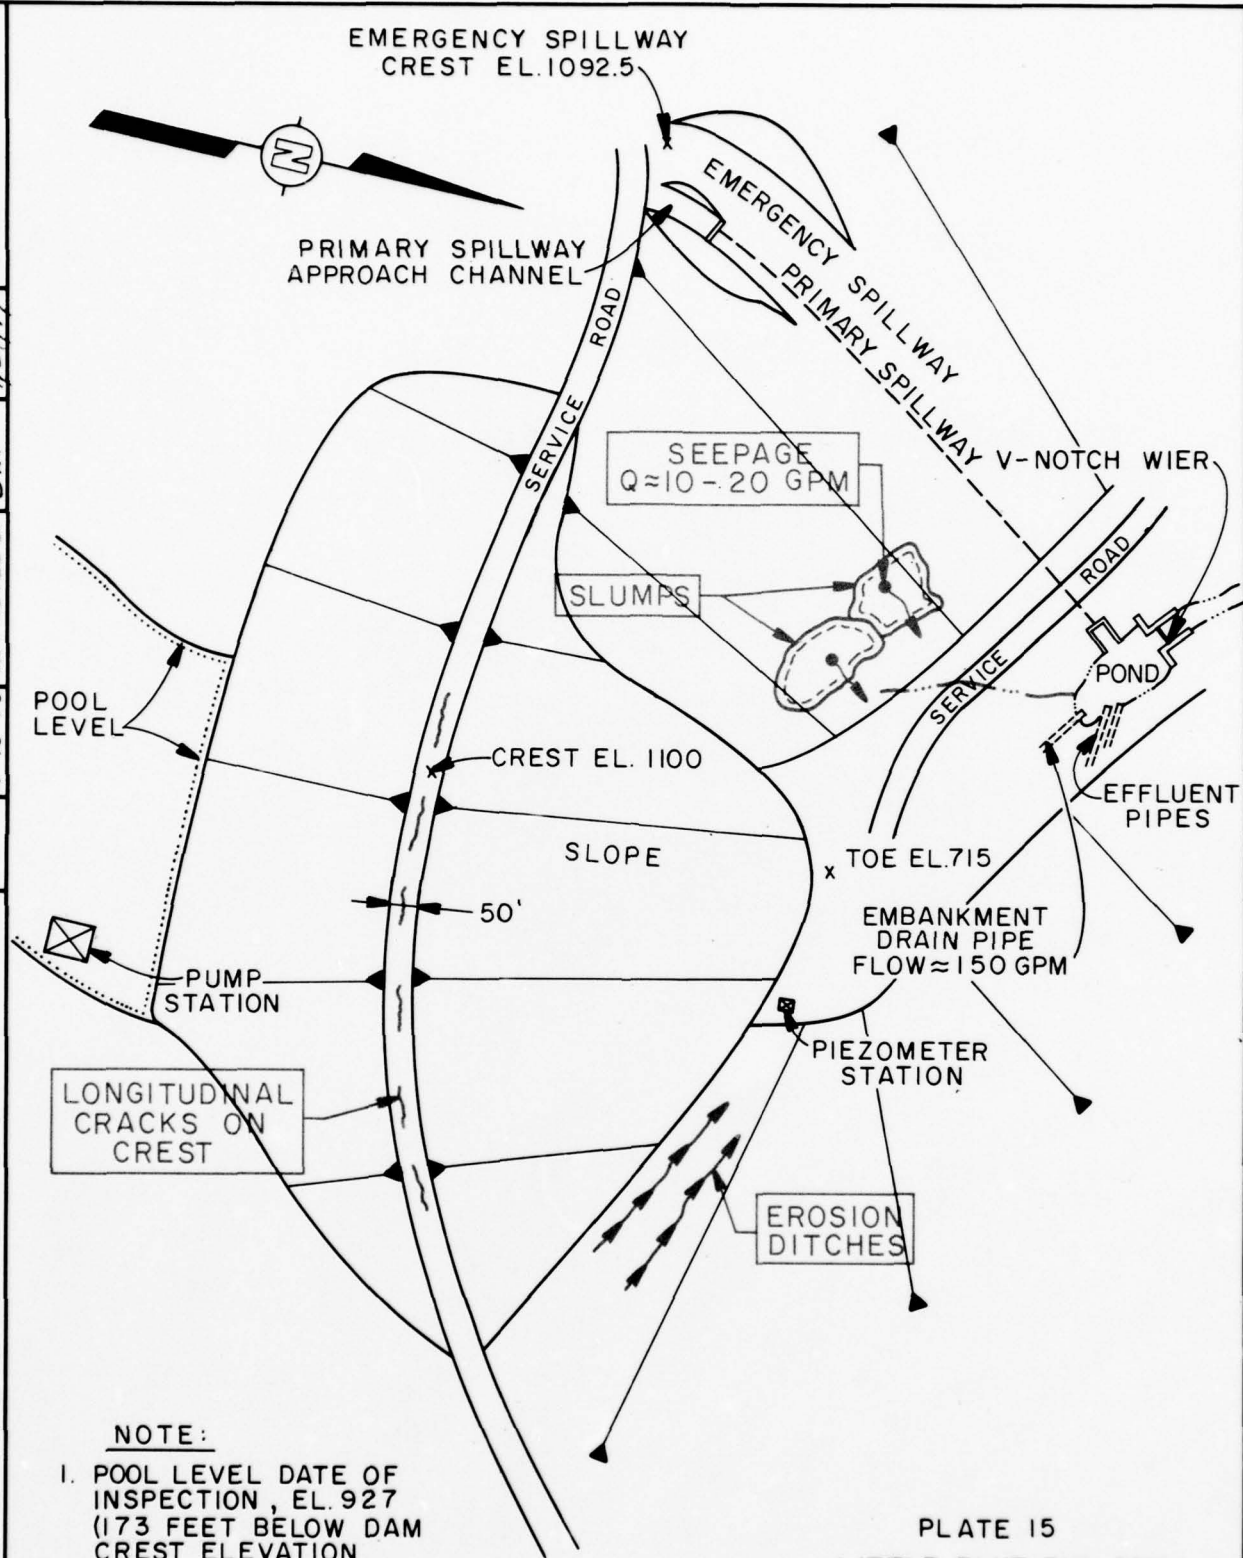
PLATE 15
 LITTLE BLUE RUN DAM
 GENERAL PLAN
 FIELD INSPECTION NOTES
 FIELD INSPECTION DATE: 3-14-79

NOTE:
 I. POOL LEVEL DATE OF INSPECTION, EL. 927 (173 FEET BELOW DAM CREST ELEVATION)

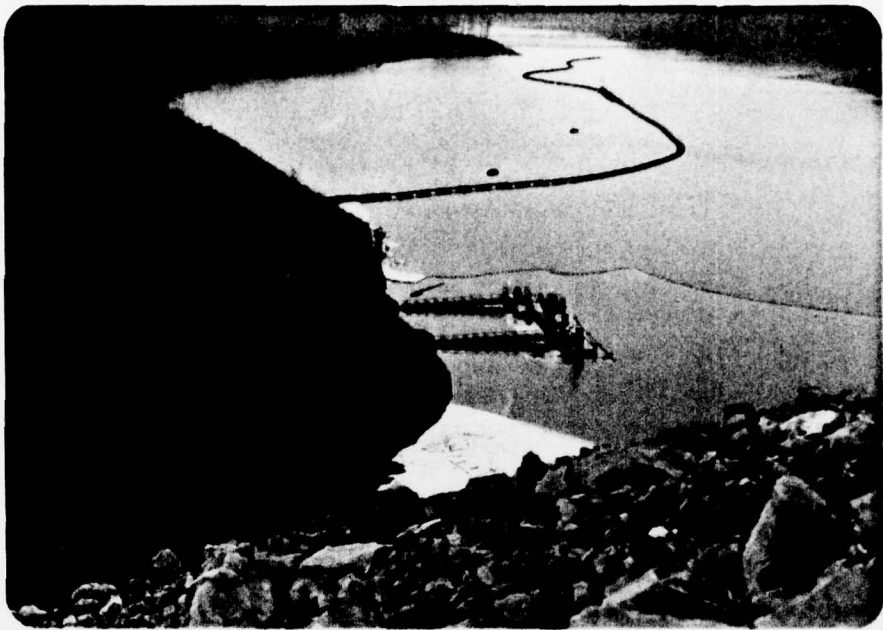
Photograph No. 1

Reservoir. Background: sludge inflow line.
Foreground: effluent pump station. (Pool
level about 170 feet below dam crest).

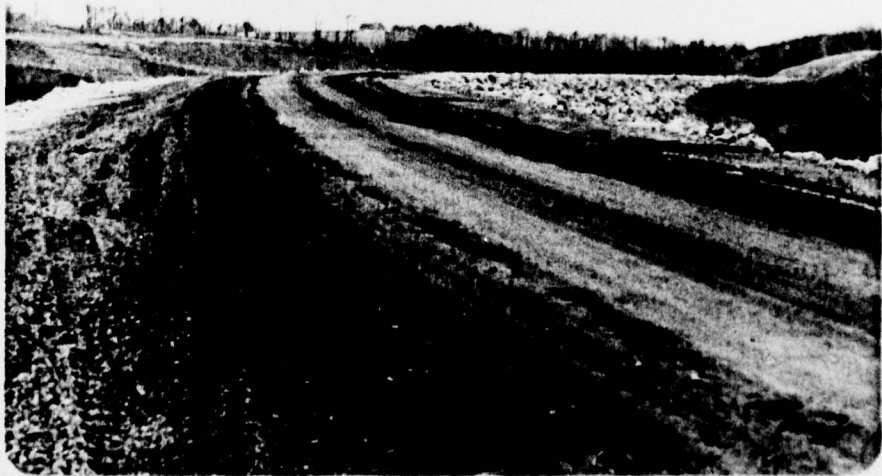
Photograph No. 2

Crest (looking west).

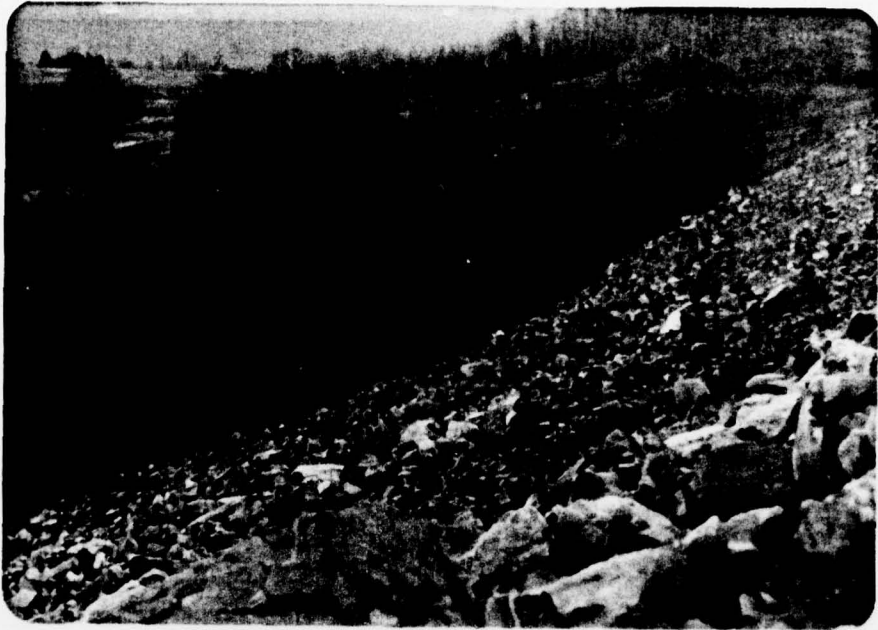
Photograph No. 3

In general, the condition of the dam is considered to be good. Several longitudinal cracks were observed on the crest of the dam. The owner's representative indicated that this cracking problem is being closely monitored and investigated by the designers. Several slumps and a seepage area were observed on the left abutment approximately at Elevation 740. Flow from the seep is being collected and monitored by the owner. The design engineer's representative indicated that this slumping problem is also being closely monitored by them. Some surface erosion was observed along the right abutment.

Right abutment. Note erosion ditches.

4.2 Maintenance of the Dam. The maintenance condition of the dam is considered to be good. The erosion ditches along the right abutment should be filled and necessary diversion performed to avoid future erosion problems.

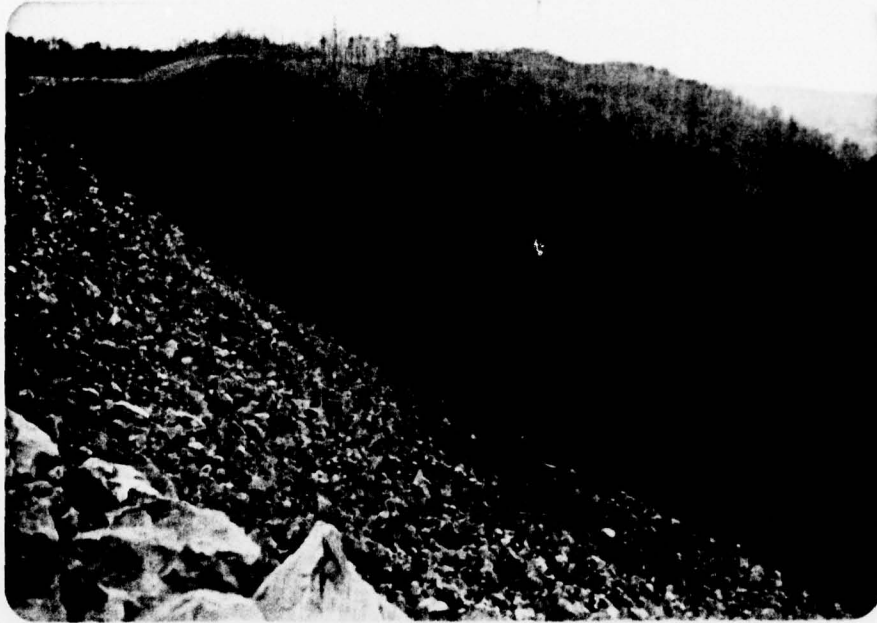
Photograph No. 5
Left abutment. View from crest.

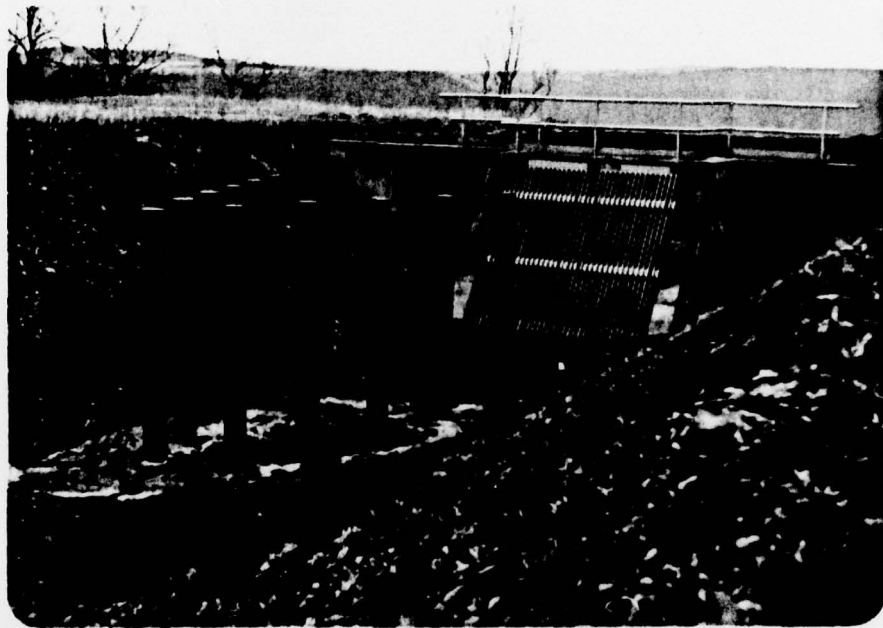
Photograph No. 7
Primary spillway intake structure.

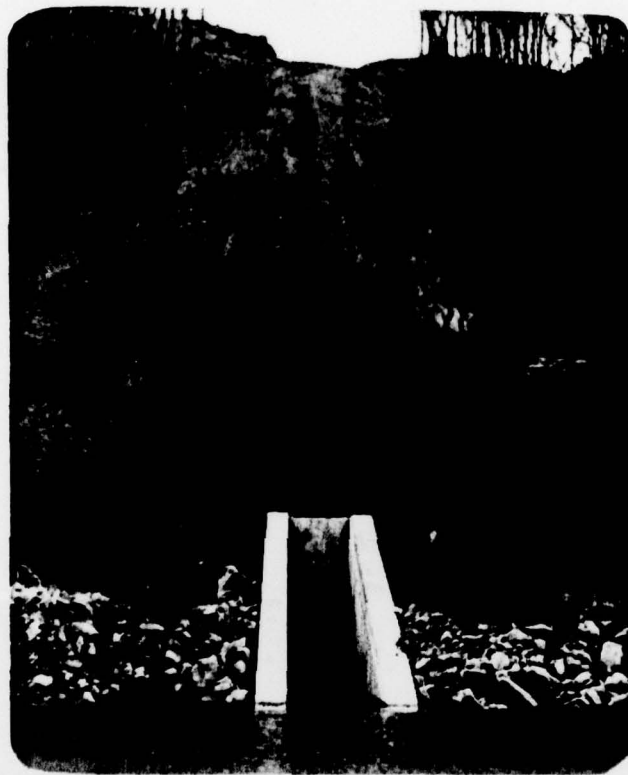
Photograph No. 8
Primary spillway discharge structure.

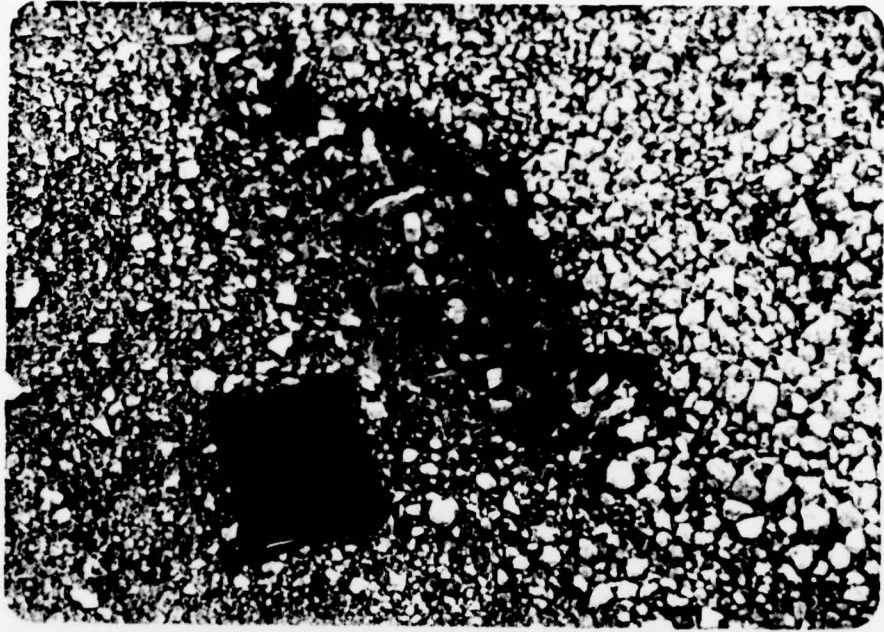
Photograph No. 9

3.2 Evaluation. The condition of the dam is considered to be good. It is recommended that the cracking problem on the crest, which appears to be due to differential settlement of the various rock zones of the embankment, should continue to be evaluated by the design engineers. Similarly, attention should be given to the slumping and seepage problem on the left abutment. Erosion ditches on the right abutment should be filled.

VISUAL EXAMINATION OF	OBSERVATIONS	REMARKS OR RECOMMENDATIONS
SURFACE CRACKS	There are numerous longitudinal cracks along the crest of the dam.	The extent of cracking on the crest should continue to be monitored.
UNUSUAL MOVEMENT OR CRACKING AT OR BEYOND THE TOE	None.	
SLOUCHING OR EROSION OF EMBANKMENT AND ABUTMENT SLOPES	There are several small slumps along the left abutment at approximately Elevation 740.	These slumps should be periodically inspected.
VERTICAL AND HORIZONTAL ALIGNMENT OF THE CREST	No misalignment was observed. It was reported that monuments along the crest are periodically surveyed.	
RIPRAP FAILURES	None.

Longitudinal cracks near upstream side of the crest.

1. The cracking observed on the crest should continue to be evaluated by the design engineers. Also, attention should be given to the slump and seepage observed on the left abutment. Erosion ditches on the right abutment should be filled.
2. A formal warning system should be developed to alert the downstream residents in the event of emergencies.

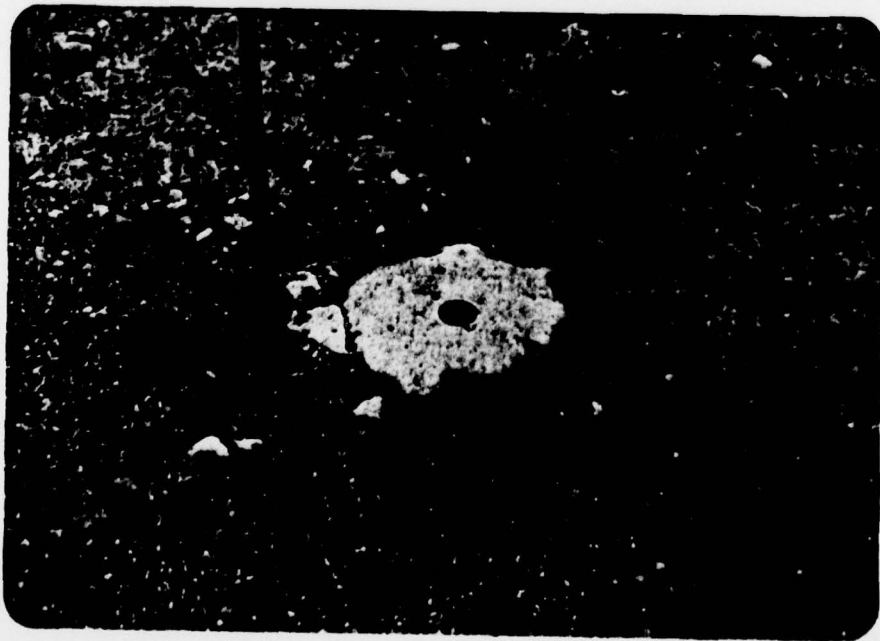
Photograph No. 10

Settlement monument on crest (typical).

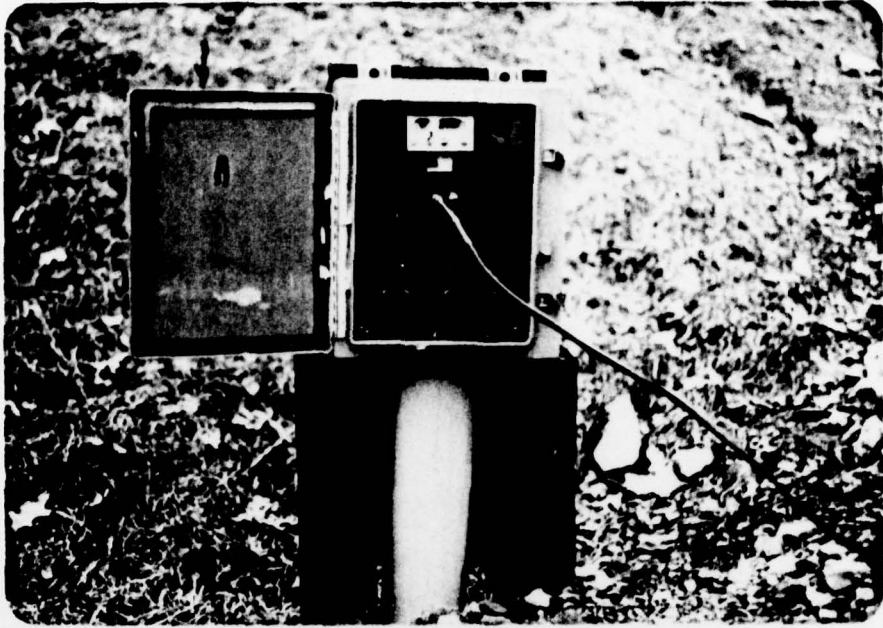
Photograph No. 11
Piezometer monitoring station.
