6 National Dam Inspection Program. Number  
Musser Forests Dam (NDIVPA-287,  
DER IDV 32-65), Ohio River Basin, McKee  
Run, Indiana County, Pennsylvania.

PHASE I ~~REPORT~~ Inspection Report,  
NATIONAL DAM INSPECTION PROGRAM

NAME OF DAM: Musser Forests Dam  
STATE LOCATED: Pennsylvania  
COUNTY LOCATED: Indiana  
STREAM: McKee Run  
SIZE CLASSIFICATION: Small  
HAZARD CLASSIFICATION: High  
DATE OF INSPECTION: May 23 and 25, 1979

MUSSER FORESTS DAM  
NDI I.D. NO. PA-287  
MAY 23, 1979

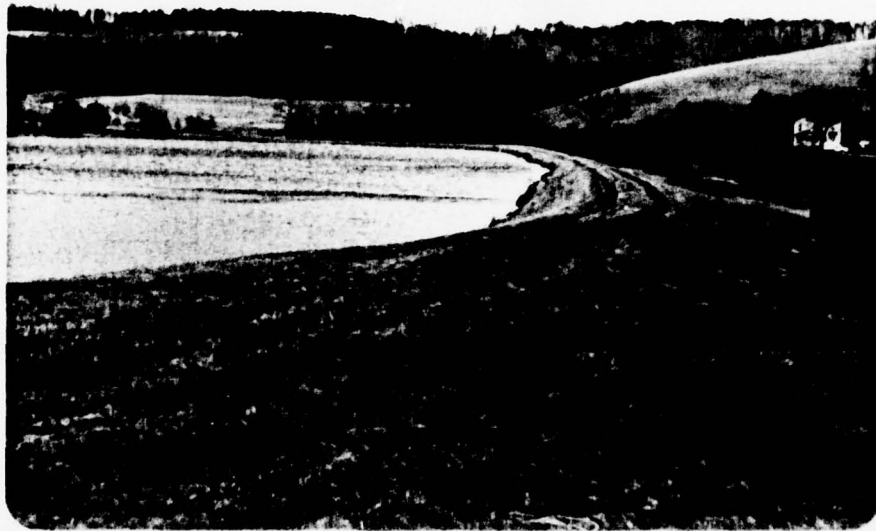
Photograph No. 1  
Crest (looking east).

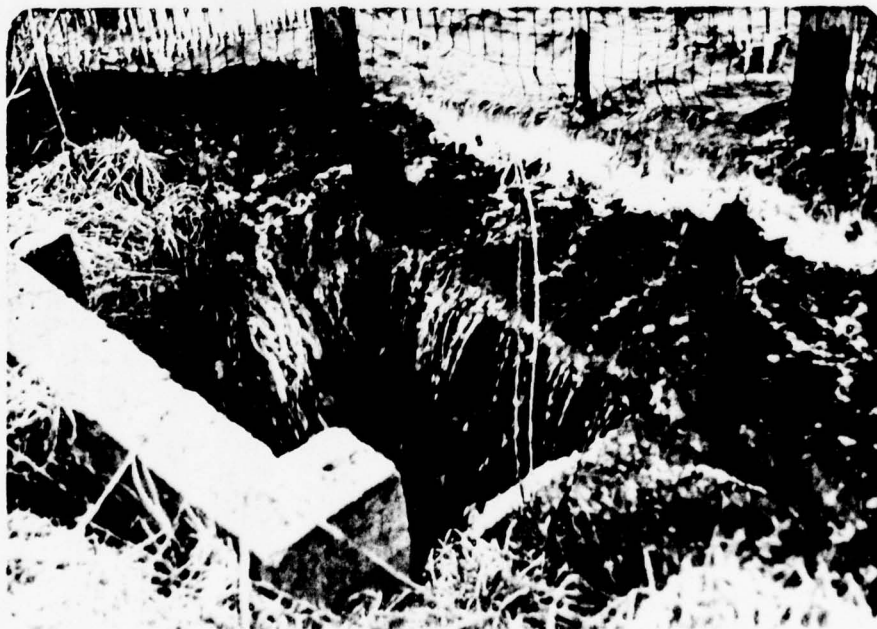
Photograph No. 2  
Primary spillway intake structure.

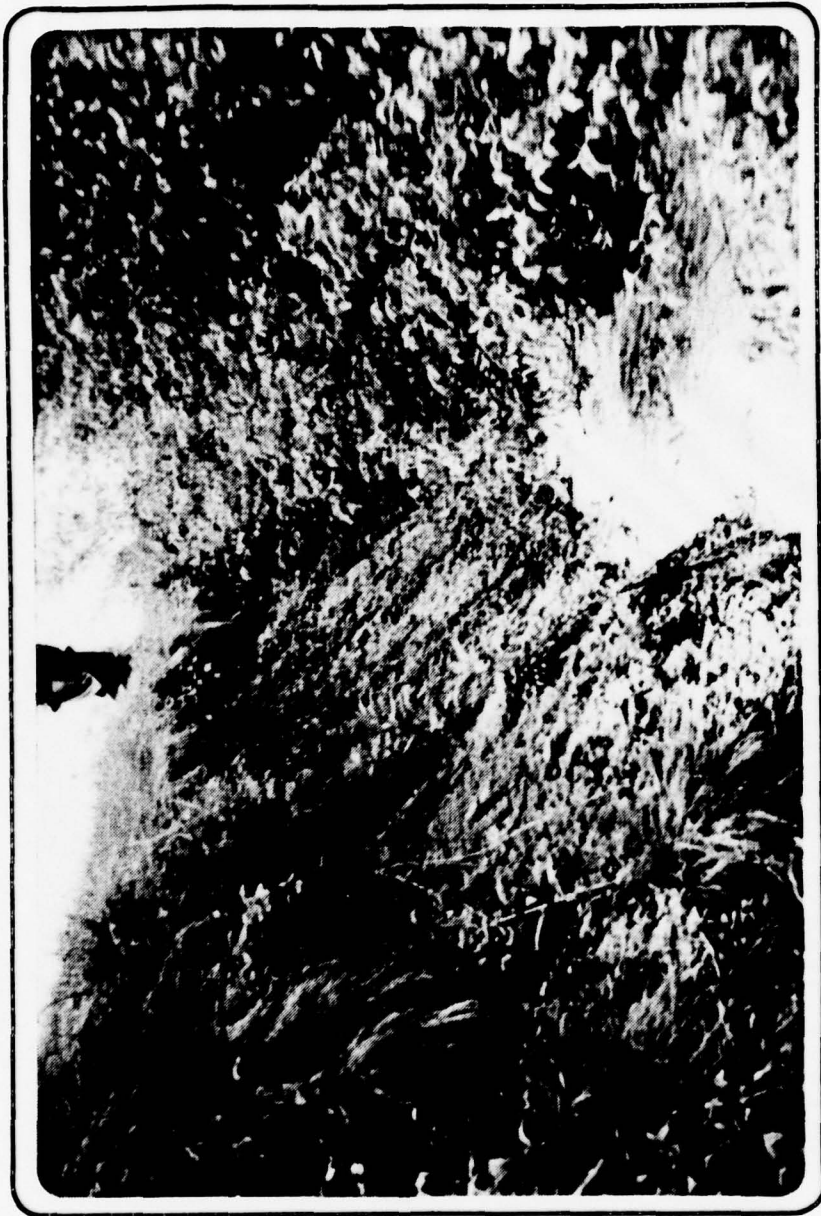
Photograph No. 6

Discharge through the primary spillway discharge channel which follows the toe of the embankment near the left abutment was found to be eroding the embankment toe. At some sections, the toe of the embankment appears to be cut 4 to 5 feet deep by this erosion. This condition is considered to constitute a threat to the integrity of the embankment if allowed to continue. The condition of the remaining portion of the embankment is considered to be fair. The crest of the dam was found to be irregular. However, the irregularities do not appear to be from recent movements. The upstream slope of the dam has no erosion protection and has eroded due to wave action. A wet area was observed at the toe level of the dam at the center of the main embankment. No measurable seepage appears to be associated with this wet area.

(2) Appurtenant Structures. Severe erosion in the spillway discharge channel along the toe of the dam near the left abutment is considered to pose a stability problem to the embankment if this condition is not corrected.

| VISUAL EXAMINATION OF | OBSERVATIONS | REMARKS OR RECOMMENDATIONS |
|---|---|---|
| SLOUCHING OR EROSION OF EMBANKMENT AND ABUTMENT SLOPES | Severe erosion along the toe of the dam near the left abutment caused by flows through the primary spillway discharge channel. | The erosion problem should be evaluated by a professional engineer and the toe of the dam should be protected against erosion. |

Primary spillway discharge channel. Note erosion along the toe of the dam.

1. The owner should immediately retain a professional engineer to evaluate the erosion in the primary and emergency spillway discharge channel and to prepare and execute plans for providing adequate erosion protection. This study should also consider means of providing emergency drawdown facilities or restoring and improving the existing facilities with upstream closure or control.
