HAMILTON LAKE DAM

NDS ID NO. PA-33
DER ID NO. 59-65
SCS ID NO. PA-602

PHASE I INSPECTION REPORT
NATIONAL DAM INSPECTION PROGRAM

L. ROBERT KIMBALL & ASSOCIATES
CONSULTING ENGINEERS & ARCHITECTS
EBENSBURG, PENNSYLVANIA
15931

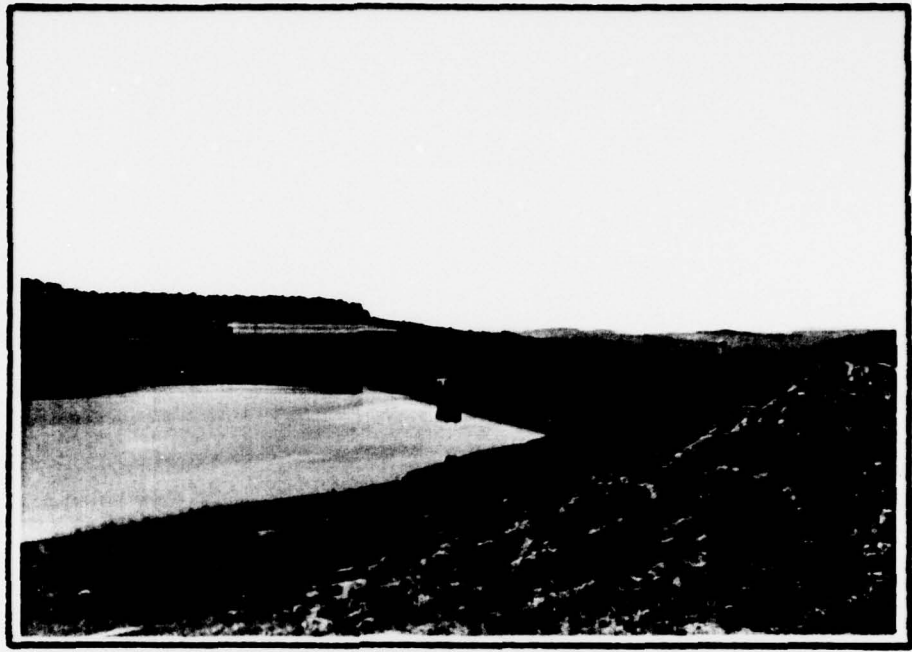
Overview of upstream slope of dam.

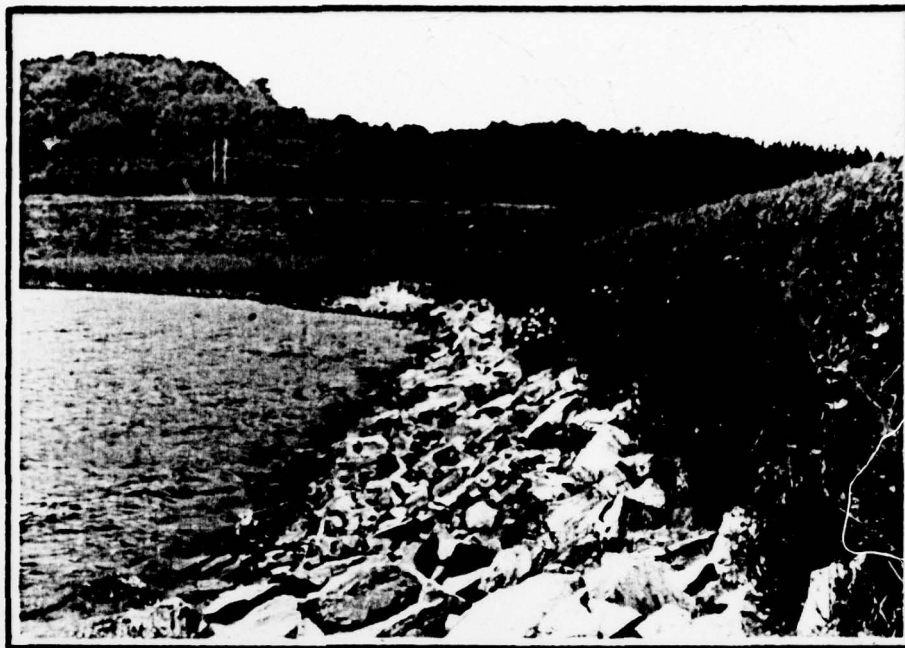
Upstream slope of dam showing riprap and emergency spillway approach.

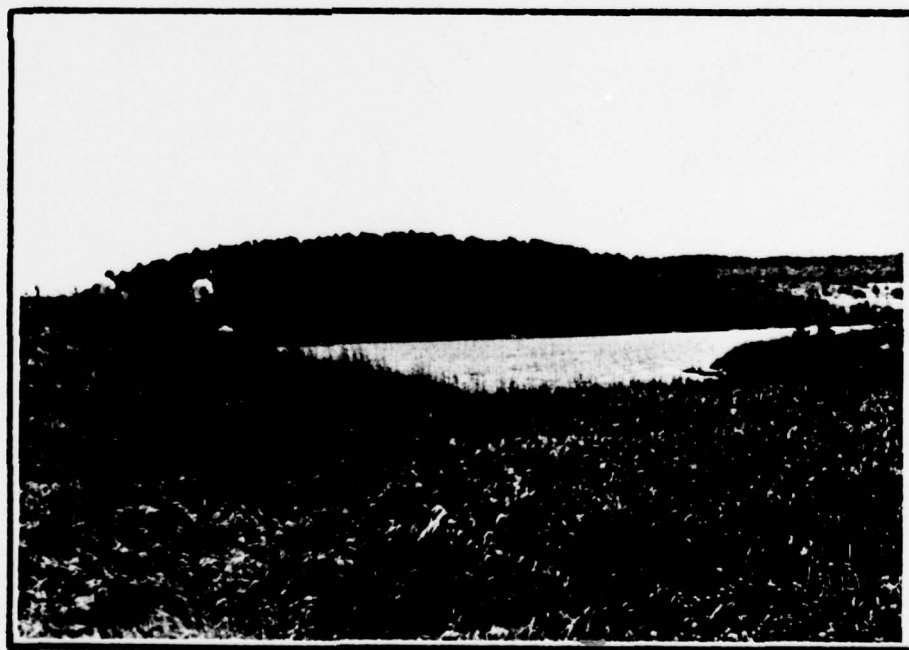
Emergency spillway approach channel.

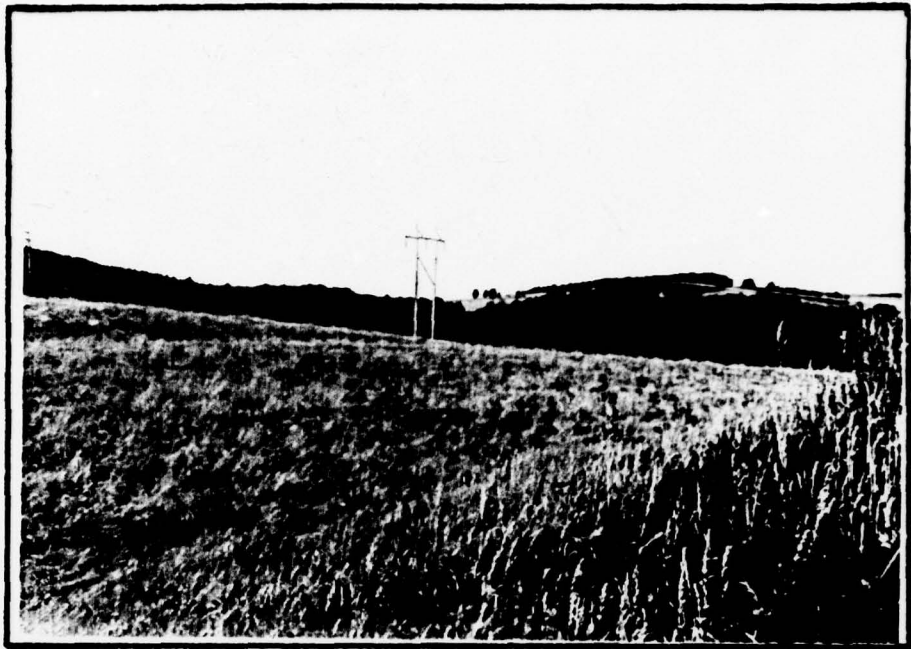
Emergency spillway discharge channel.

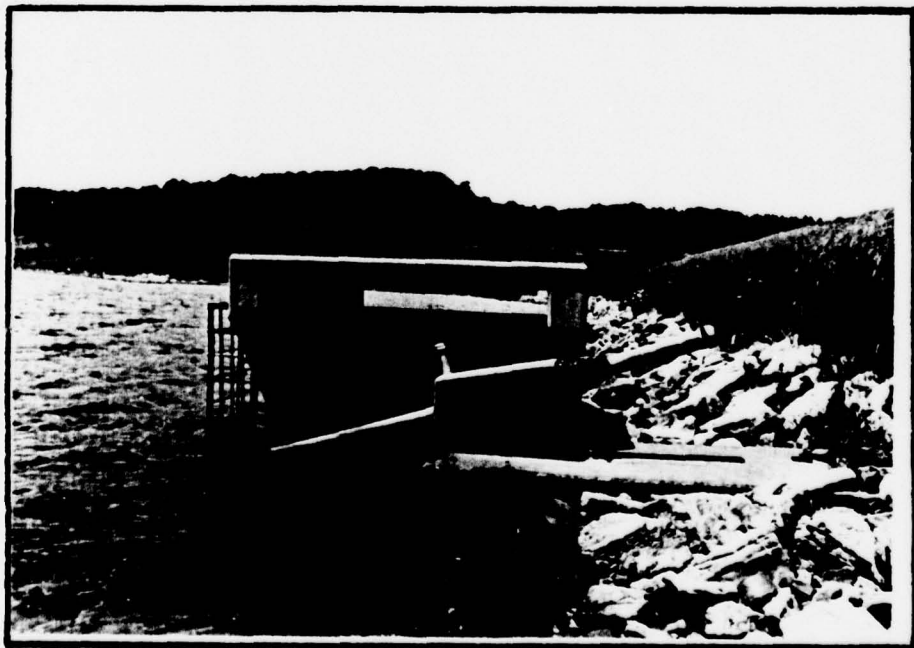
Principal spillway, orifice invert and drain line stem.

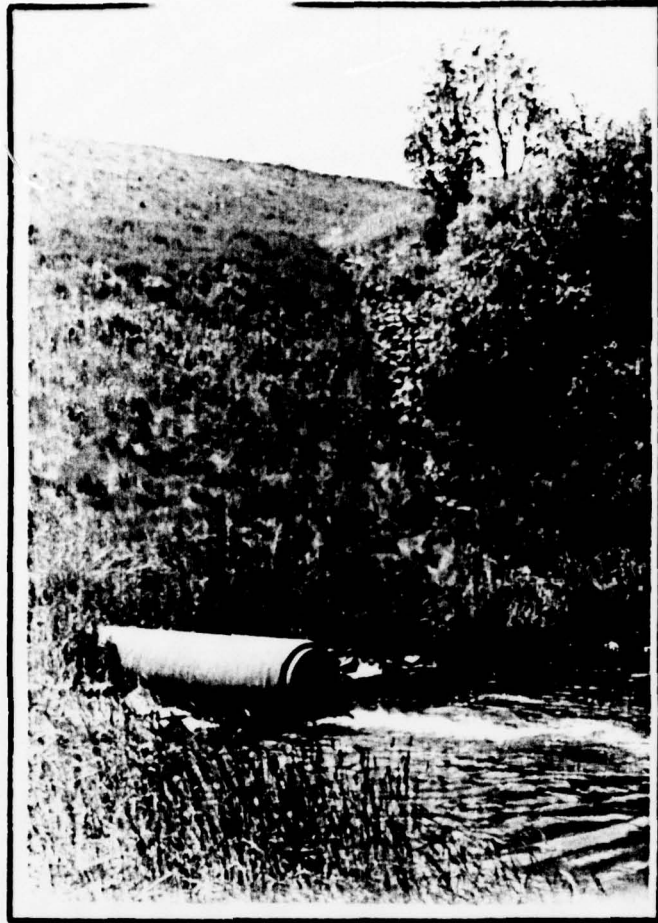
Outlet works and principal spillway discharge.

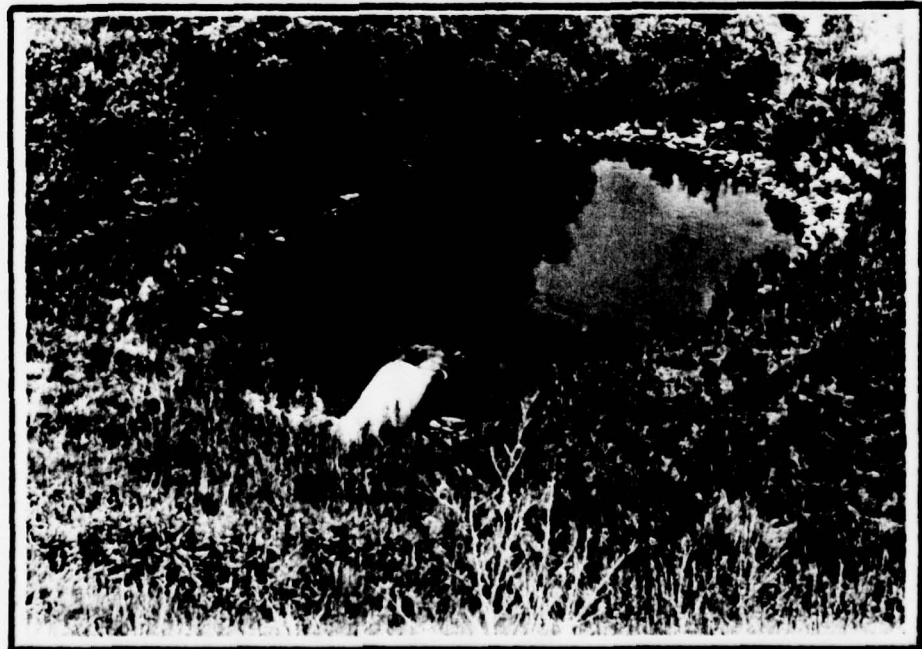
Tailwater at outlet works discharge.

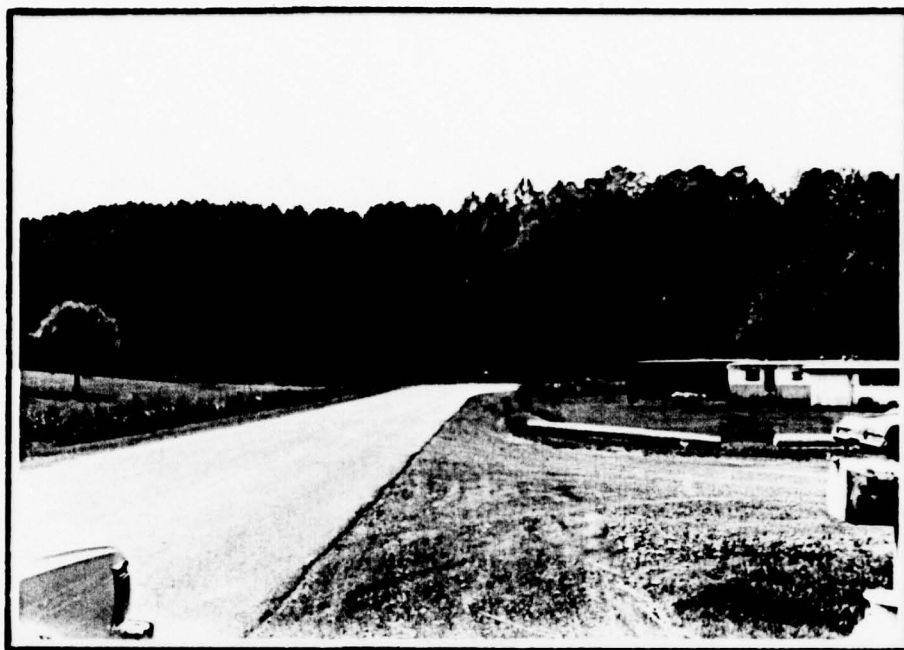
First downstream residences.

2. A warning system should be instituted to warn downstream residents of large spillway discharges or failure of the dam.

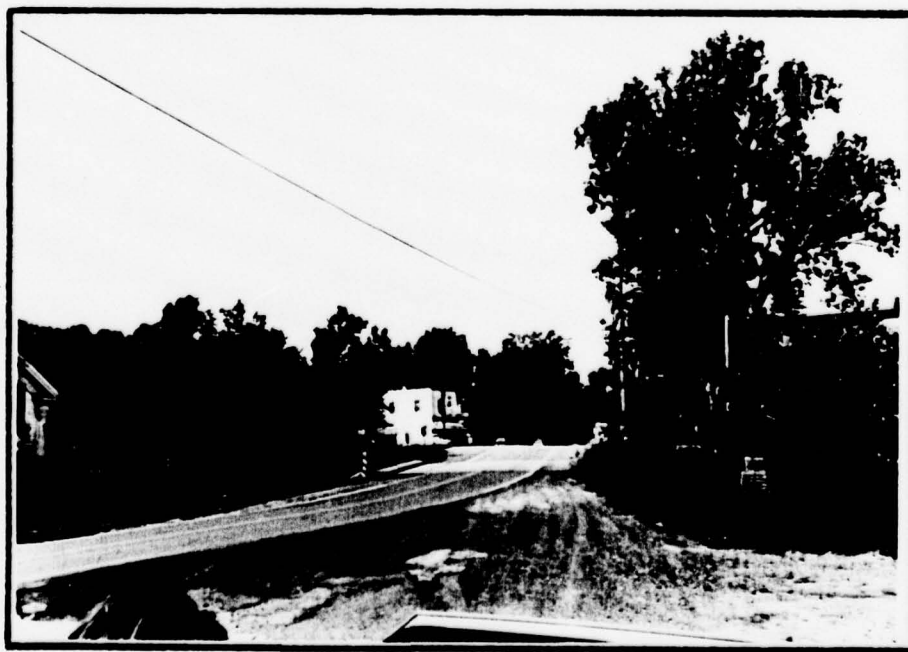
Downstream residences.
