⑥ Number National Dam Inspection Program. Number ①  
PA-468 Dam (NDI-I.D. PH-00046,  
DER-I.D. 58-132, SCS-ID, PA-468),  
SUSQUEHANNA RIVER BASIN, Number  
BROOKLYN RUN, SUSQUEHANNA COUNTY,  
PENNSYLVANIA, Phase I Inspection  
Report,  
PA-468 Dam

NDI ID No. PA-00046  
DER ID No. 58-132  
SCS ID No. PA-468

PHASE I INSPECTION REPORT  
NATIONAL DAM INSPECTION PROGRAM

⑪ AUGUST 1979

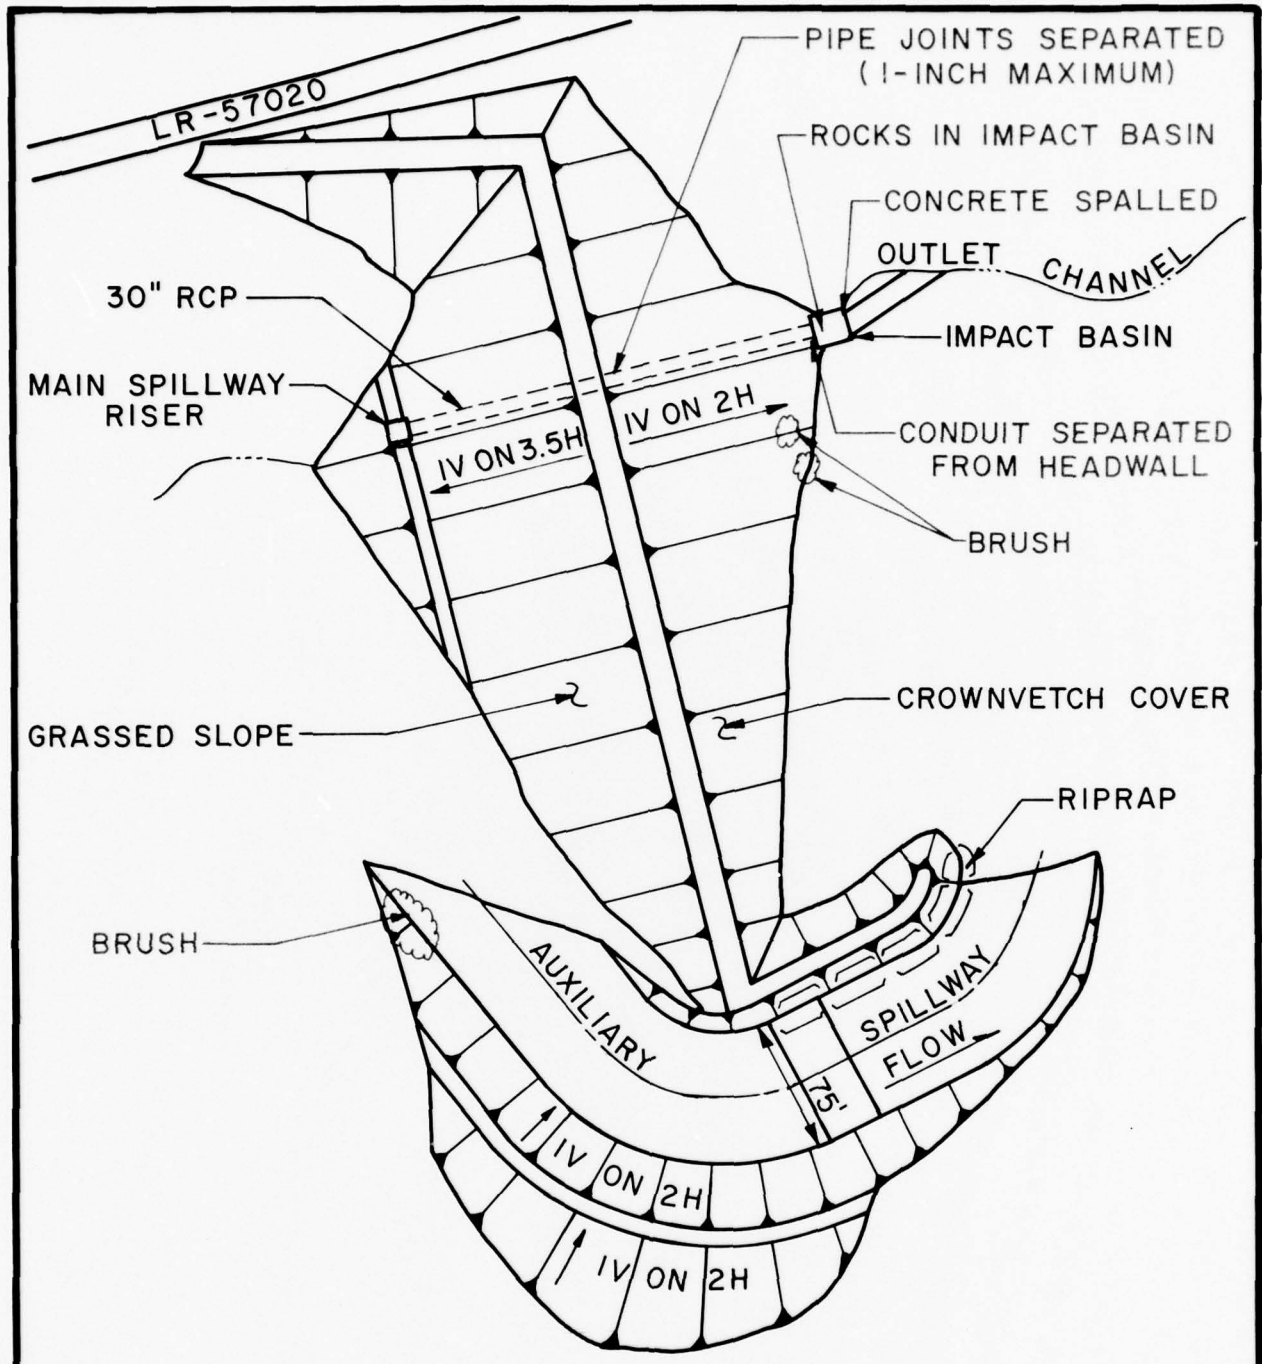
PHASE I INSPECTION REPORT  
 NATIONAL DAM INSPECTION PROGRAM  
 PA-468 DAM  
 SUSQUEHANNA COUNTY COMMISSIONERS  
 RESULTS OF VISUAL INSPECTION  
 AUGUST 1979  
 PLATE B-1

a. General. The overall appearance of the dam is good with a few deficiencies as noted herein. The locations of deficiencies are shown in Appendix B on Plate B-1. Survey data acquired during this inspection are presented in Appendix B. Datum for the survey was assumed at the design elevation of the end sill of the impact basin, El. 1190.00. On the day of the inspection, the pool was 0.1 foot above the crest of the orifice in the main spillway riser.

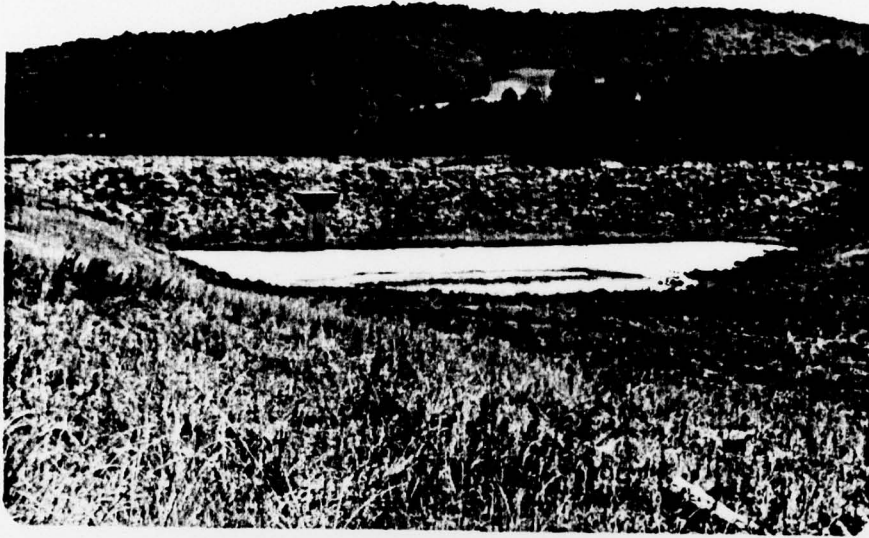
b. Embankment. The embankment is in good condition. The grass cover on the upstream slope and the crownvetch cover on the downstream slope are in excellent condition. There is no slope protection on the upstream slope other than the grass cover. A survey performed for this inspection showed that embankment lines and grades are in good conformance with the design lines and grades. Two foundation drain outlets, located at the impact basin, each had a slight, clear flow. Two small shrubs were growing on the downstream slope of the dam.

A. Upstream Slope of Embankment.

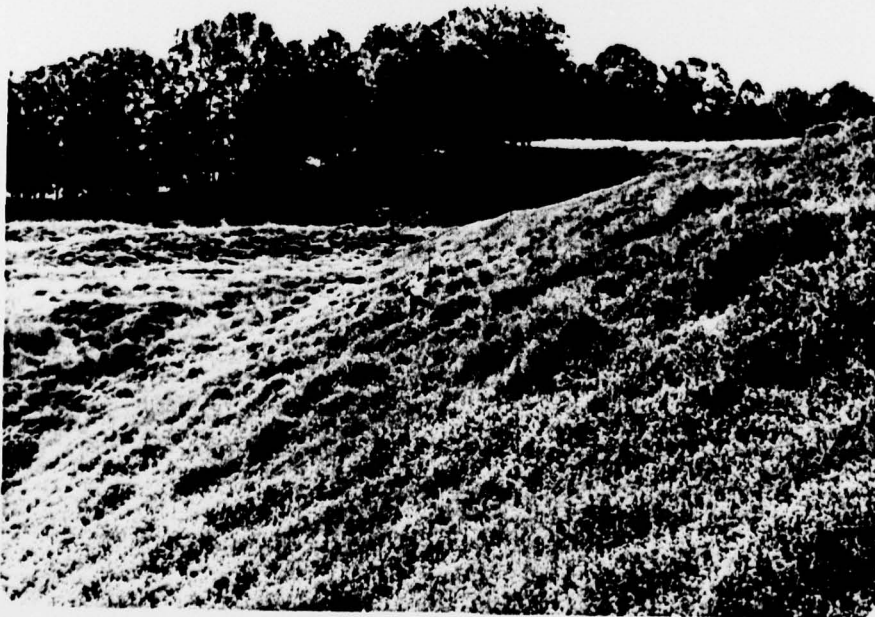
<u>Feature and Location</u>	<u>Observed Deficiencies</u>
<u>Embankment:</u>	
Downstream Slope	Minor amount of brush.
<u>Main Spillway:</u>	
Conduit	Conduit joints separated; slight separation of conduit from impact basin headwall with slight, clear leakage.
Impact Basin	Rocks in impact basin; minor spalling of concrete.
<u>Auxiliary Spillway:</u>	Minor amount of brush.

B. Downstream Slope of Embankment.

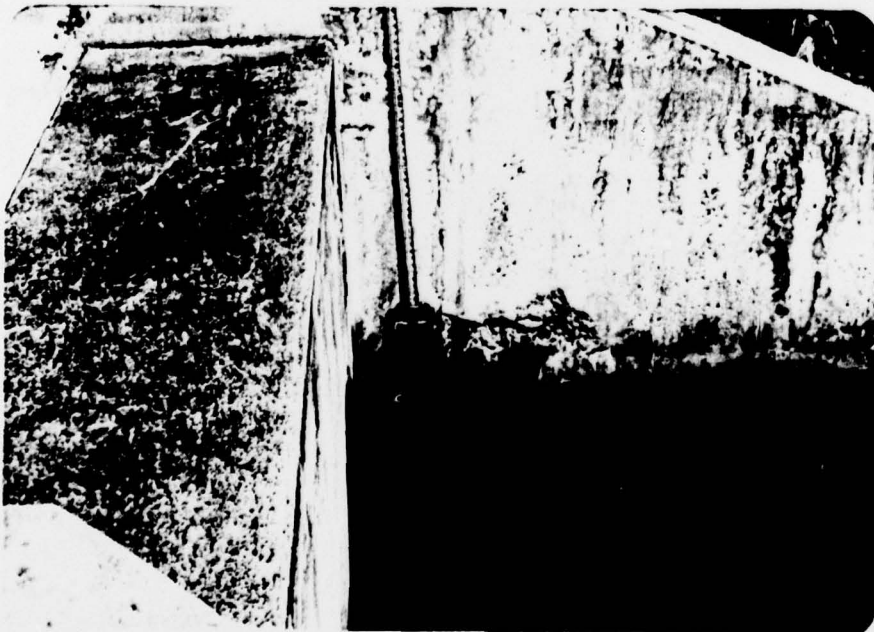
The main spillway riser was in good condition. The reinforced concrete outlet conduit was inspected and found to be in good condition. Joint separations, up to a maximum of 1 inch, were observed along the conduit. The joint separations were nearly zero at each end and increased progressively toward the maximum section of the dam. At its downstream end, the reinforced concrete outlet conduit was slightly separated from the impact basin headwall. A slight, clear flow of water was visible at the separation. The impact basin contained several large rocks, apparently the result of vandals. There was some minor spalling of the concrete along the inside of the left wall of the impact basin.

(3) Appurtenant Structures. Although joint separations as large as 1 inch were present in the 30-inch main spillway conduit, the Specifications indicate that the pipe joints have a minimum extensibility of 2 inches. Therefore, the joint openings are less than the allowable openings, and the joints should be watertight. The connection of the outlet conduit to the impact basin headwall is not watertight. Although this condition has apparently not resulted in any adverse effects, it is considered to be undesirable. Potentially adverse

conditions, such as possible loss of fine filter material, might occur under high head conditions. The large rocks in the impact basin are also considered to be undesirable. During periods of high spillway discharge, turbulence might cause the rocks to damage the impact basin. The amount of brush in the auxiliary spillway is not significant at the present time, but control of it is necessary to insure that no reduction of spillway capacity occurs.

D. Main Spillway Impact Basin  
and Foundation Drain Outlet.

(2) Make repairs necessary to eliminate the separation and leakage between the main spillway conduit and the impact basin headwall.
