BEECHWOOD LAKE DAM

NDS ID NO. PA-37

PHASE I INSPECTION REPORT
NATIONAL DAM INSPECTION PROGRAM

L. ROBERT KIMBALL & ASSOCIATES
CONSULTING ENGINEERS & ARCHITECTS
EBENSBURG, PENNSYLVANIA
15931

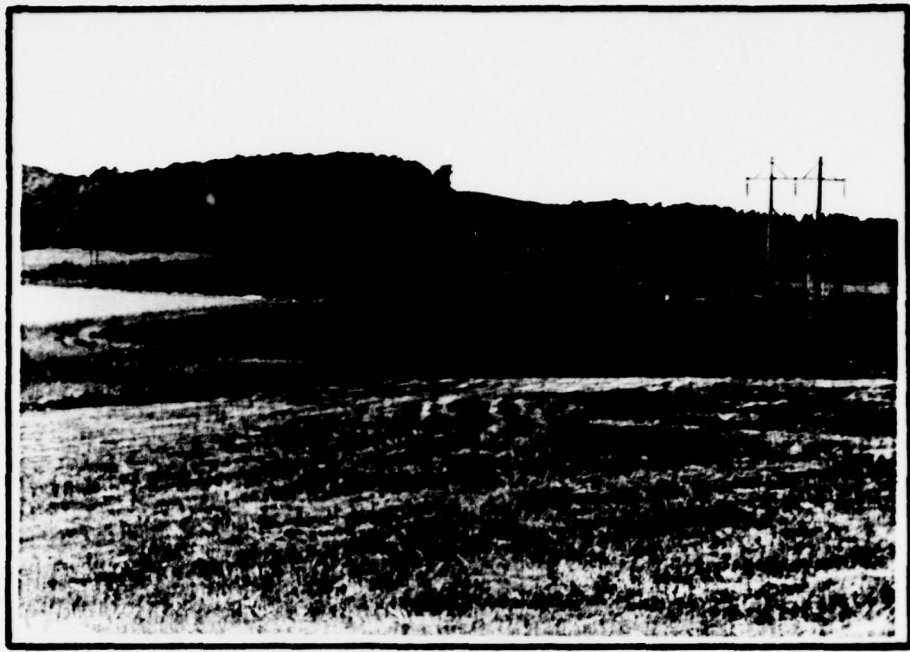
Overview of dam from right abutment.

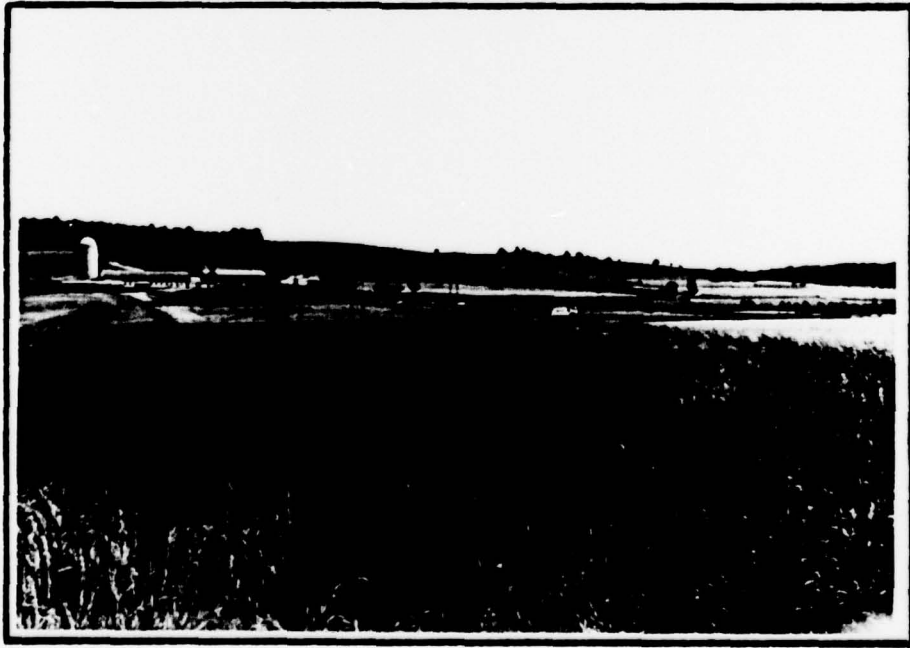
Overview of dam from left abutment.

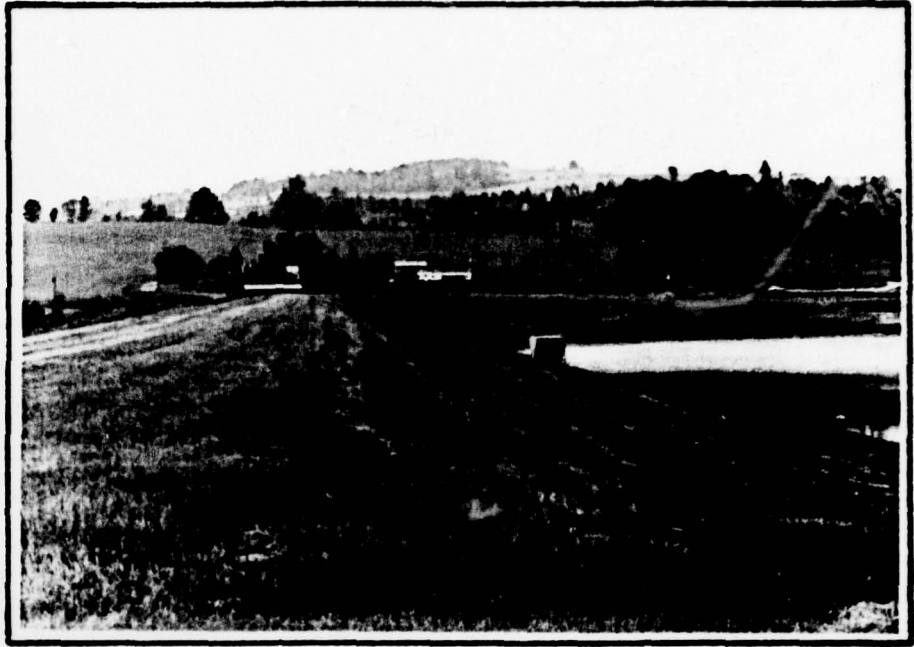
b. Dam. The dam appears to be in good condition. The dam appears to conform closely to the as-built drawings. From a brief survey conducted during the inspection, it was noted that the crest of the dam is approximately 0.4 feet higher than the design height of the dam. The upstream slope is 3H:1V and covered with riprap in the vicinity of normal pool and principal spillway crest. The downstream slope is 2H:1V. The upstream slope, downstream slope and crest are grass covered. No signs of erosion, seepage, or instability was noted during the inspection.

Overview of crest of dam and upstream slope.

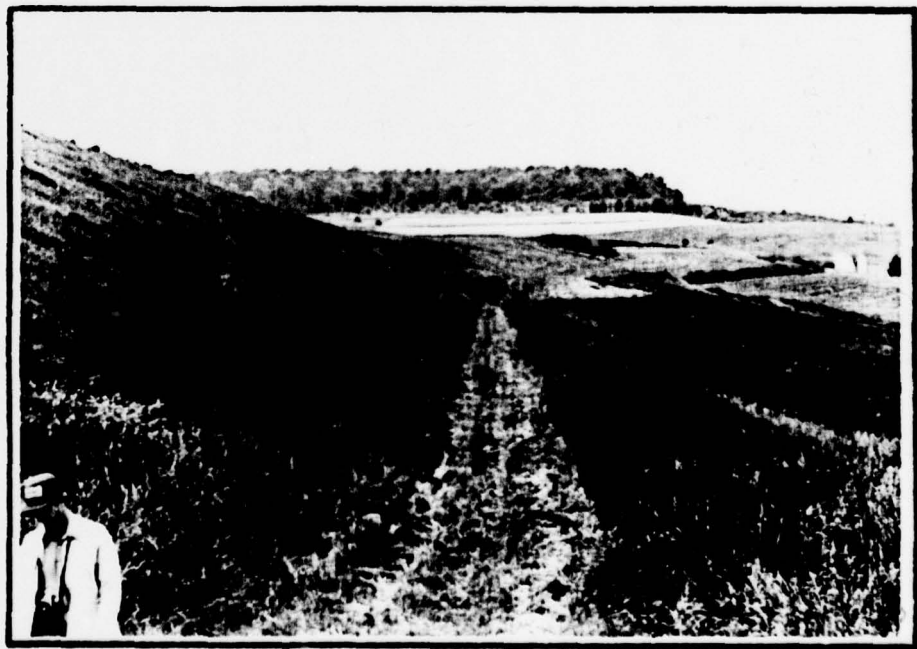
a. Visual Observations. No signs of sloughing, erosion or instability were noted during the inspection. The embankment appears to be in good condition.

Downstream slope of dam.

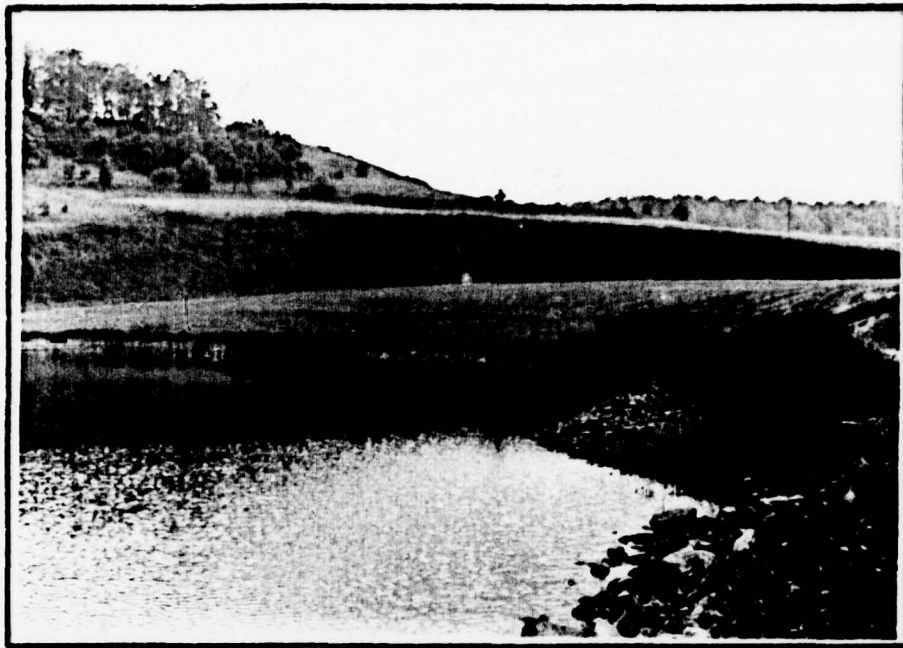
Spillway approach channel.

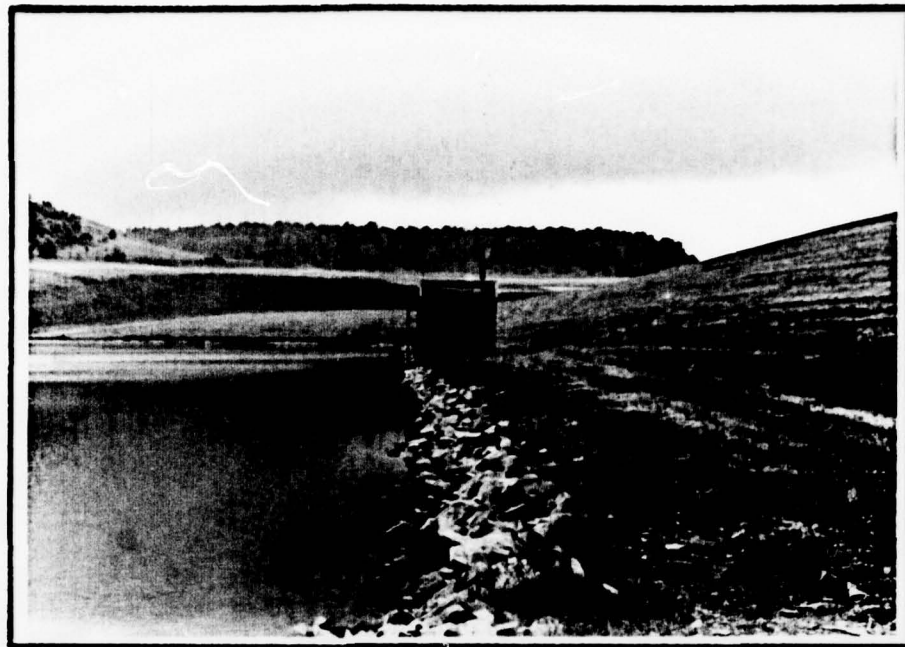
Principal spillway, orifice invert and
drain line structure.

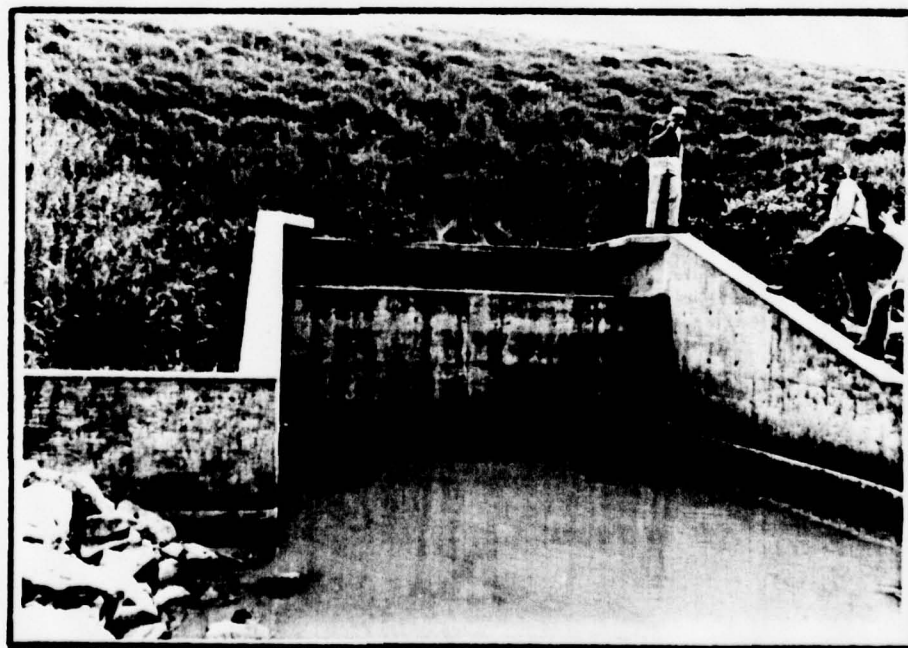
Impact basin at toe of dam.

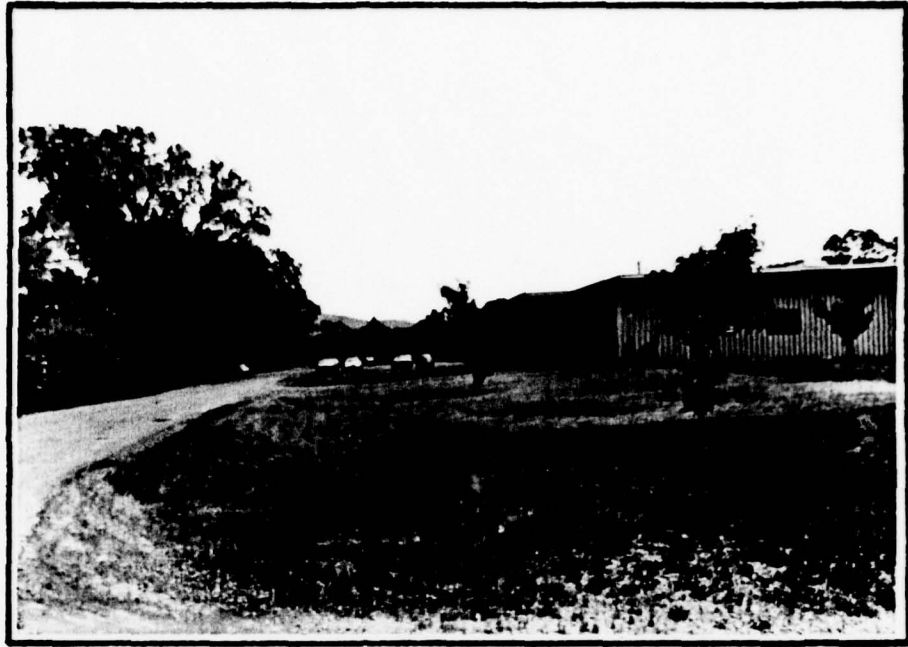
Clothing factory downstream of dam.

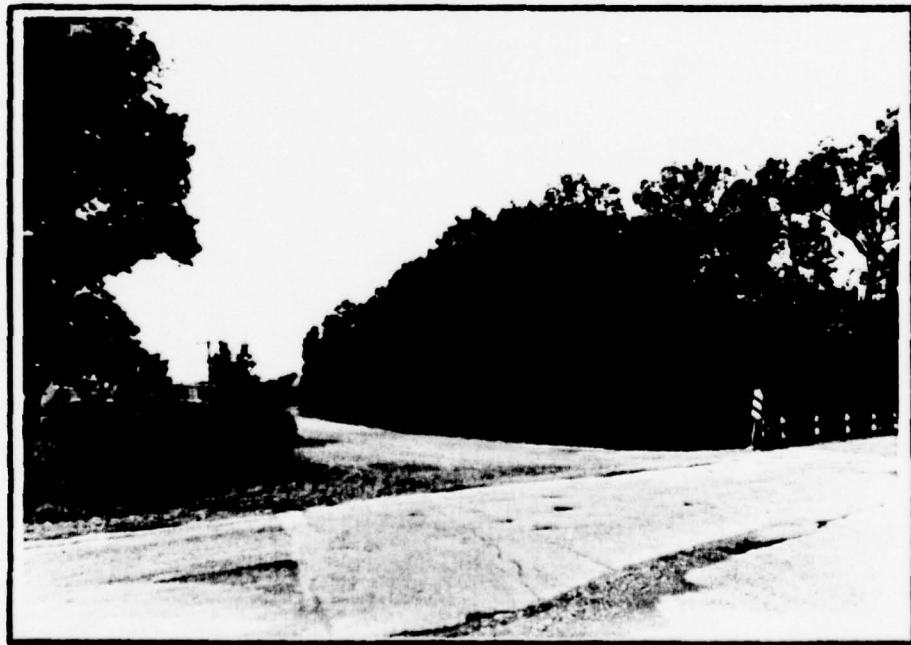
Business downstream of dam.
