PENNSYLVANIA **LEVEL**  
**SHANGRI-LA DAM**

NDI - PA 00248  
PA DER 15-295

PHASE I INSPECTION REPORT  
NATIONAL DAM INSPECTION PROGRAM

Name of Dam: Shangri-La Dam ID #PA00248  
State Located: Pennsylvania  
County Located: Chester  
Stream: Broad Run  
Coordinates: Latitude 39° 47.0', Longitude 75° 44.4'  
Date of Inspection: (June 12, 1979),

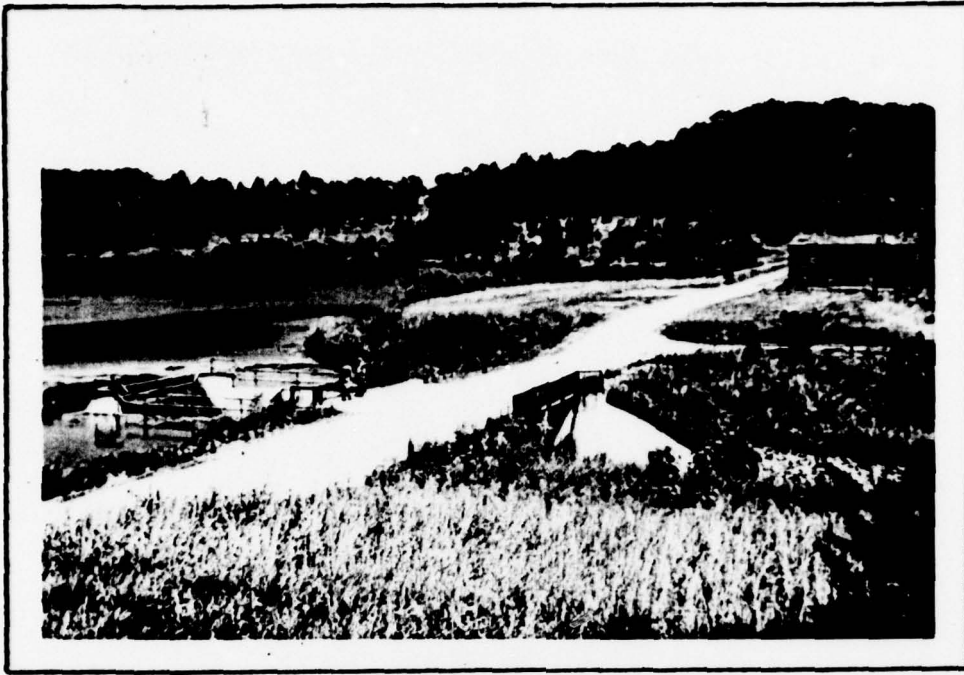
*VIEW OF THE EMBANKMENT FROM THE DOWNSTREAM  
RIGHT ABUTMENT SHOWING THE SPILLWAY SYSTEM*

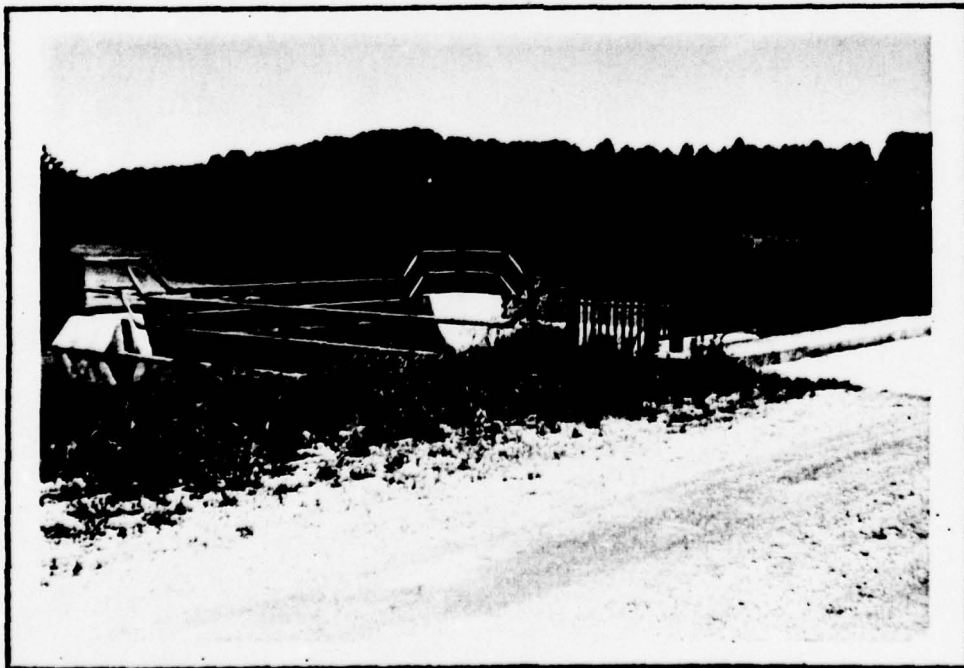
*CLOSE UP OF THE SERVICE SPILLWAY  
NEAR THE RIGHT ABUTMENT OF THE DAM*

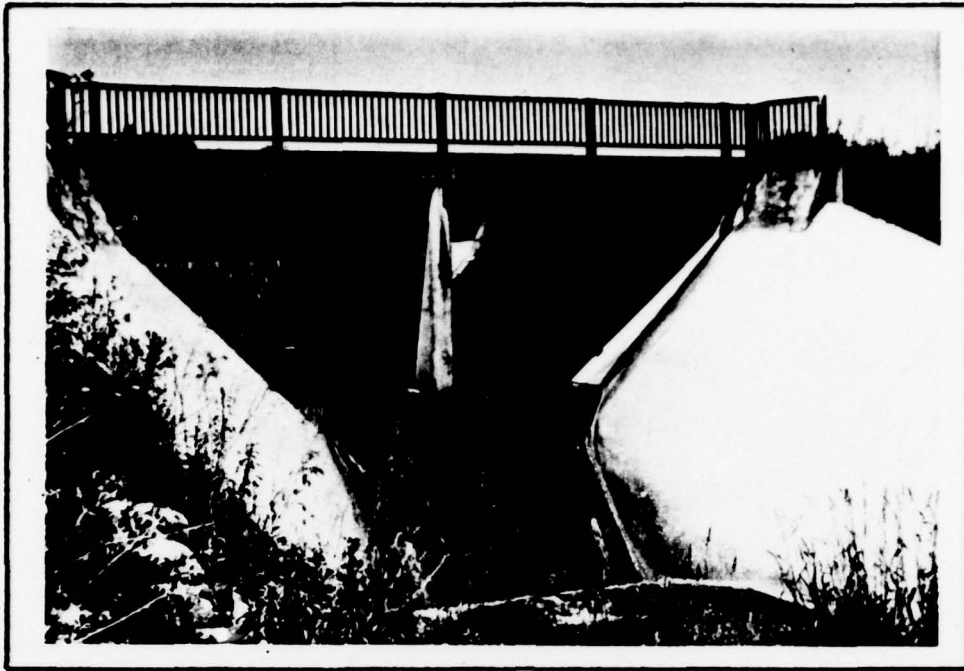
The structural features of the service spillway appear to be in good condition. On the date of the inspection, the spillway discharge channel was overgrown with weeds so that the three drop structures located in the channel could not be inspected properly.

*DROP SECTIONS THROUGH THE SERVICE SPILLWAY  
LOOKING UPSTREAM*

1. The trees, brush, and weeds that have overgrown the dam, spillways and outlet channels should be removed to permit more detailed inspection of the dam. If any distress such as sloughing, cracking, or seepage is observed, the condition should be evaluated by a licensed professional engineer experienced in the design and construction of dams.

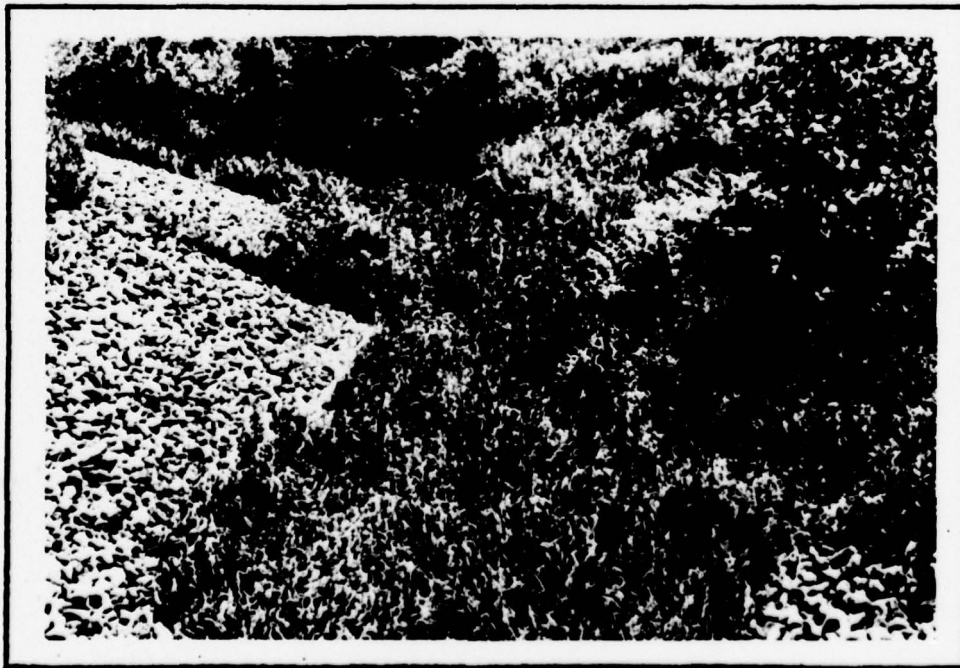
e. Downstream Channel. The spillway discharge channel and outlet works channel were overgrown with weeds and brush and could not be properly inspected. According to the design drawings, the discharge channel merges with the natural stream at a stilling basin located approximately 200 feet downstream of the outlet works impact basin. There are no inhabitable structures along the downstream channel in the area that would be subject to flooding in the event of a dam failure. However, the two bottom floors of the 3-story structure located in the downstream portion of the embankment would be flooded in the event of a dam failure and many lives could be endangered if the building were occupied.

*SPILLWAY DISCHARGE CHANNEL AS VIEWED  
FROM THE BRIDGE OVER THE SERVICE SPILLWAY*

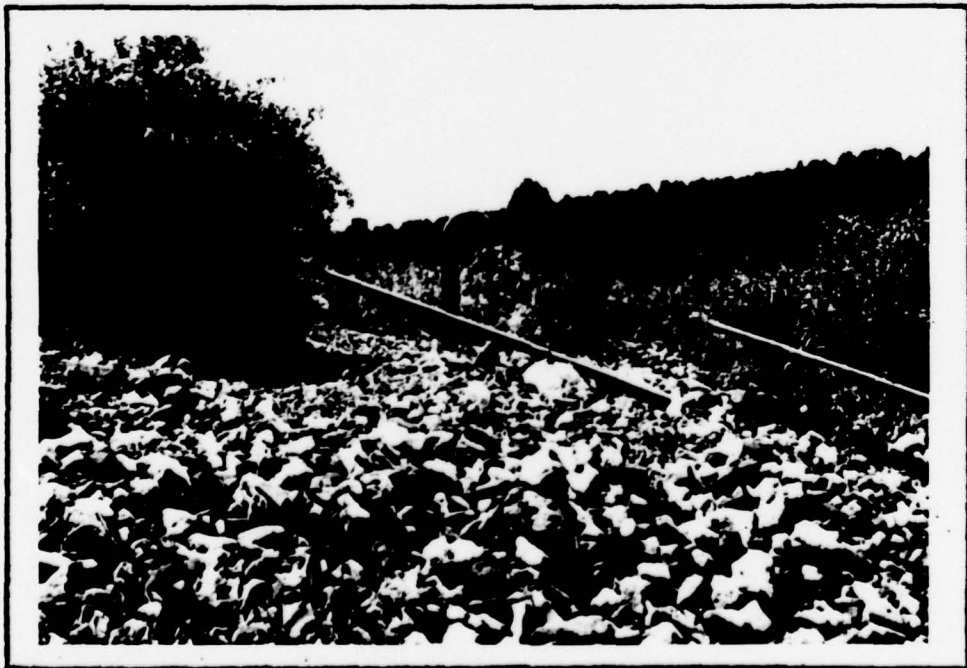
According to the Owner's representative, the operating gates are not maintained on a regular basis. At the time of inspection, the concrete structure upon which the upstream gate controls are located was overgrown with bushes and was not readily accessible. During the inspection, the hand wheel for operation of the 8-inch sluice gate was provided by Mrs. Powell. However, an adapter is required to fit the wheel to the gate stem; therefore, the operating condition of the sluice gate could not be assessed.

*RESERVOIR DRAIN HOIST STEM AND  
HOIST MOUNTING BLOCK*

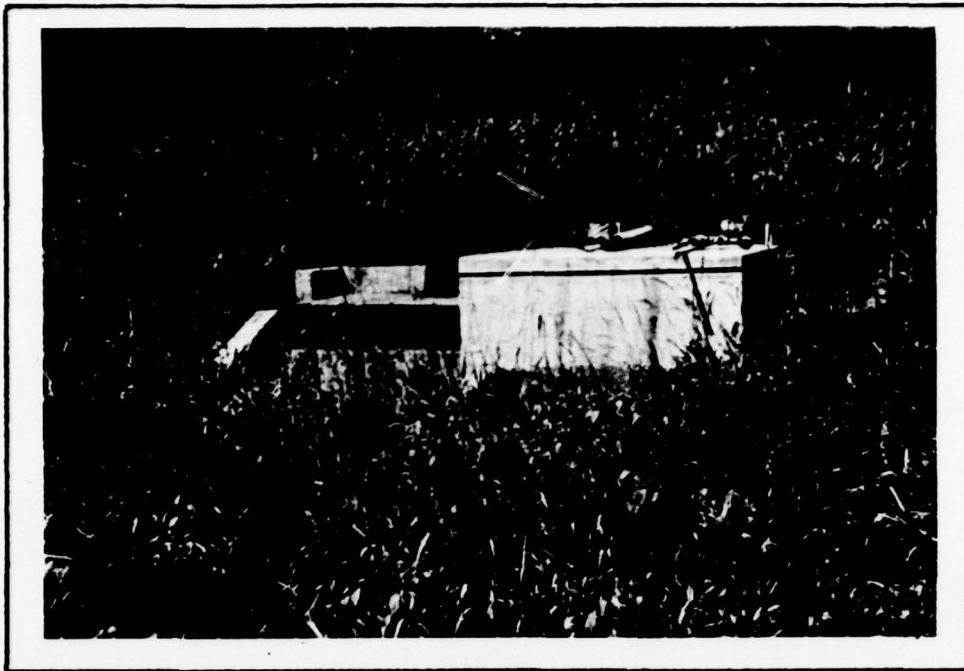
The outlet works impact basin appears to be in good condition. A trapezoidal, riprap-lined stilling basin is located immediately downstream of the impact basin. During the inspection, water was discharging into the basin from a 6-inch diameter galvanized steel pipe which provides drainage in the area of the building. The entire outlet area was overgrown with weeds and brush.

*RESERVOIR DRAIN SYSTEM IMPACT BASIN  
AND BOX OUTLET STRUCTURES*
