BELLWOOD DAM

NDI ID. No. PA - 00524

PHASE I INSPECTION REPORT
NATIONAL DAM INSPECTION PROGRAM

JUNE 1979

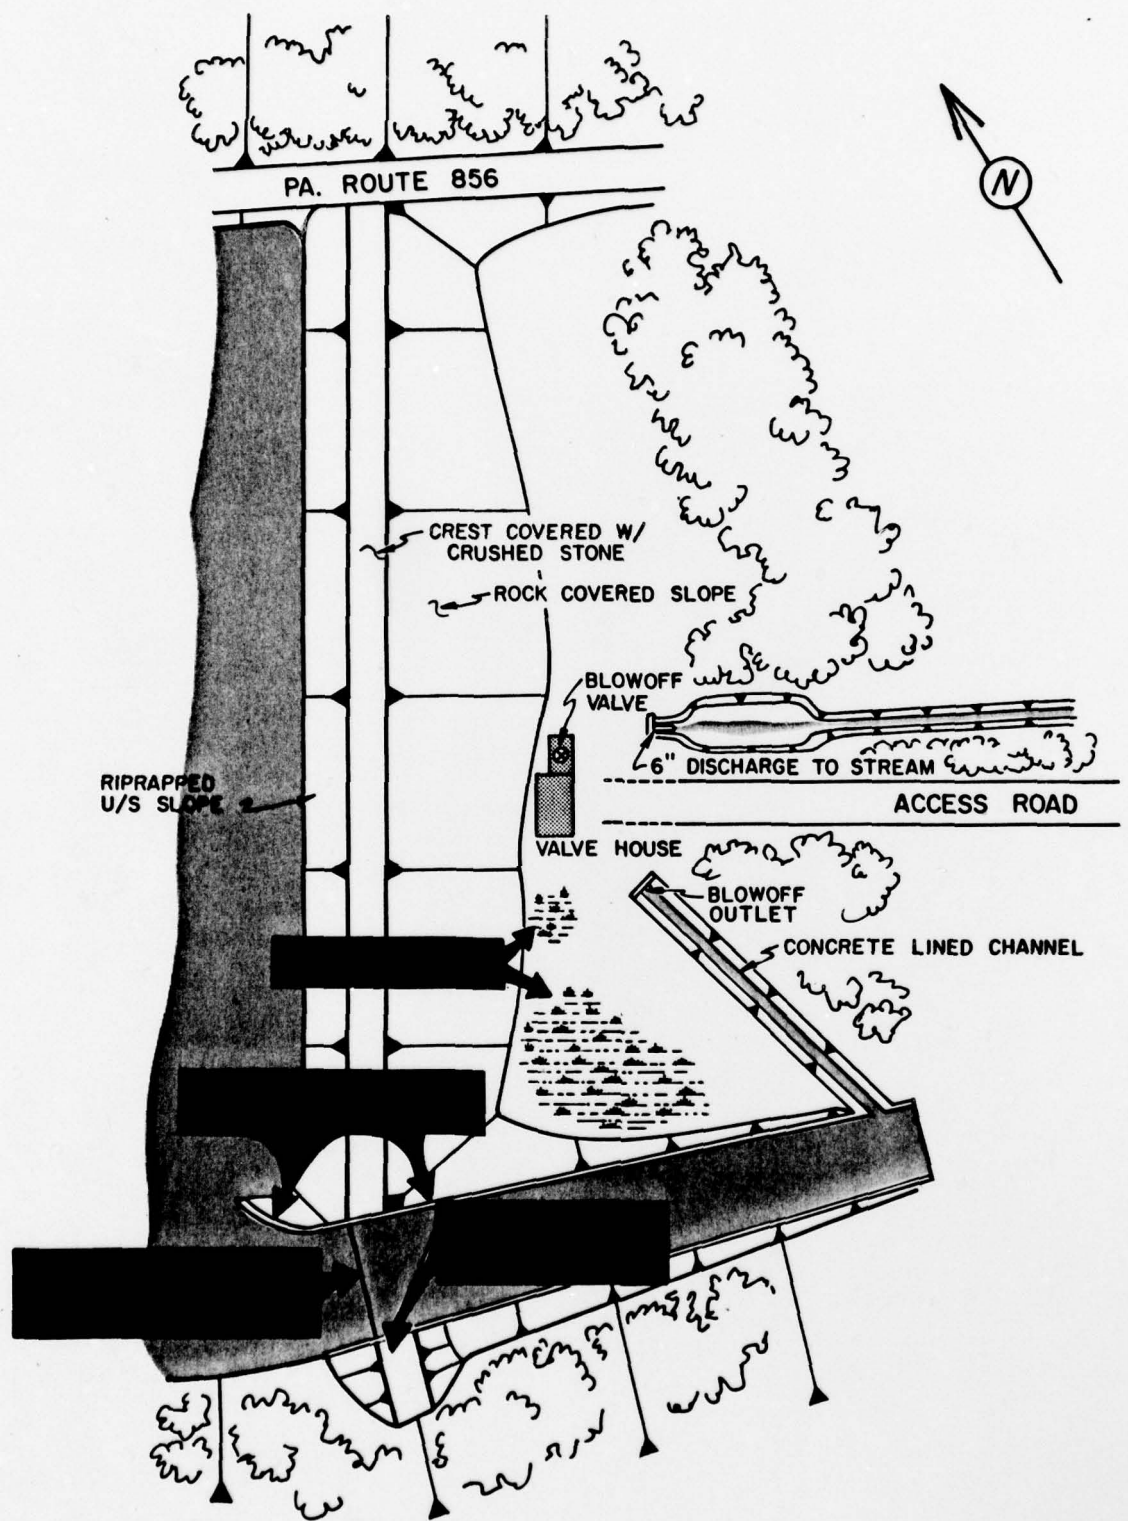
FIGURE 1 - BELLWOOD DAM
GENERAL PLAN
FIELD INSPECTION NOTES

b. Embankment. The visual inspection indicates that the embankment is in good condition and well maintained. Two wet areas were observed below the downstream toe between the spillway and gate house. The smaller of the two areas (about 2 to 3 feet in diameter) is located about 140 feet to the left of the gate house. The larger area is triangular shaped (40 by 100 feet) located adjacent the toe of the embankment and spillway wall slopes (see Photograph 9). No measureable flow was observed in either area. A rough survey performed during the field inspection indicates that the short embankment section to the right (west) of the spillway is approximately 0.9 foot below the design top of dam and thus reduces the effective spillway capacity.
