GRACE MINE TAILINGS DAM

NDI-PA 00715
PA DER 6-445

PHASE I INSPECTION REPORT NATIONAL DAM INSPECTION PROGRAM

Name of Dam: Grace Mine Tailings Dam - ID # PA 00715
State Located: Pennsylvania
County Located: Berks
Stream: Tributary to Hay Creek
Coordinates: Latitude 40^o 11.3' Longitude 75^o 52.1'
Date of Inspection: May 15, 1979

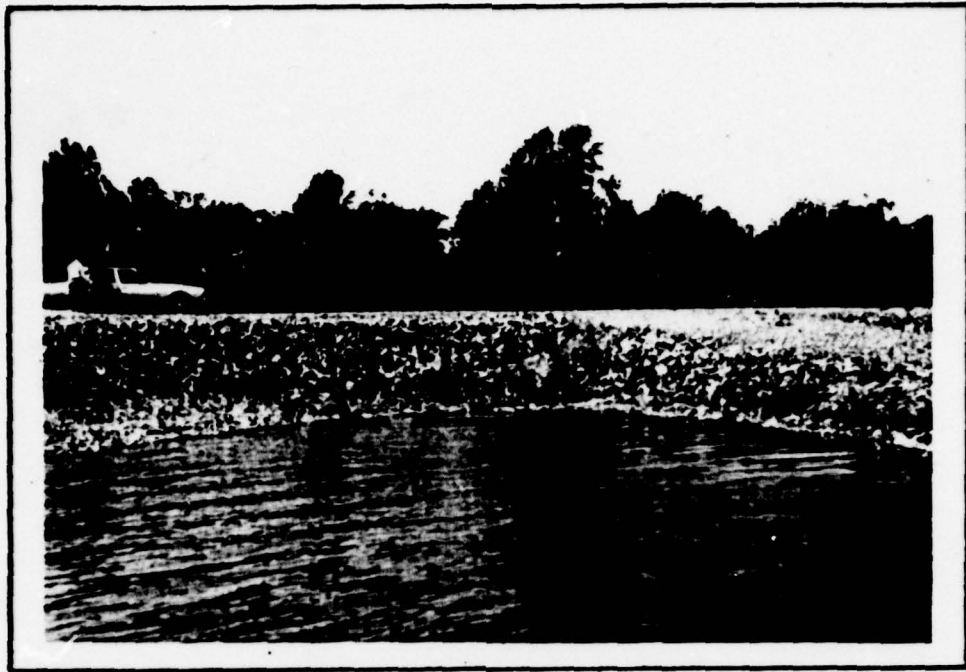
c. Appurtenant Structures. The spillway section is a rock filled channel that is difficult to differentiate from the remainder of the structure on the basis of surface appearance. The condition of the spillway crest and side walls could not be determined. There is no outlet channel provided for the spillway.

*VIEW OF THE ROCK FILLED SPILLWAY SECTION
NEAR THE LEFT ABUTMENT*

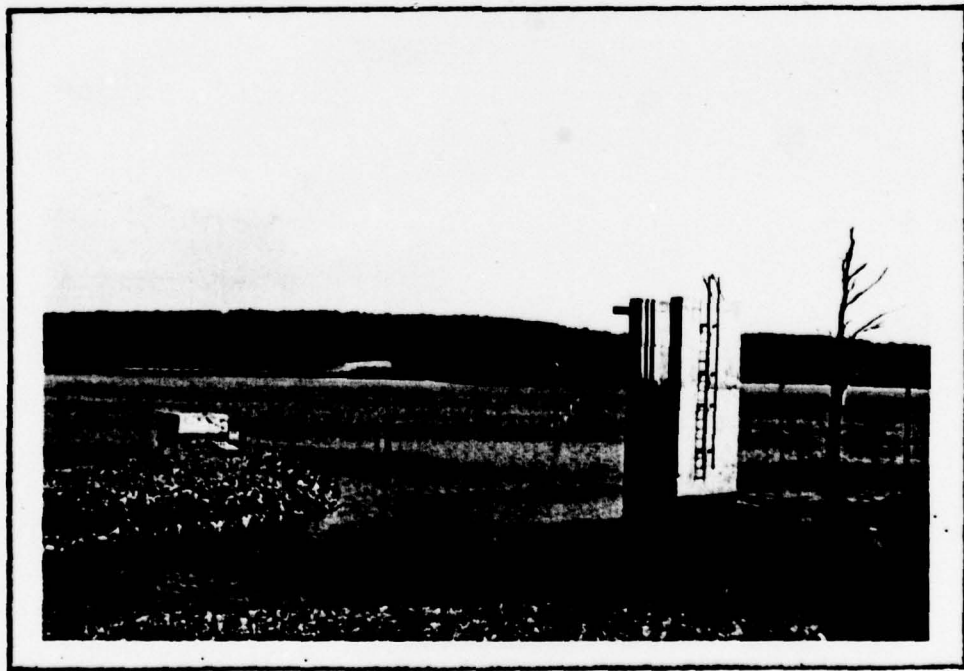
The first three decants were completely submerged on the date of the inspection. The water level was near the top of decant #4 and approximately 1.7 feet below the crest of decant #5. Both decants appeared to be in good condition. The connecting pipe extends beyond decant #5 and above the water surface to natural ground on the left abutment. The outlet pipe was discharging a small amount of flow (0.1 cfs) into the outlet structure during the inspection. The outlet structure is a rectangular concrete box, approximately 10 feet by 12 feet, which releases the flow through a Parshall flume and into the downstream channel. An additional Parshall flume is located in the channel downstream, but it is in a state of disrepair. Some discharge (0.15 cfs) was observed from the outlet end of a 12-inch diameter spring drain pipe which protrudes from the right abutment approximately 70 feet from the outlet structure. Water was also observed flowing down the left abutment slope and into the downstream channel.

The visible portions of decants #4 and #5 appear to be in good condition and show no signs of structural instability.

*DECANT #4 (NEARLY SUBMERGED) AND DECANT #5
NEAR THE LEFT ABUTMENT*

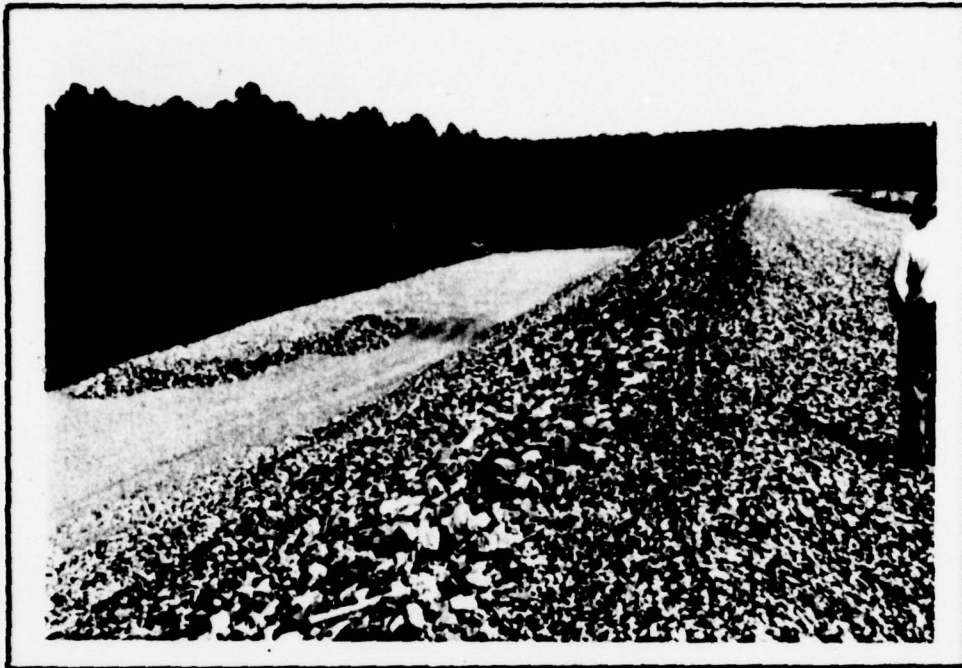
b. Dam. The downstream slope of the embankment appears to be consistent with the design drawing slope of 1.75H:1V. The slope is composed of rockfill, has an 80-foot wide berm at elevation 540 and appears to be in good condition. The visible portion of the upstream slope also appears to be in good condition. The rockfill material on the surface of the dam appears to be well graded.

*TOP PORTION OF THE DOWNSTREAM SLOPE
AND THE DOWNSTREAM BERM*

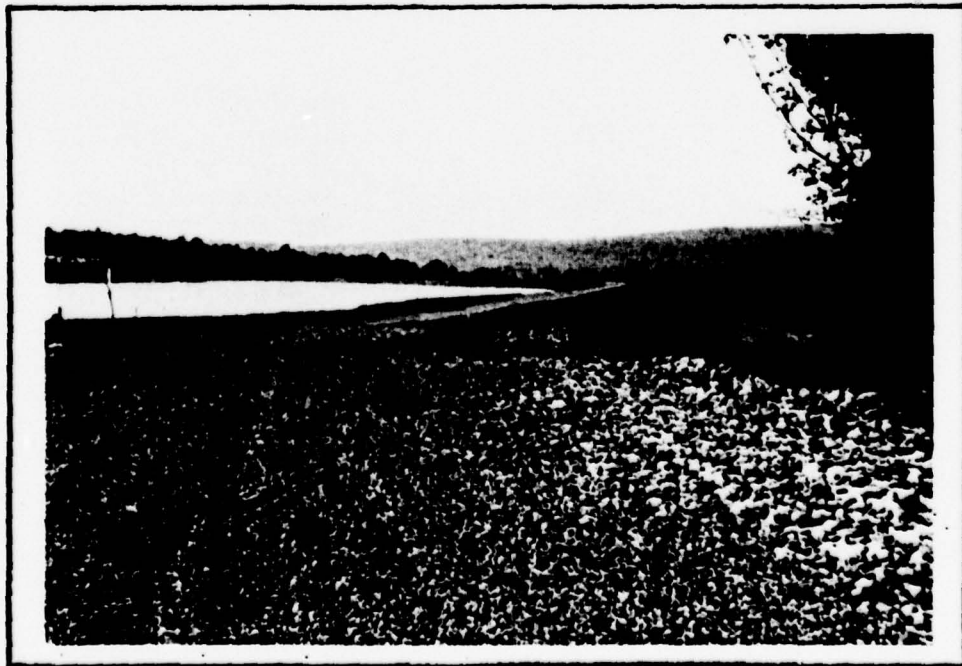
*VIEW OF THE DAM AND RESERVOIR AS
SEEN FROM THE RIGHT ABUTMENT*

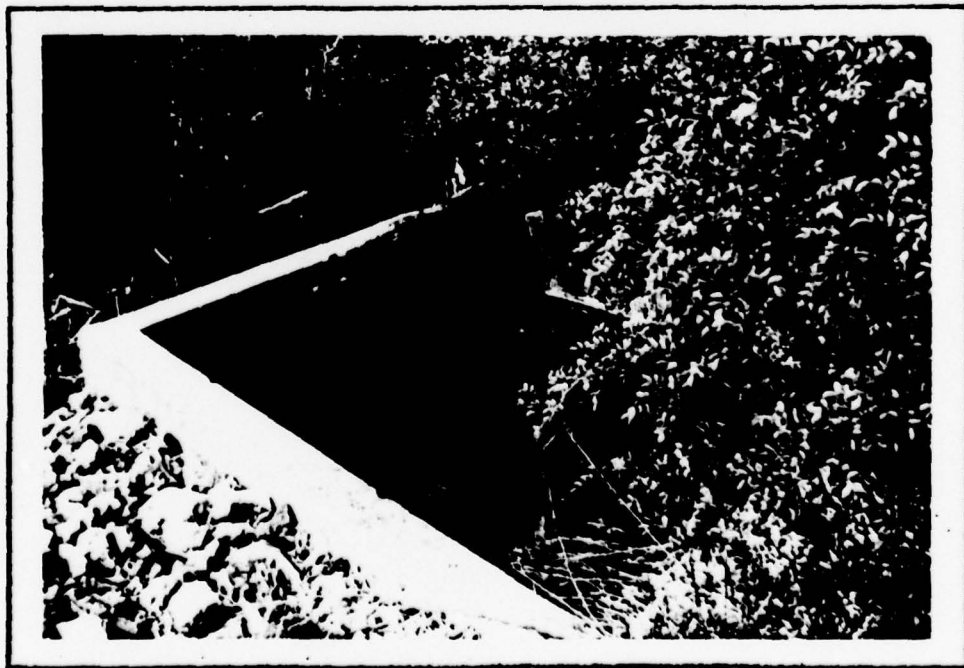
*CONCRETE BOX OUTLET STRUCTURE INTO WHICH THE
20 INCH DIAMETER OUTLET PIPE DISCHARGES*

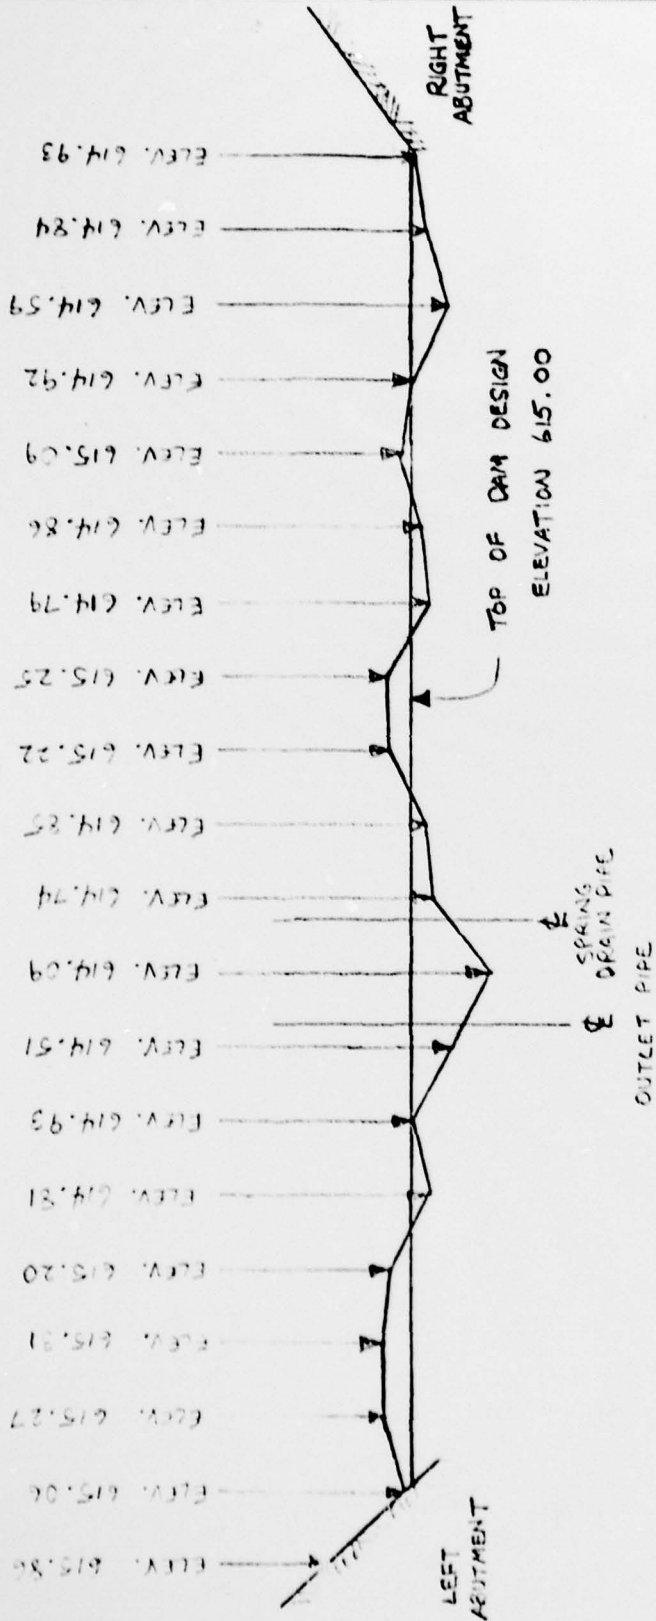
PLATE 10
TOP OF DAM PROFILE
LOOKING DOWNSTREAM

The survey of the crest of the dam revealed variations in elevation of more than a foot (refer to Plate 10, Appendix E). A depressed area located in the vicinity of the outlet pipe centerline was surveyed as nearly a foot below design elevation.

1. The top of the dam should be restored to design elevation with suitable compacted material. Surface monuments should be installed to monitor any future settlement of the top of the dam.
2. The seepage observed at the left abutment should be monitored. If any substantial increases in flow or migration of fines are noted, then a drainage pipe should be provided for this seepage to insure that the integrity of the embankment is not endangered.
