BEAVER LAKE DAM

FINAL INSPECTION REPORT

NATIONAL DAM INSPECTION PROGRAM

6 National Dam Inspection Program.
Beaver Lake Dam (NDS I.D.
Number PA-354, DER I.D. Number
41-10), Beaver Lake Enterprises,
Susquehanna River Basin, Beaver
Run, Lycoming County, Pennsylvania.
Phase I Inspection Report,

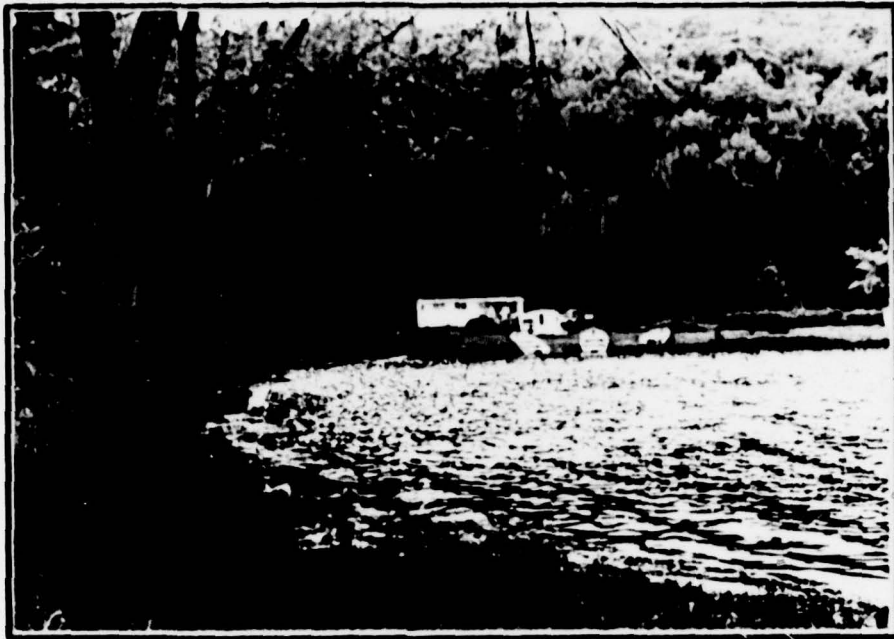
Overview of dam from left abutment.

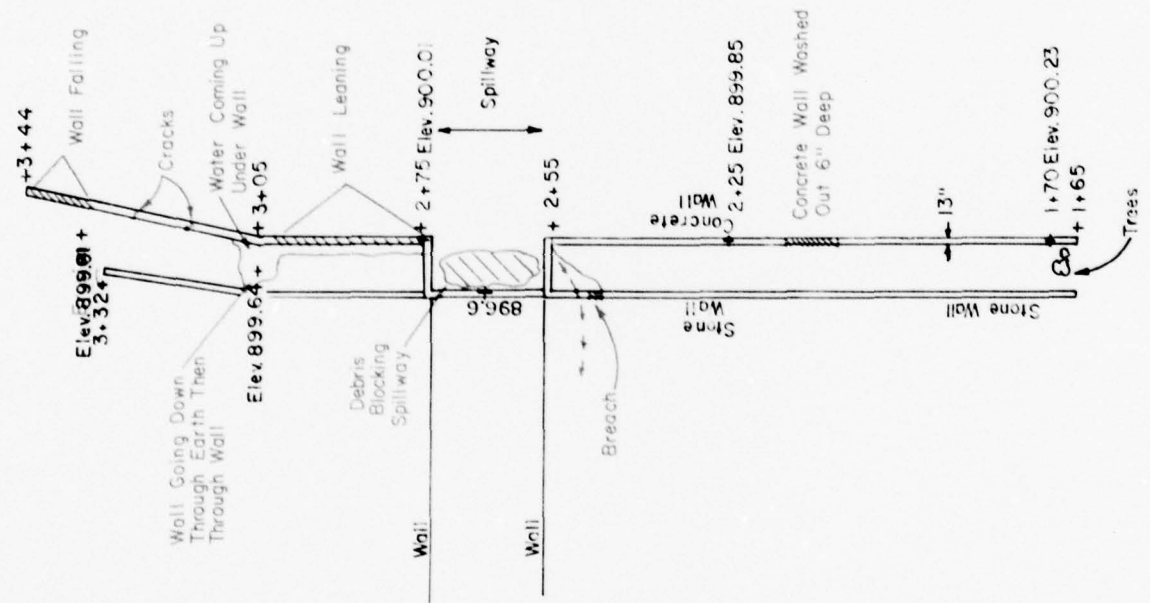
SHEET A-13
BEAVER LAKE DAM
Scale: 1" = 30'

b. Dam. The dam is in very poor condition. The concrete wall on the upstream slope is broken, cracked, deteriorated and leaning. Part of the wall to the left of the spillway has been washed out (See page A-13). To the right of the spillway most of the wall is leaning and may fail. The stone wall forming the downstream slope is in fair condition. Near the left abutment are several large trees growing on the dam. Near station 3 + 05 water is seeping through or under the concrete wall and up onto the embankment crest. The water is then flowing over the crest and down through a hole in the embankment and eventually through the stone wall. The crest varies from elevation 899.8 to 900.2. Water level at the time of inspection was at elevation 899.7. Wave action was carrying water over the crest. In addition, a breach in the spillway left wall was carrying more water over the embankment to the left of the spillway than through the spillway.

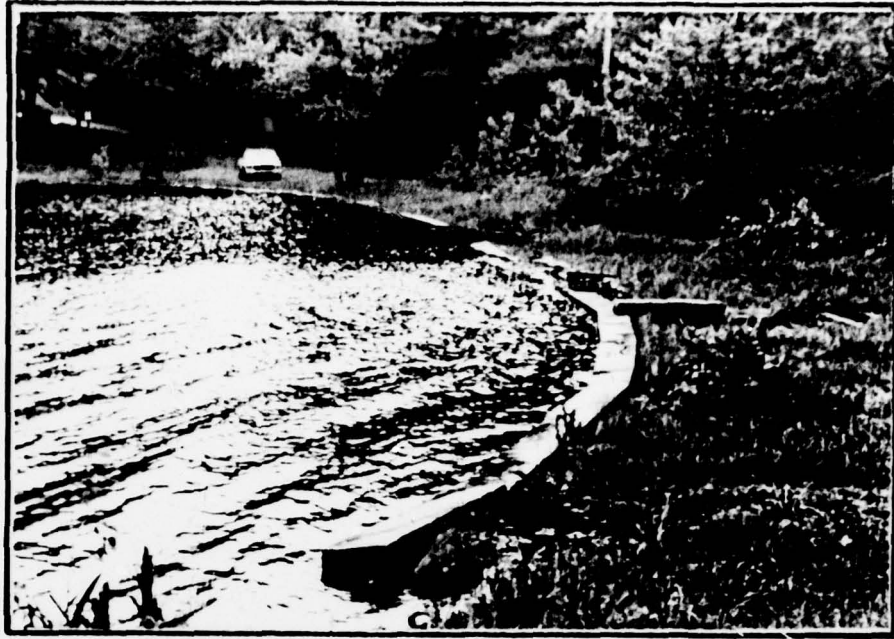
Concrete wall from right end of dam.

- 4. The concrete wall should be repaired and stabilized.
- 5. The left spillway wall should be repaired.
- 6. All holes and erosion of the embankment should be repaired.
- 7. The trees on the embankment should be selectively removed under the direction of an engineer knowledgeable in dam design.
- 8. A warning system should be instituted to warn downstream residents or large spillway discharges or failure of the dam.
- 9. Institute a formal safety inspection program to be conducted at regular intervals.
- 10. A method to drain the reservoir should be developed.

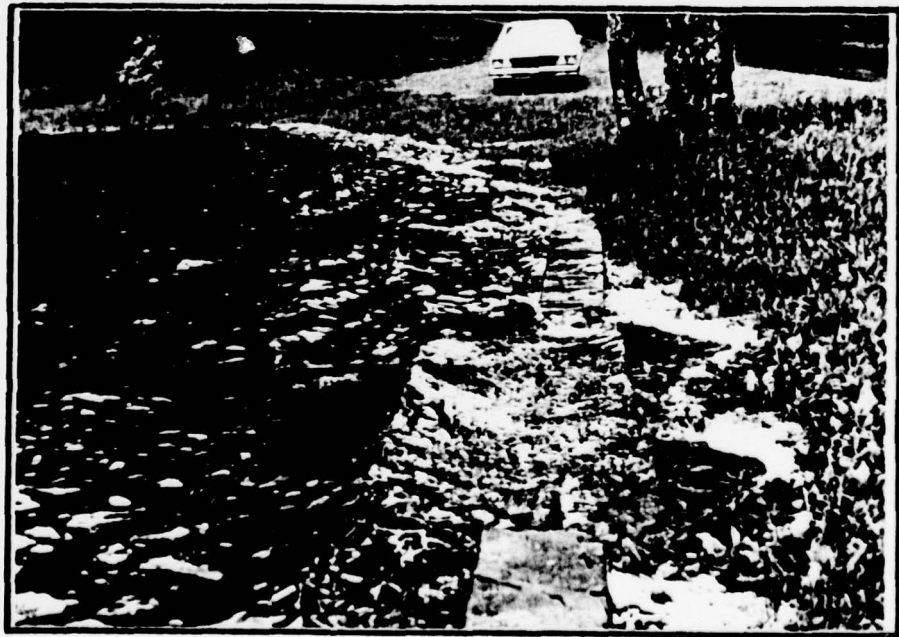
Concrete wall to the left of spillway.
Note no freeboard.

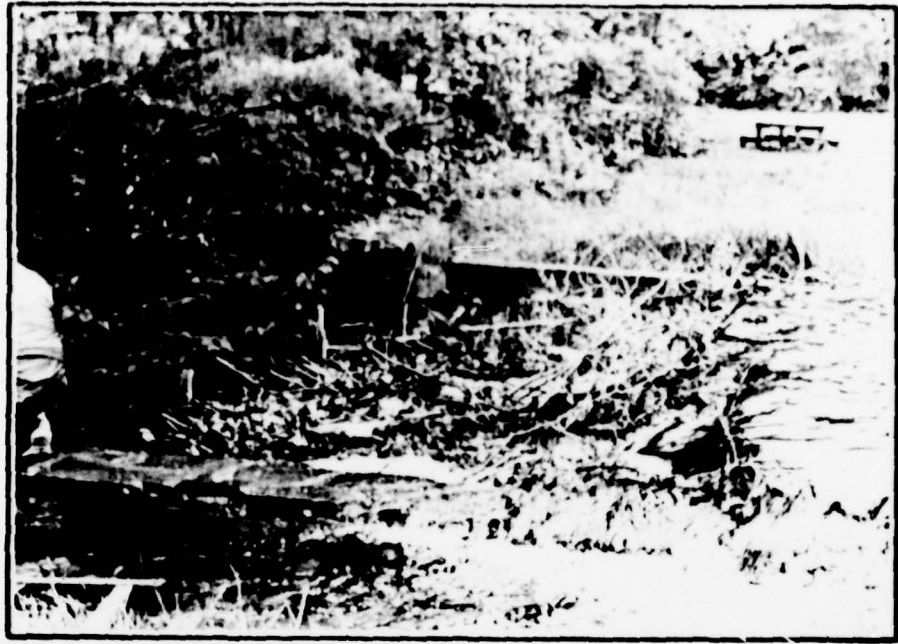
VISUAL EXAMINATION OF	OBSERVATIONS	REMARKS OR RECOMMENDATIONS
CONCRETE WEIR	Fair condition - several flashboards and debris in spillway.	
APPROACH CHANNEL	Lake.	
DISCHARGE CHANNEL	Fair condition.	
BRIDGE AND PIERS	Bridge about 120' downstream.

Debris blocking spillway.

1. The flashboards and debris in the spillway should be removed.
2. A detailed hydrologic and hydraulic study should be conducted by a professional engineer knowledgeable in dam design to increase spillway capacity. The spillway capacity should be increased in accordance with the Corp of Engineers guidelines.
3. The services of a professional engineer knowledgeable in dam design should be retained to evaluate the effect of the seepage through the dam.

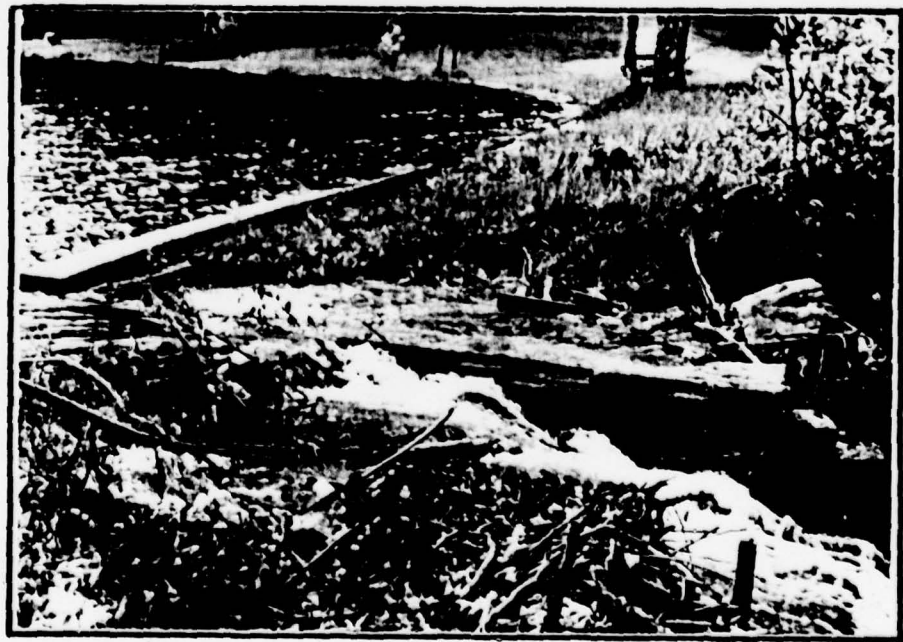
c. Appurtenant Structures. The spillway is located in the center of the dam. The concrete crest is 3 feet (896.6) below top of dam. However, during the inspection several flashboards and debris in the form of sticks, brush and tires blocked the spillway making the crest approximately 899.6. The left spillway wall is deteriorated and during the inspection water was flowing over the dam to the left of the spillway. Wave action was also carrying water over the dam. The left abutment of the dam is very flat and during high reservoir there may be flow over this portion.

Debris blocking spillway and water flowing around spillway.

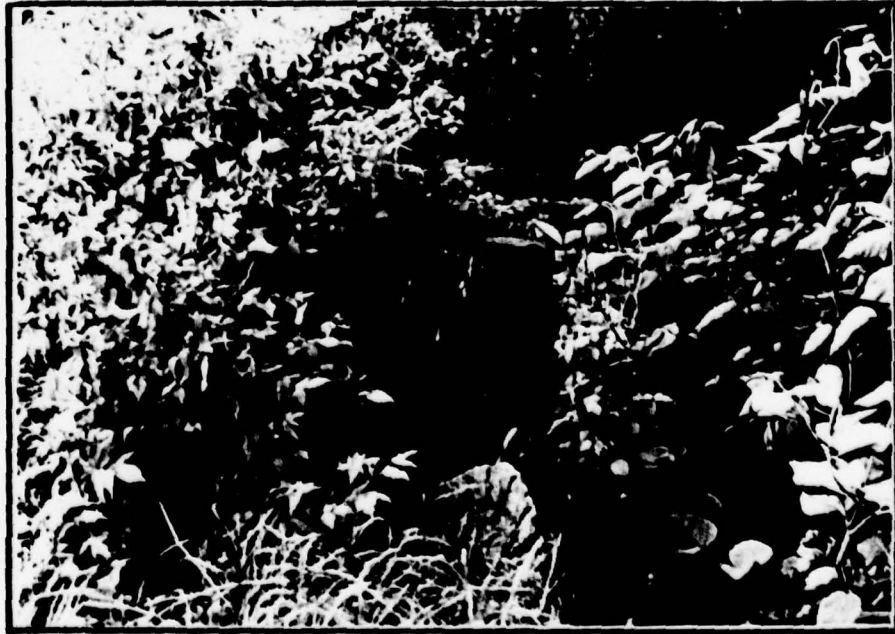
VISUAL EXAMINATION OF	OBSERVATIONS	REMARKS OR RECOMMENDATIONS
VEGETATION	Several trees growing on crest.	
JUNCTION OF EMBANKMENT AND ABUTMENT, SPILLWAY AND DAM	Left spillway wall failed.	
ANY NOTICEABLE SEEPAGE	Seepage under concrete wall and through embankment and stone wall.	
STAFF GAUGE AND RECORDER	None.	
DRAINS	None.

Stump on embankment at stone wall.
