BEAR CREEK LAKE DAM

NDI NO. PA-00610

**PHASE I INSPECTION REPORT
NATIONAL DAM INSPECTION PROGRAM**

BY
Berger Associates, Inc.
Harrisburg, Pennsylvania
AUGUST 1979

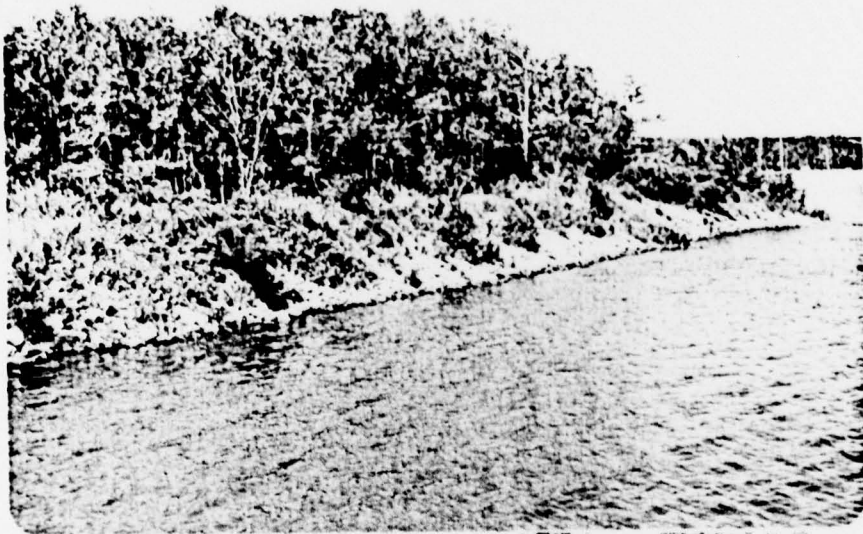
The general appearance of the Bear Creek Lake Dam is fair. This impression is based upon the heavy growth on both the upstream and downstream slopes and the rusty condition of the exposed slide gate control. The concrete spillway and outlet chute are in good condition. The visual inspection check list is in Appendix A of this report. Photographs taken during the inspection are reproduced in Appendix E.

Upstream Slope

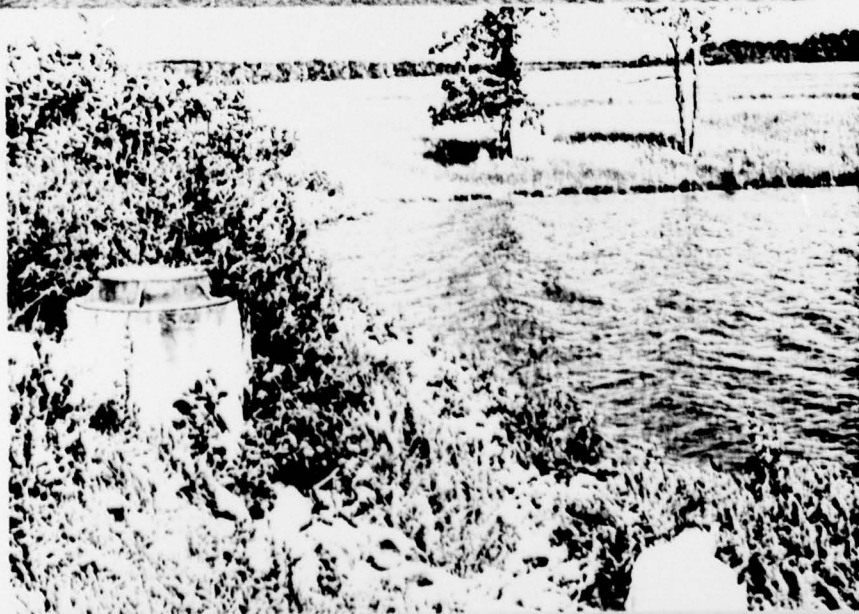
The control structure for the blowoff pipe is a precast concrete manhole. This structure is situated just upstream from the upstream edge of the embankment crest. The outside appearance of this unit is good. The owner indicated that there was no one available to open or operate the valve at this time; therefore, the inside of the structure and the valve could not be inspected. A sloped stem for the control of an upstream slide gate was observed projecting from the upstream slope at the water's edge. The owner indicated that this gate was installed several years after the completion of the dam when the lake was drawn down for repairs. This control was also not operated at the time of this inspection. The stem is in a very rusted condition.

Manhole with
Valve Control

The condition of the control valve and slide gate and the ability to operate these devices was not established during this inspection. A program should be developed for the operation of these controls at least once each year.

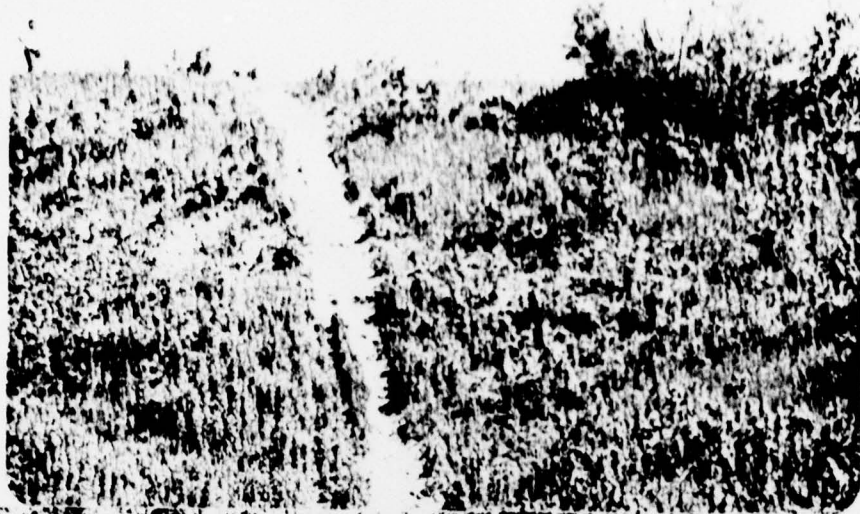
Downstream Slope
with
"Bike" Path

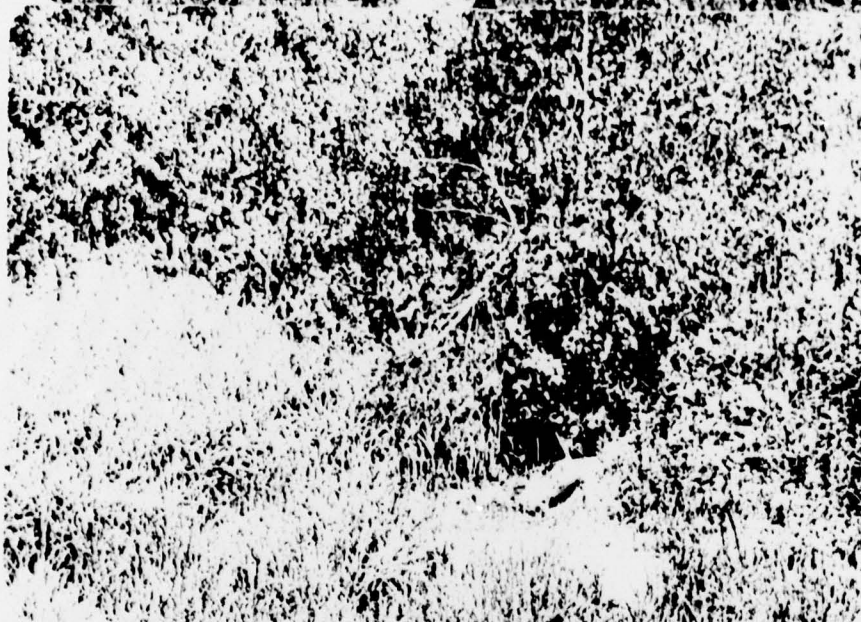
Seepage was noted at the downstream toe and beyond at several locations. At one location, near the outlet structure, the water was stagnant with no apparent flow. The ground surface, beneath the water, was rust colored. A second location, near the right abutment, was actually flowing. The discharge point was right at the toe and the source appeared to be beneath the embankment. Here, again, the bottom was rust colored, but the water was clear.

The seepage observed during the visual inspection appears to be coming from springs under the embankment rather than through the embankment. This condition should not cause any stability problems for the structure. It should, however, be observed on a regular basis.

Seepage of Springs
at
Downstream Toe

3. That the removal of growth on the downstream slope be extended to ten feet downstream from the toe of the slope to allow close observation of the seepage in this area.
4. That regular observations of the seepage condition along the toe of the downstream embankment slope be made and recorded. If changes in volume or clarity are noted, immediate action should be taken to assess and remedy the condition.
5. That the control structure be inspected and examined for pipe alignment and settlement and that the control valve in the structure and the sloping gate on the upstream intake structure be operated to assure their use in the event of an emergency.
6. That the hole adjacent to the right spillway outlet channel wall be cleaned and backfilled.

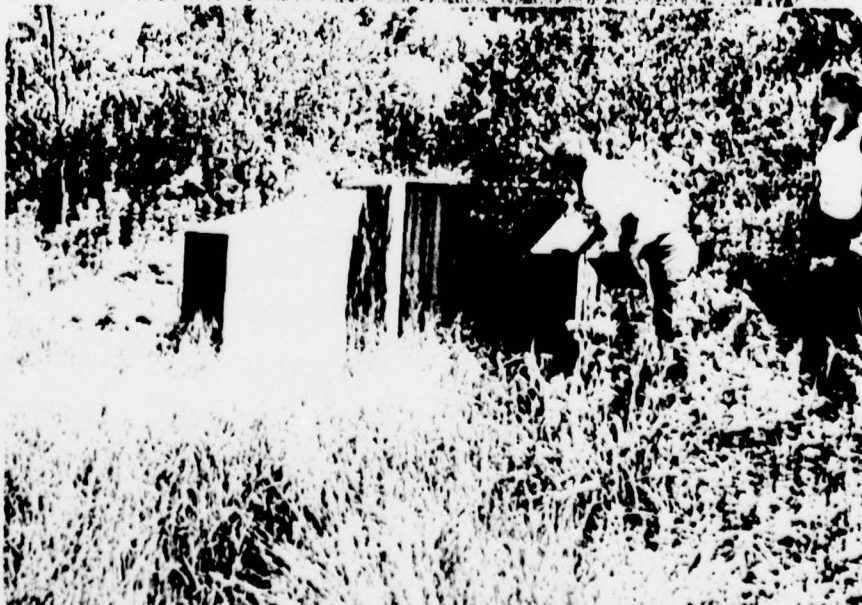
The outlet structure, at the toe of the downstream embankment slope appeared to be in sound and stable condition.

Conduit Outlet

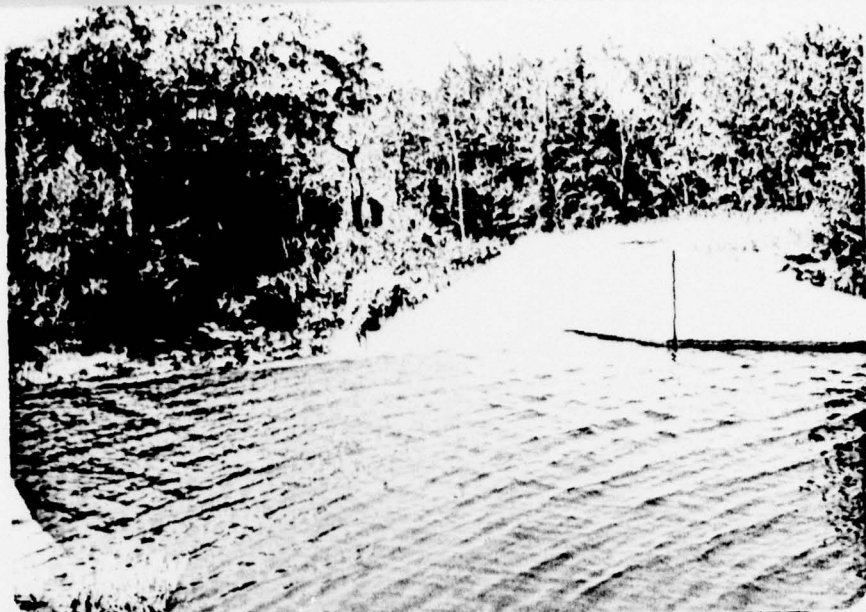
The uncontrolled ogee spillway section was observed to be in very good condition. The approach to the spillway is directly from the reservoir and is unobstructed. The depth of the water, on the upstream side of the weir, was 2.3 feet. Water was just flowing over the crest at the time of this inspection. The concrete lined outlet channel, from the ogee spillway to its terminus is also in good condition. The slopes and walls did not show any signs of distress. The natural channel, downstream from the slab, is unobstructed with a rocky bottom and short slopes. Trees and brush cover the overbanks.

Forebay of
Spillway

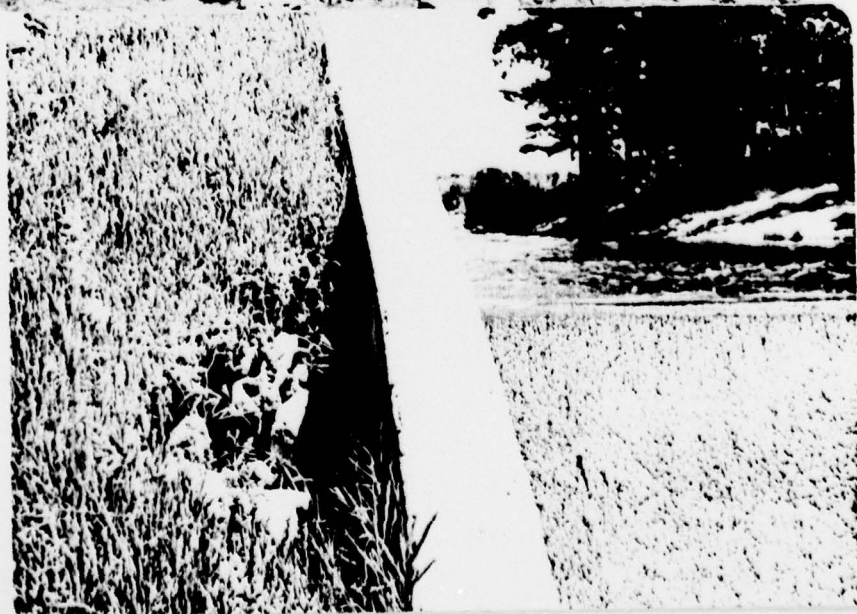
One hole was observed in the embankment adjacent to the right spillway channel wall. This hole is about three feet by six feet in area and about three feet deep. Large stones were noted in this hole. This condition should be repaired to prevent further erosion.

The spillway, spillway outlet channel and walls all appear to be in stable condition. There is no indication of major cracking of the concrete and the walls show no evidence of tilting. At one location on the downstream slope, adjacent to the right spillway outlet channel wall, there is a hole in the embankment. This hole is about three feet by six feet in area and approximately three feet in depth. This hole has not caused any distress to the wall, but should be repaired to prevent any future problems.

Settlement
Adjacent to
Right Spillway
Wall
