PA-467 DAM

NDI ID No. PA-00054
DER ID No. 58-131
SCS ID No. PA-467

SUSQUEHANNA COUNTY COMMISSIONERS
PHASE I INSPECTION REPORT
NATIONAL DAM INSPECTION PROGRAM

AUGUST 1979

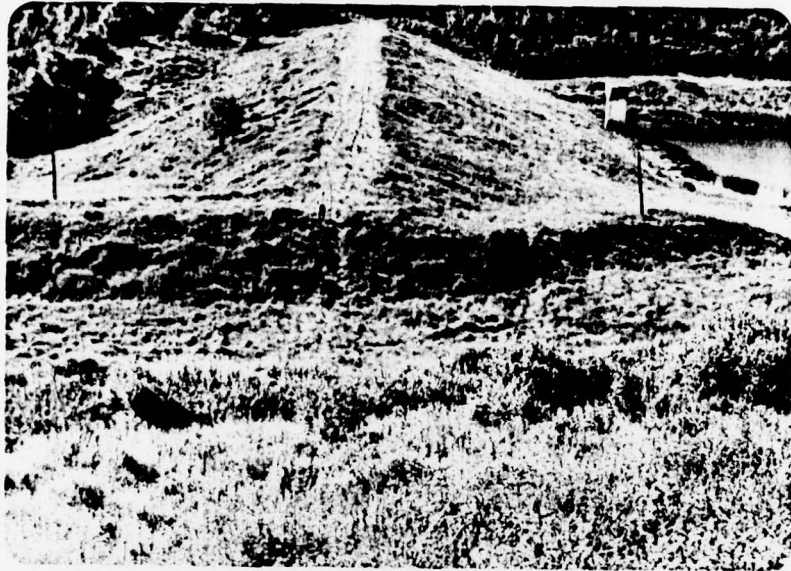
b. Embankment. The embankment is in good condition. The upstream slope has a grass cover and the downstream slope is covered with crownvetch (Photograph A). The vegetal cover is in excellent condition. Surveys performed for this inspection indicated that while both the measured top of dam elevation and the auxiliary spillway crest elevation differ from design values, the relative difference between them is approximately the same. The surveys also showed that the embankment slopes have only minor deviations from the design values. One 4-inch diameter tree was growing on the downstream slope (Photograph A). A communications line, apparently used in connection with a radio system, crosses the top of the dam near the spillway (Photograph A). The line was about 6 feet higher than the top of the dam.

A. Embankment

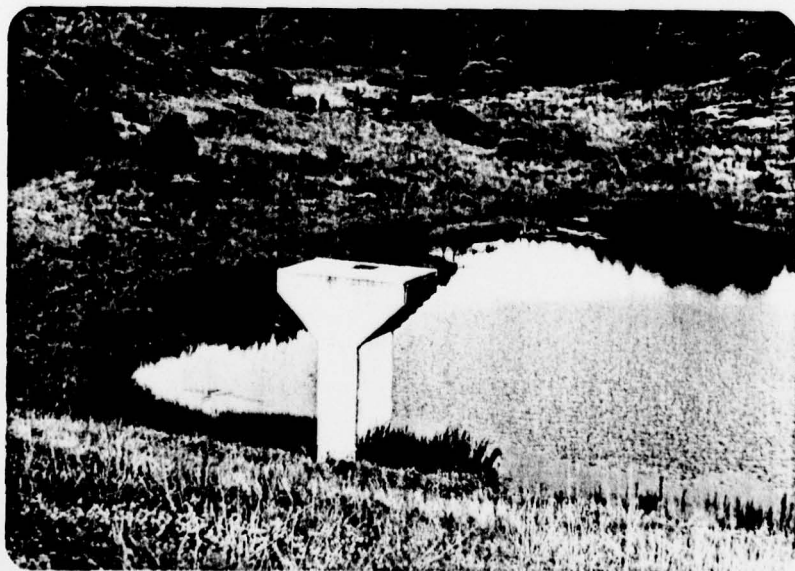
The main spillway riser and impact basin were in good condition (Photographs B and C). An inspection was made of the 30-inch diameter outlet conduit. The conduit was in good condition, but some of the joints were separated. The largest joint openings were located near the axis of the dam and were approximately 1 inch.

B. Main Spillway Riser

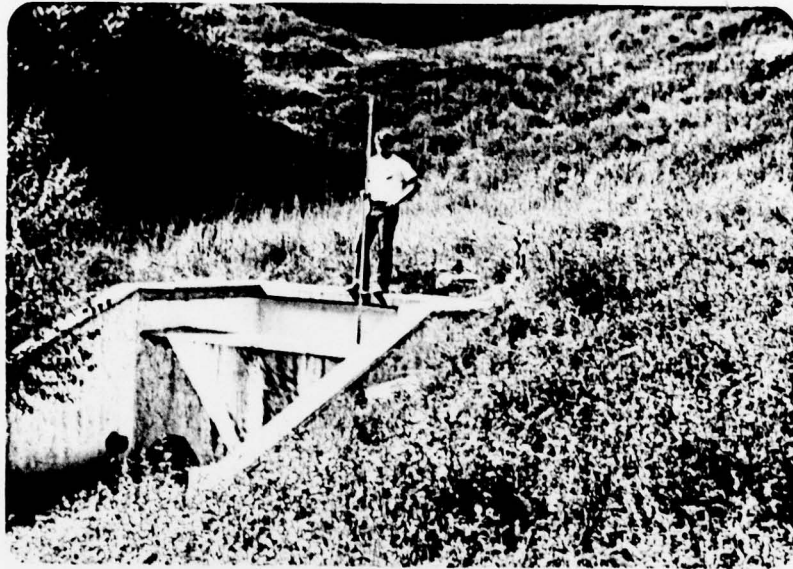
C. Main Spillway Impact Basin

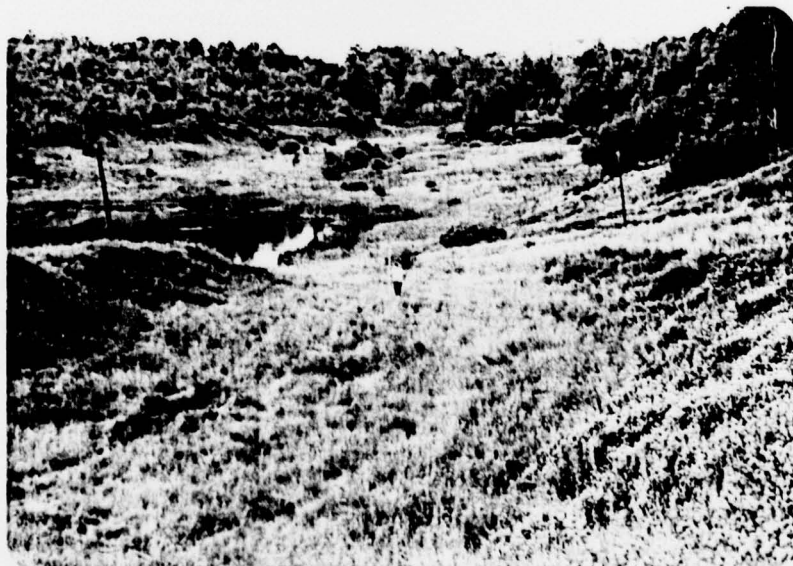
The auxiliary spillway was in good condition (Photographs A, D, and E) except for minor amounts of brush. The previously mentioned communications line spans the spillway approach channel (Photograph D). At its lowest point, the line was at the same elevation as the top of the dam. The embankment extension (dike) downstream from the dam along the right side of the auxiliary spillway outlet channel was in good condition (Photographs E and F). The dike was partially ripped, and the remaining portions were covered with crownvetch.

D. Auxiliary Spillway Approach Channel

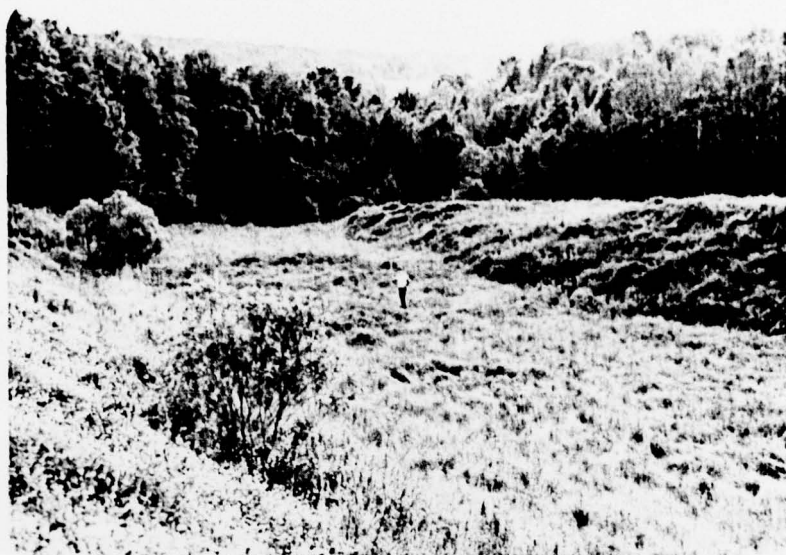
E. Auxiliary Spillway Exit Channel

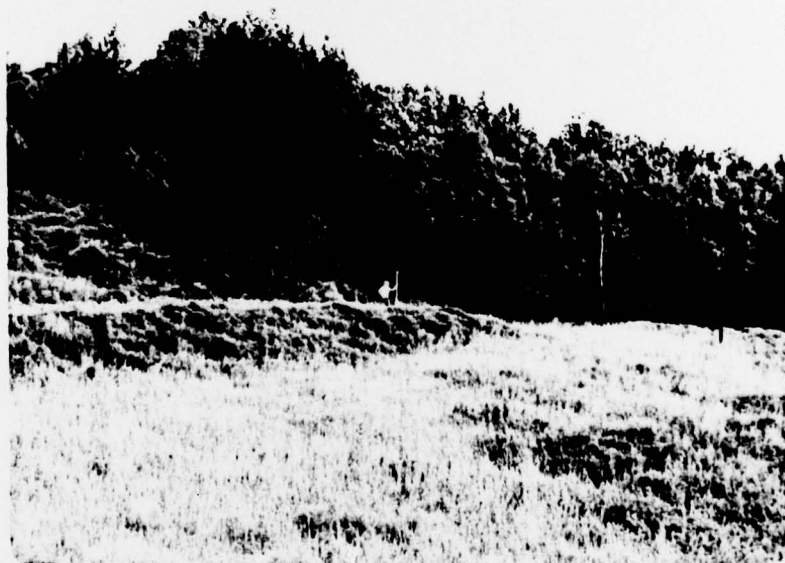
F. Embankment Extension Along Right Side of Auxiliary Spillway Exit Channel
