LAKE MONTROSE DAM

NDI ID NO. PA - 00047

PHASE I INSPECTION REPORT
NATIONAL DAM INSPECTION PROGRAM

AUGUST 1979

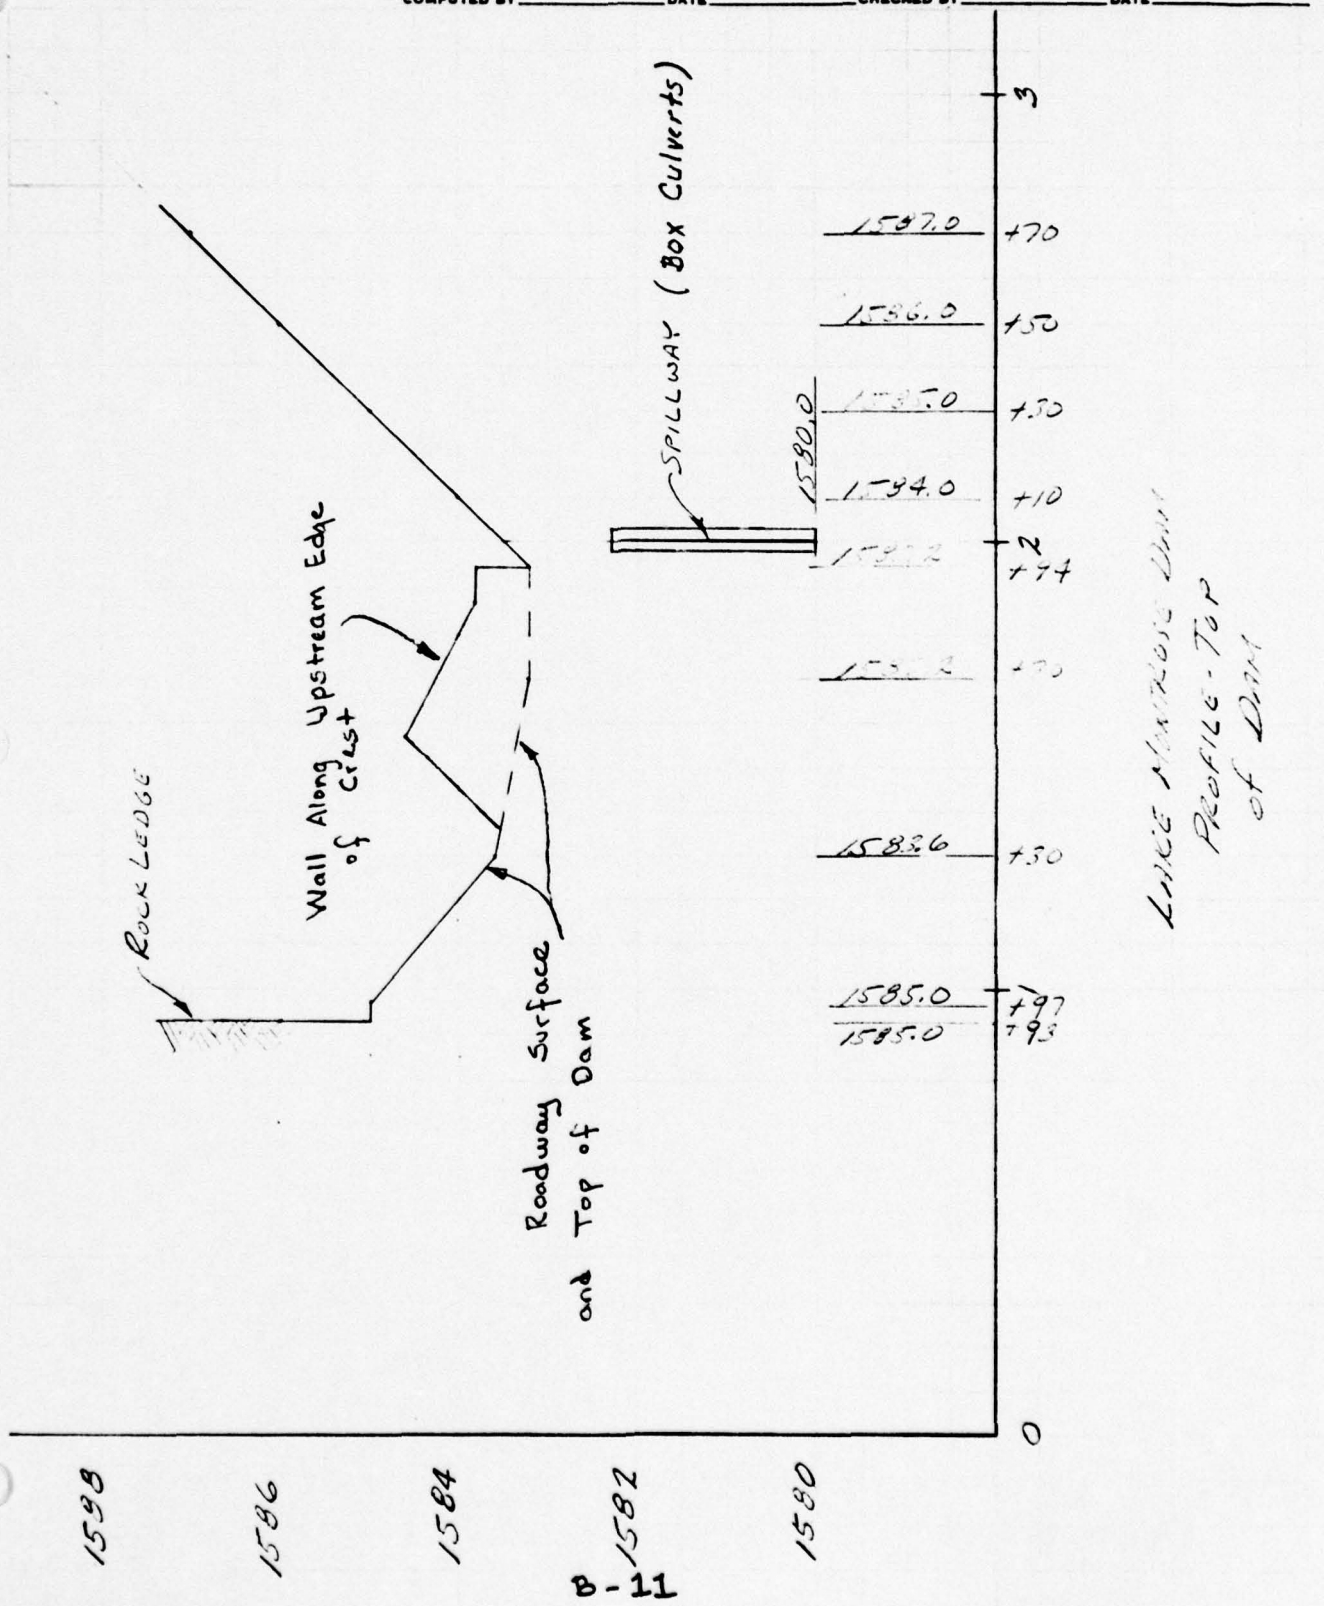
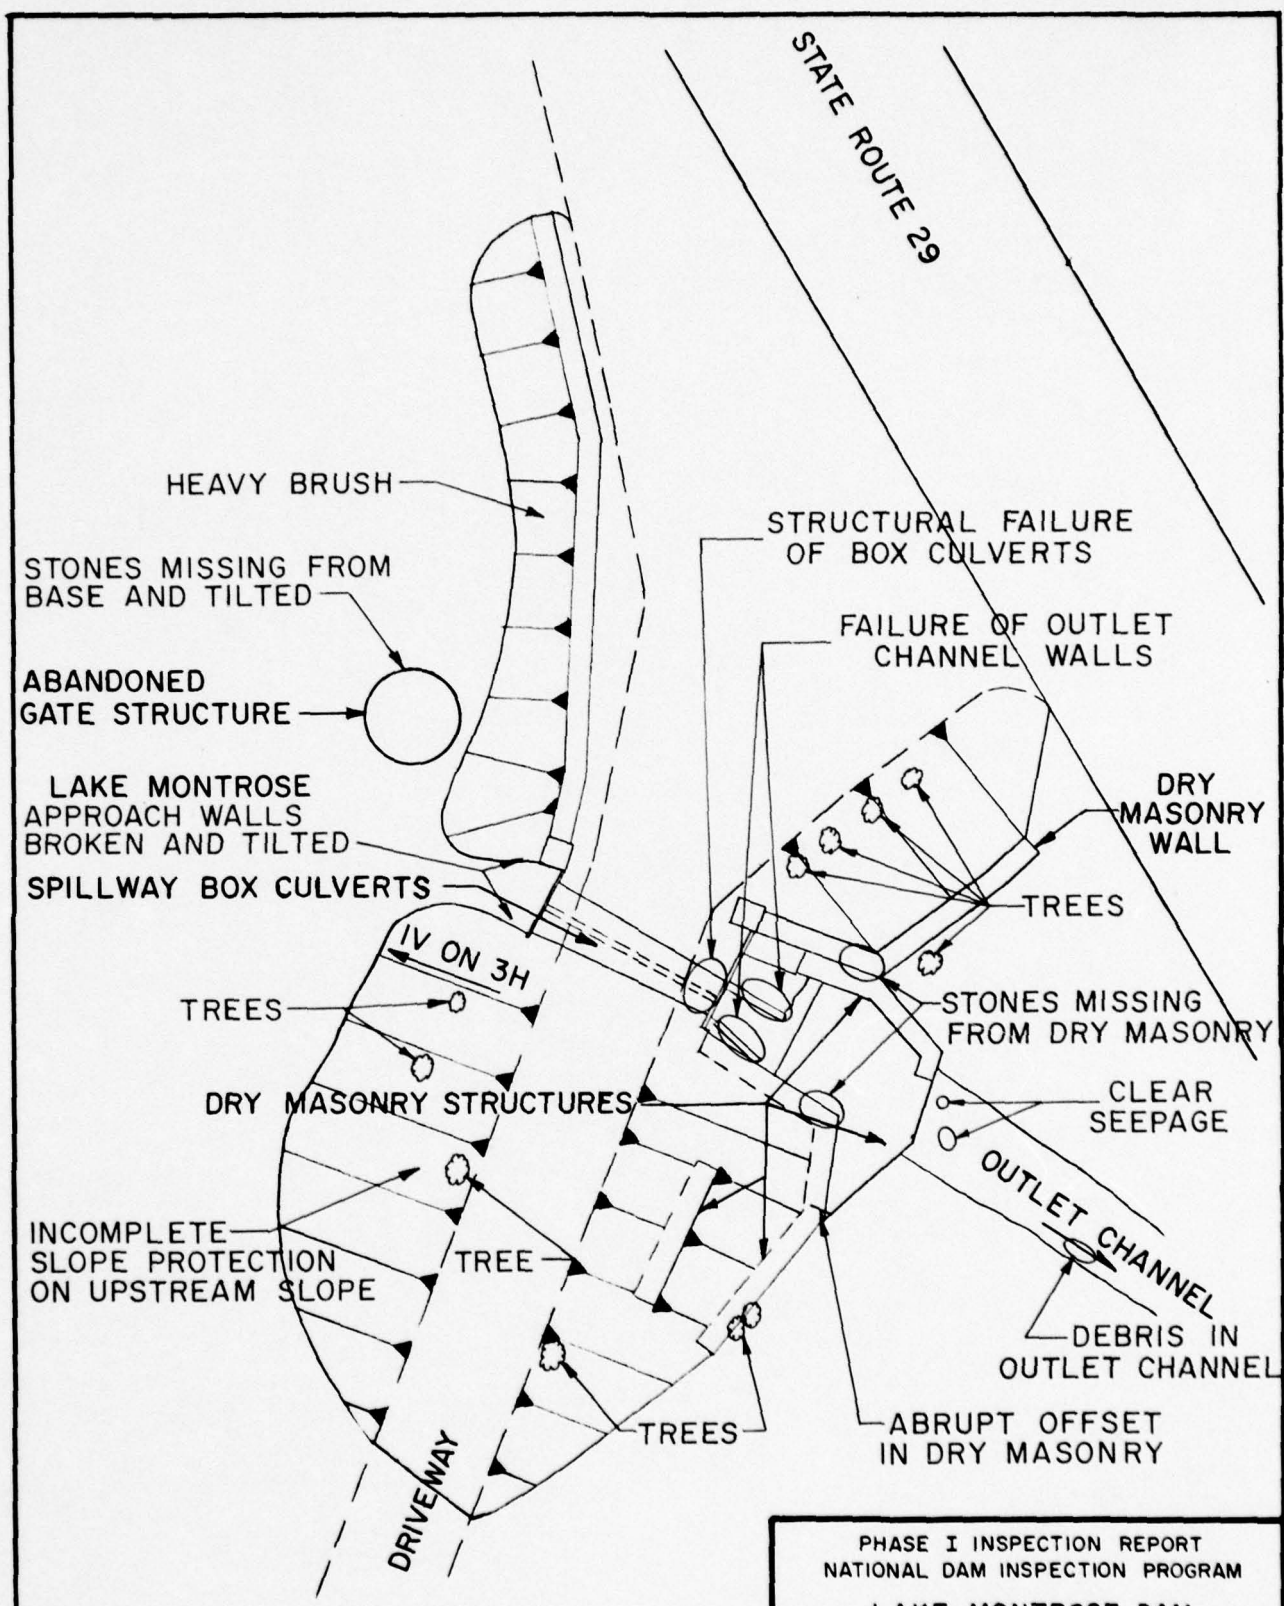
PHASE I INSPECTION REPORT
 NATIONAL DAM INSPECTION PROGRAM
 LAKE MONTROSE DAM
 KEYSTONE WATER COMPANY
 RESULTS OF VISUAL INSPECTION
 AUGUST 1979
 PLATE B-1

a. General. The overall appearance of the dam is poor, with deficiencies as noted herein. The locations of deficiencies are shown in Appendix B on Plate B-1. Survey data acquired during this inspection are presented in Appendix B. Datum for the survey was based on an assumed elevation for the spillway crest, El. 1580.0. The basis for the assumed elevation was the pool elevation shown on the USGS map. On the day of the inspection, the pool was 0.3 foot below the spillway crest.

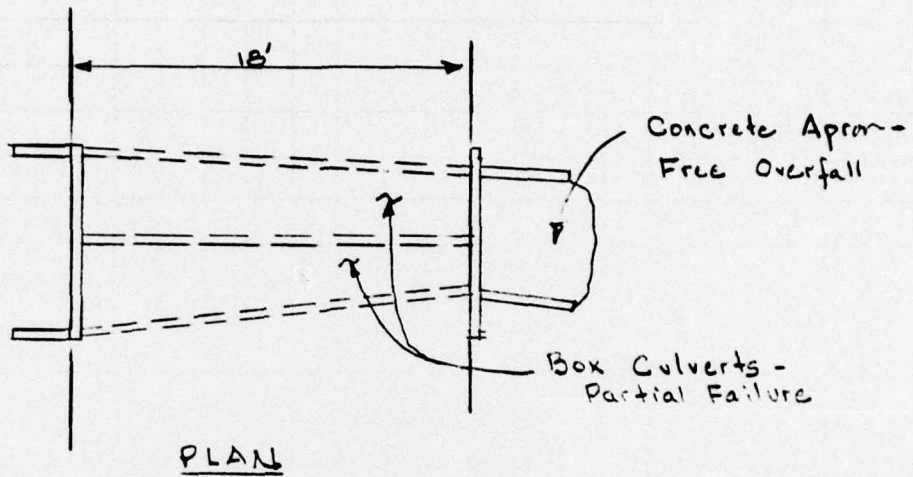
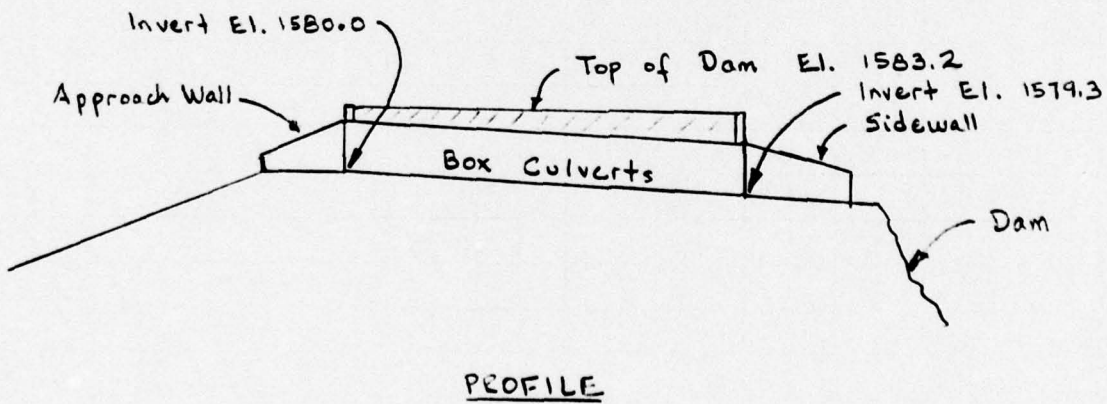
C-6

Culvert Dimensions: Both box culverts have undergone partial failure. The upstream ends are relatively undamaged and each culvert at the upstream end measures 2.3 feet wide by 2.1 feet high. At the downstream ends, the outer walls of the culverts have moved inward and have reduced the openings. The left culvert measured 1.6 feet wide by 2.4 feet high and the right culvert measured 1.3 feet wide by 2.4 feet high.

Note: The culvert dimensions used in the analysis are those at the downstream end. Because of the condition of partial failure, with failure apparently in progress, no more detailed analysis is warranted. Any resulting error will be insignificant in terms of percent of PMF.

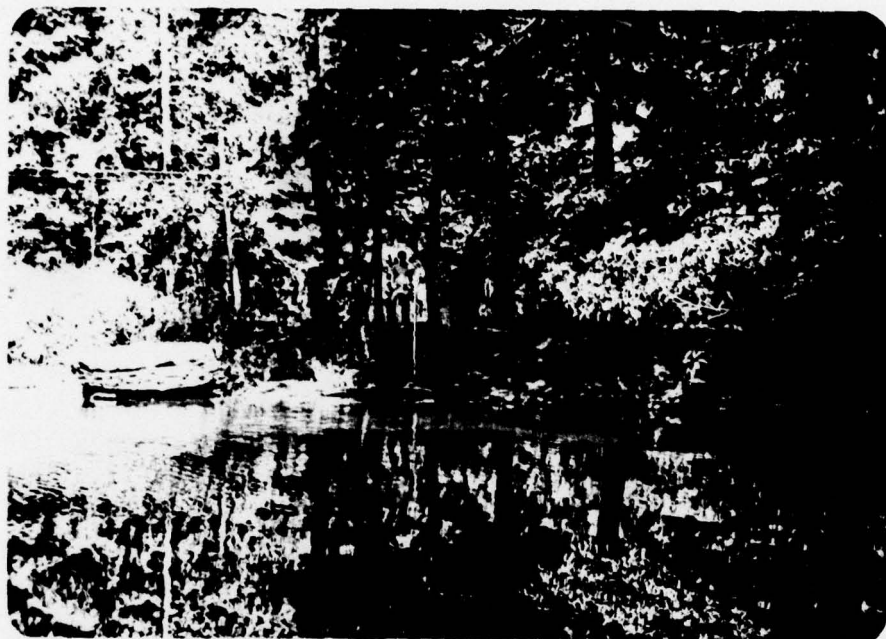
A. Upstream Slope of Embankment.

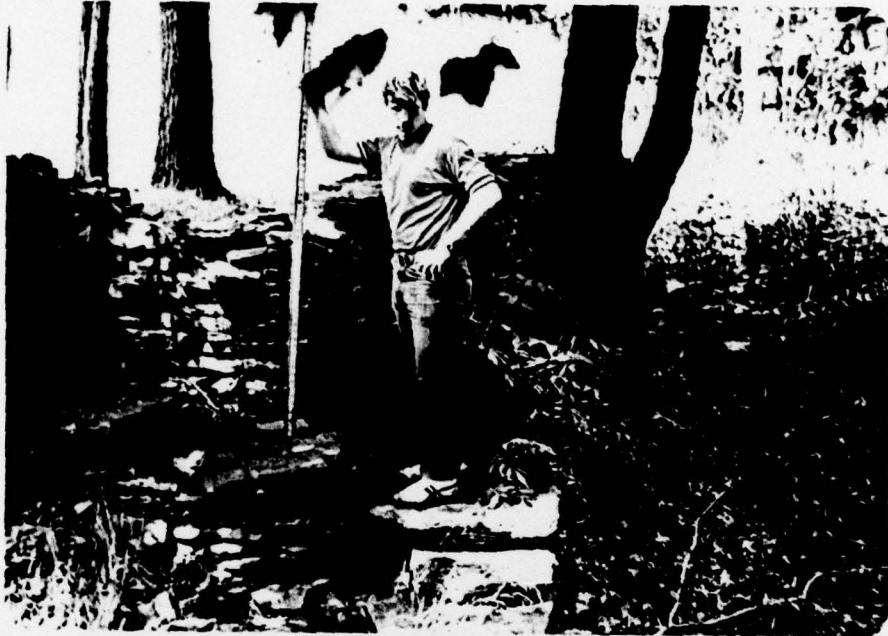
c. Dry Masonry Structure. The downstream portion of the dam is a dry masonry structure (Photographs C, D, E, and F). The portion to the left of the spillway was generally in good condition (Photograph C), except that some stones were missing and a large tree was growing at the toe. The dry masonry in the vicinity of the spillway was in poor condition (Photographs D, E, and F). Many stones were displaced or missing (Photographs D and E). Clear seepage was observed at two locations at the toe of the dam in the vicinity of the spillway. The total seepage was estimated to be approximately 3 gallons per minute. The dry masonry section located to the right of the spillway appeared to be in fair

C. Dry Masonry Structure at Left Abutment.

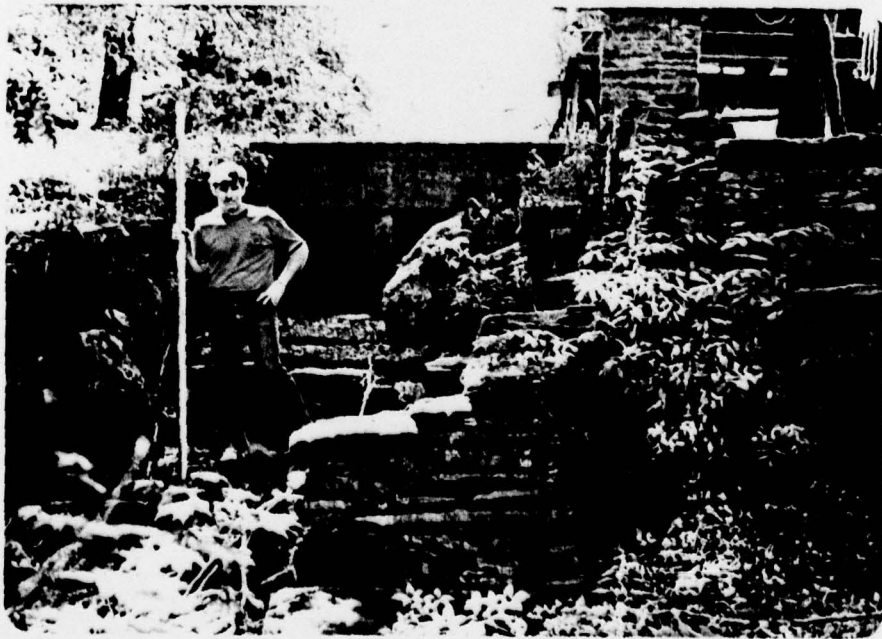
D. Dry Masonry Structure at Spillway.

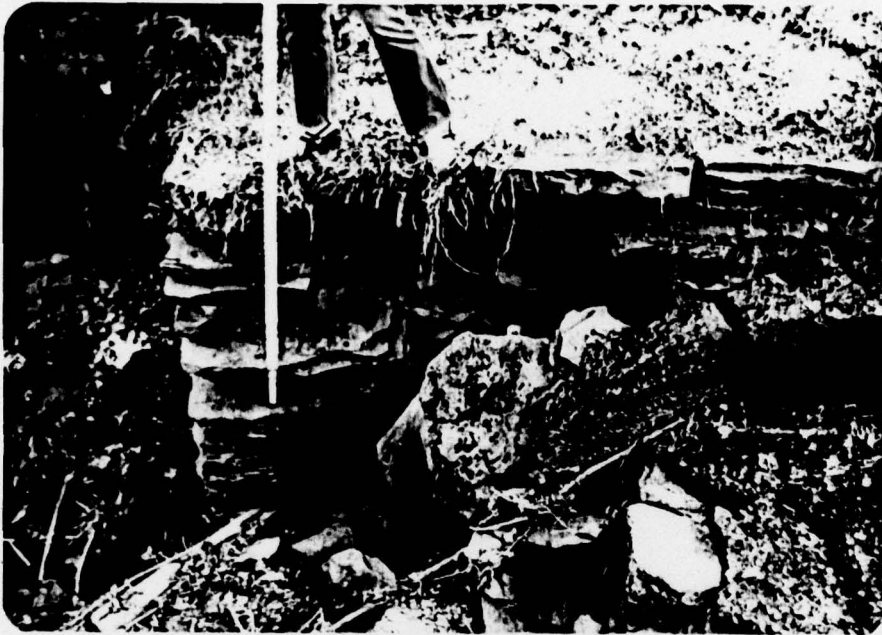
E. Dry Masonry Structure at Spillway.

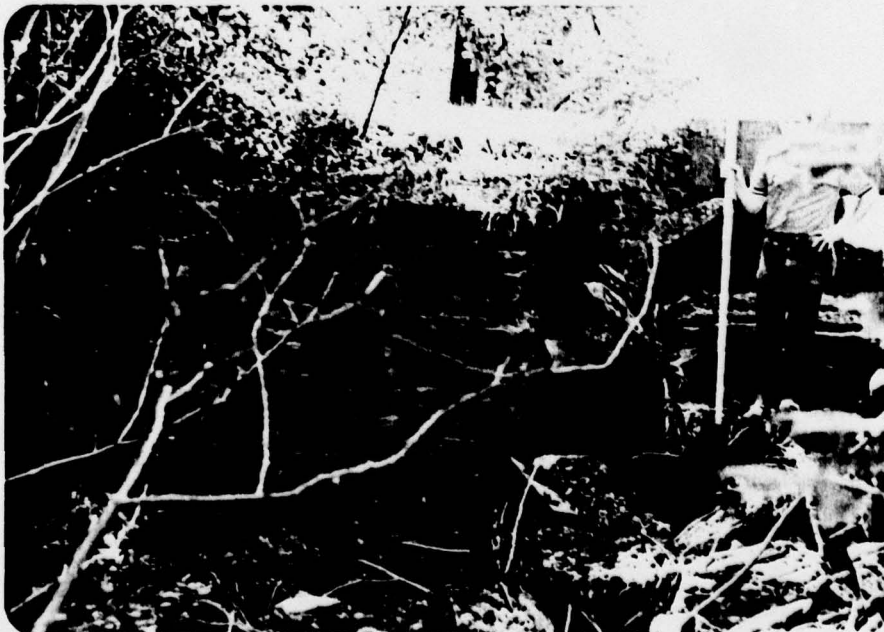
condition (Photograph F). The downstream face had an abrupt horizontal offset located about 6 feet to the right of the spillway outlet channel. The offset measured about 8 inches and was continuous for the full height of the structure at that point. Several large trees were growing at the toe of this portion of the dam. The largest was approximately 20 inches in diameter, and it had roots extending into the dry masonry structure. Rock outcrops were visible along the toe of the dam.

F. Dry Masonry Structure Near Right Abutment.

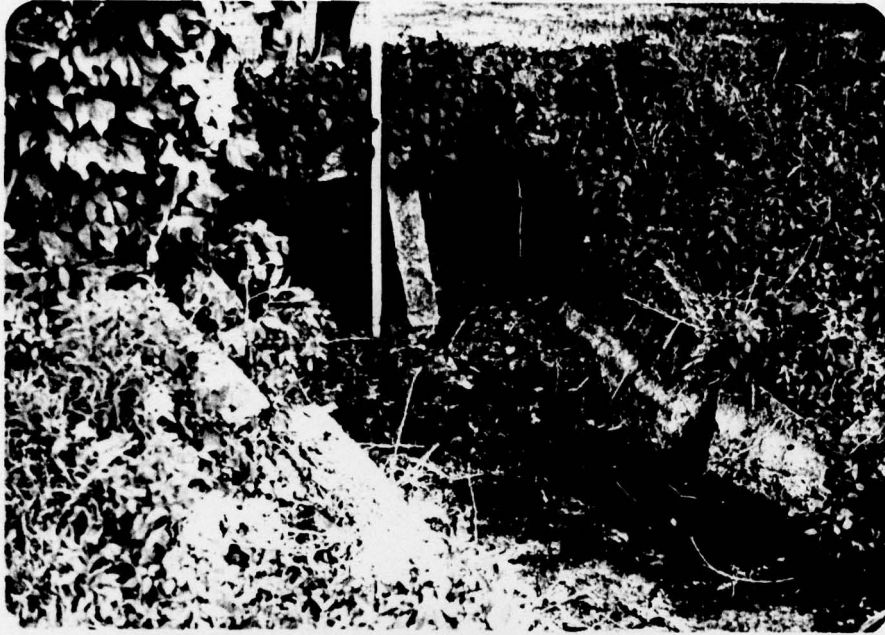
d. Appurtenant Structures. The spillway consists of a twin box culvert (Photographs G and H). The culvert serves as a bridge for the driveway across the top of the dam. Low approach walls are located at the upstream end of the spillway (Photograph G), and they were broken and tilted. The outer walls of the culvert have been displaced inward, so that the culvert openings become smaller toward the downstream end (Photographs H and J). Dimensions at each end of the culvert are presented in Appendix B. The concrete sidewalls along the culvert outlet channel are broken and tilted, and some portions are missing (Photographs H and J). The dry masonry adjacent to these sidewalls has been displaced.

G. Spillway Box Culverts at Upstream End.

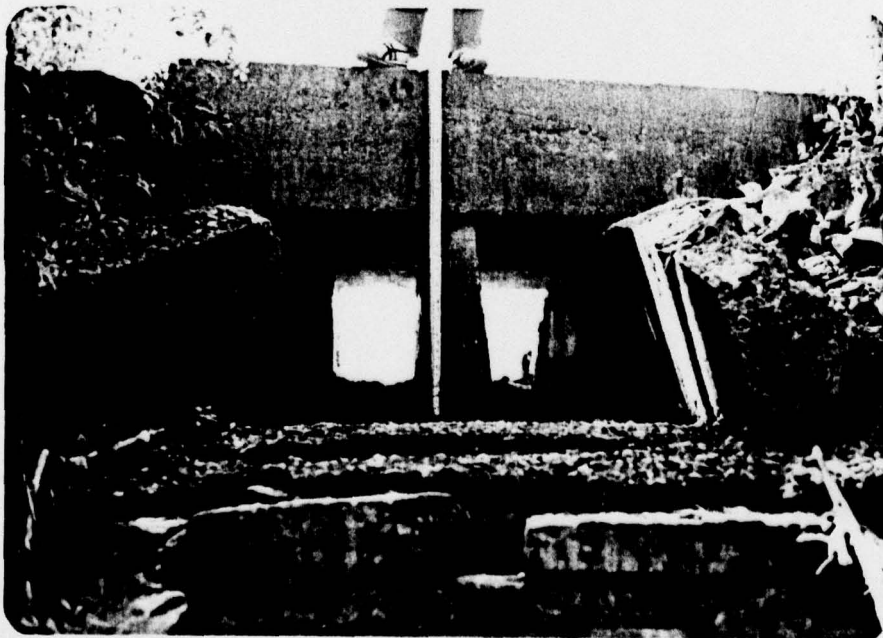
H. Spillway Box Culverts at Downstream End.

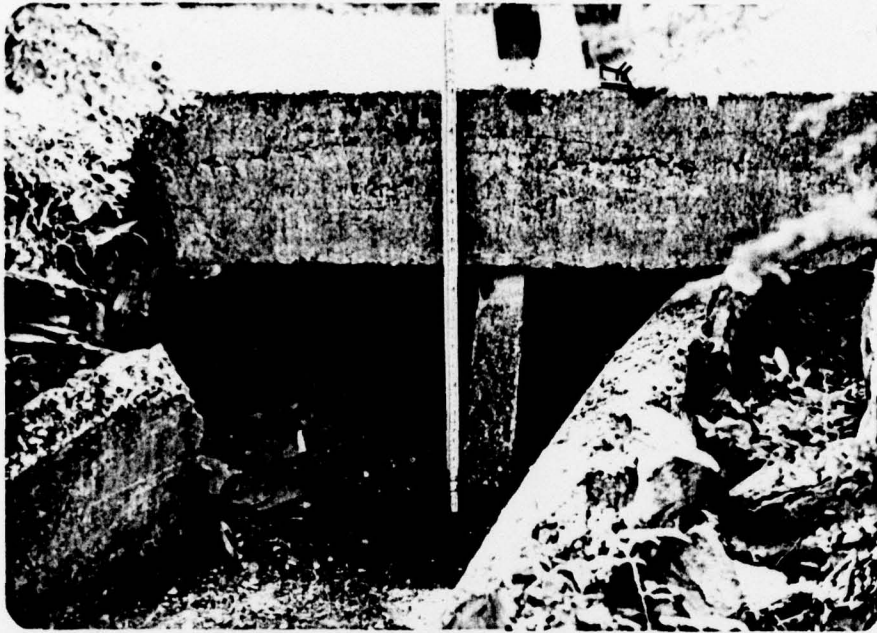
J. Spillway Box Culverts at Downstream End.

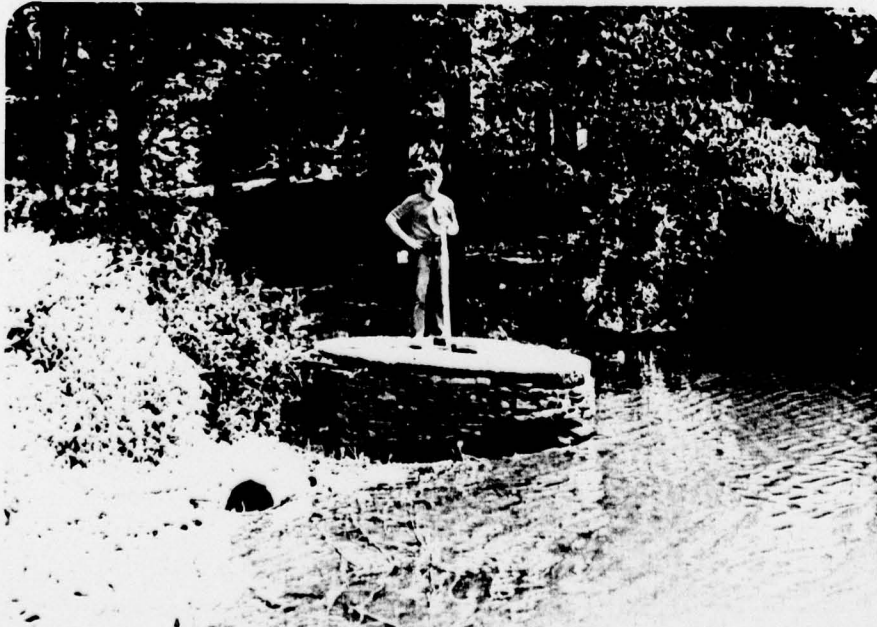
An abandoned intake structure for the outlet works is located along the upstream slope of the dam (Photograph K). The structure had stones missing from its base, and it was tilted. No evidence of an operating mechanism or an outlet conduit was visible at the intake structure. Similarly, no conduit outlet was visible on the downstream side of the dam.

K. Abandoned Intake Structure.
