**LYMAN RUN DAM**

NDS ID NO. PA-29  
DER ID NO. 53-49

PHASE I INSPECTION REPORT  
NATIONAL DAM INSPECTION PROGRAM

SEPTEMBER, 1979

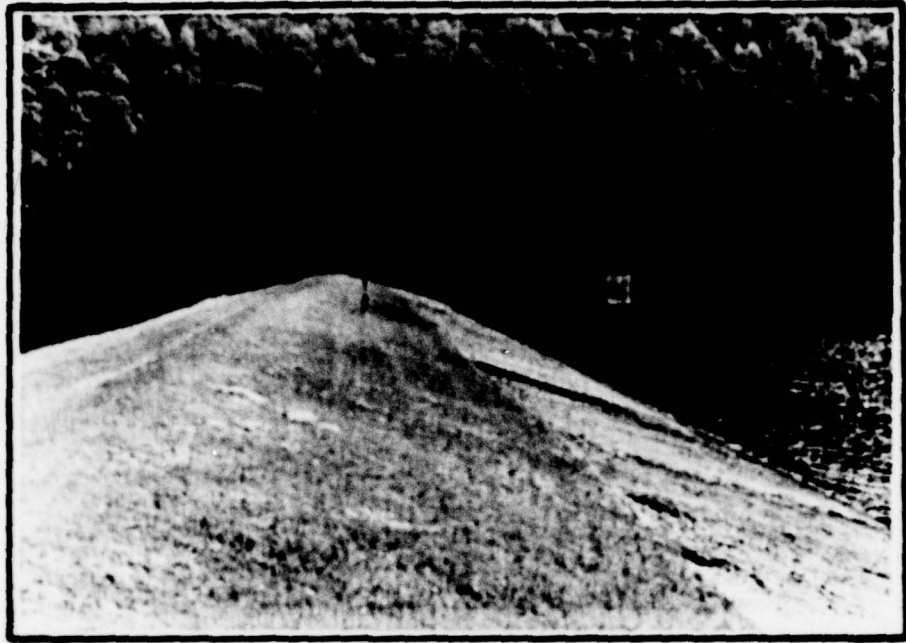
Overview of upstream slope - Note drain line  
control structure in reservoir.

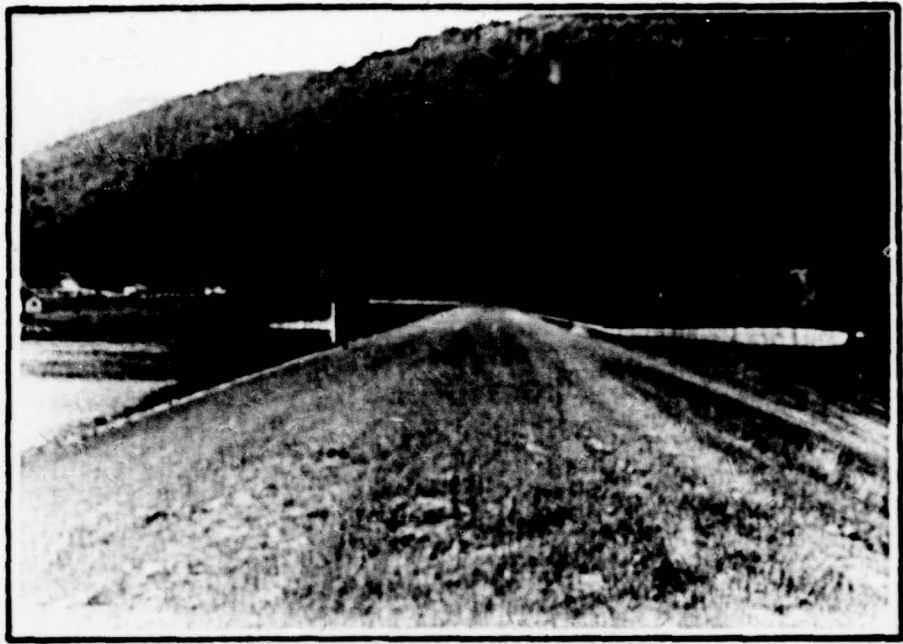
Crest of dam looking toward spillway (left abutment).

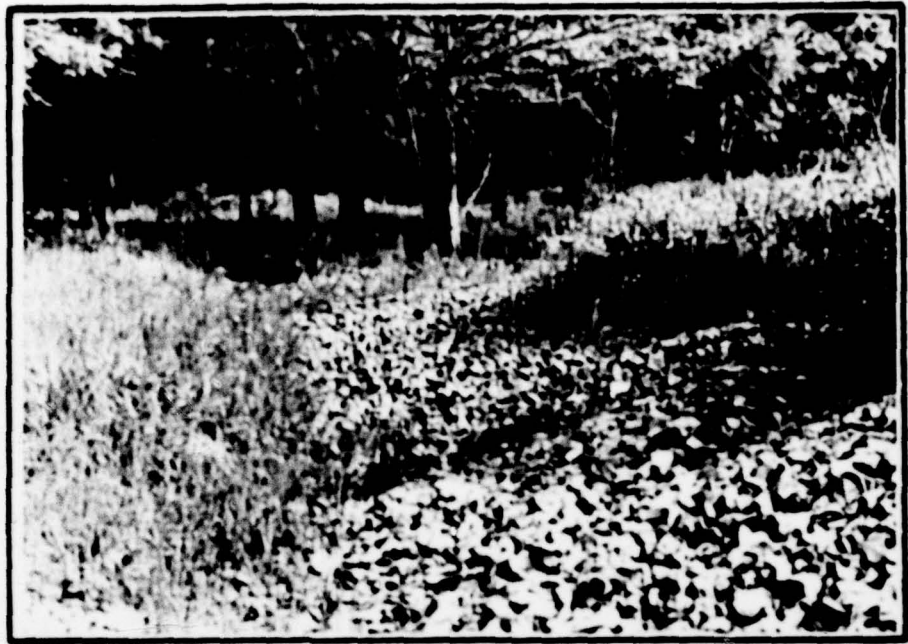
Rock underdrain beyond toe of dam.

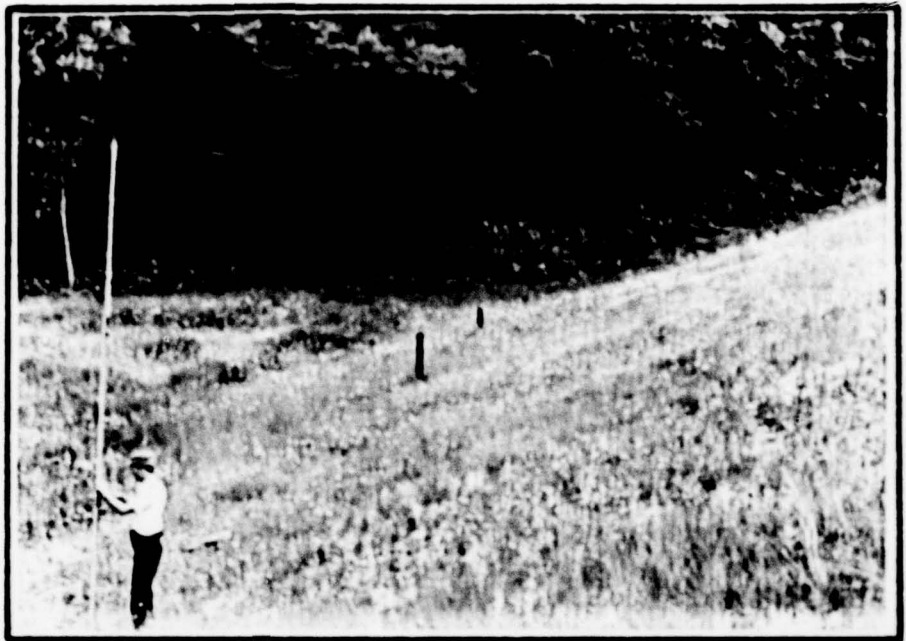
Monitors on downstream slope near right abutment.

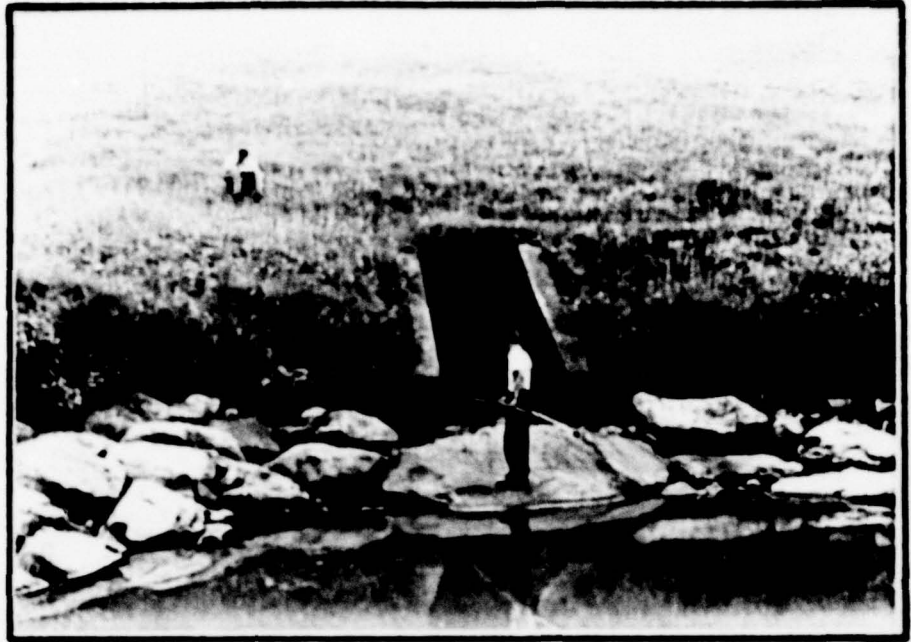
Discharge end of outlet works.

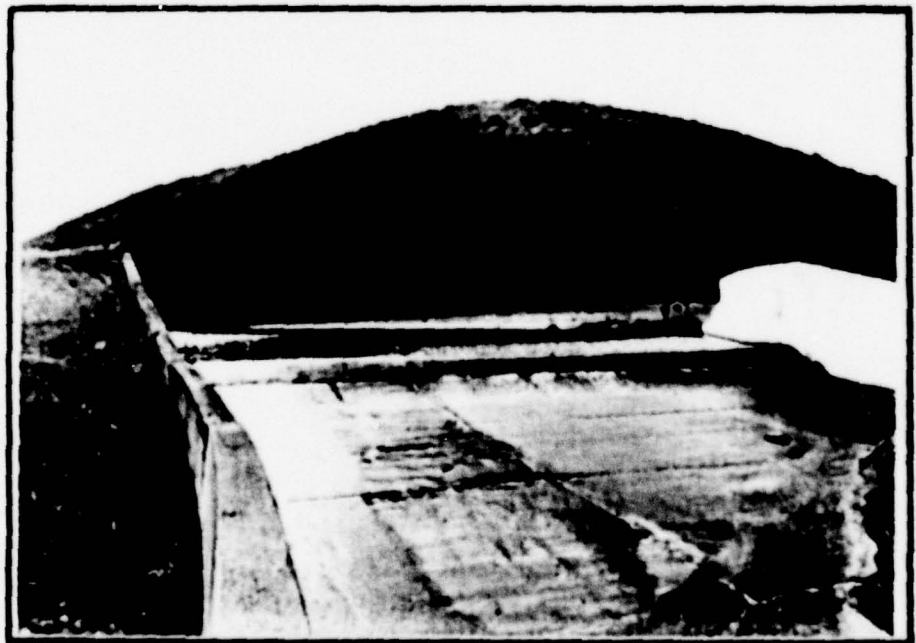
Spillway weir.

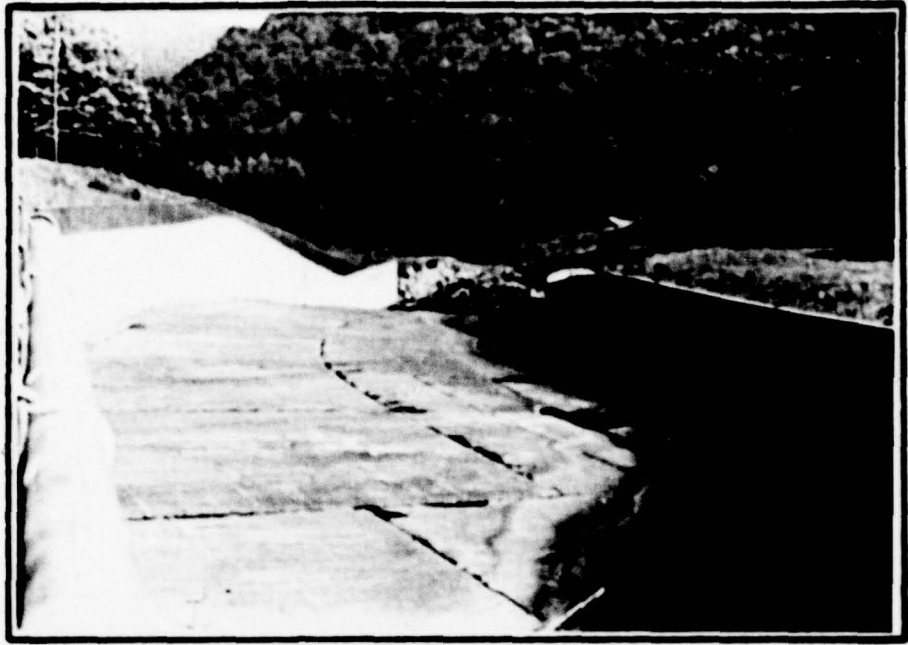
Emergency spillway.

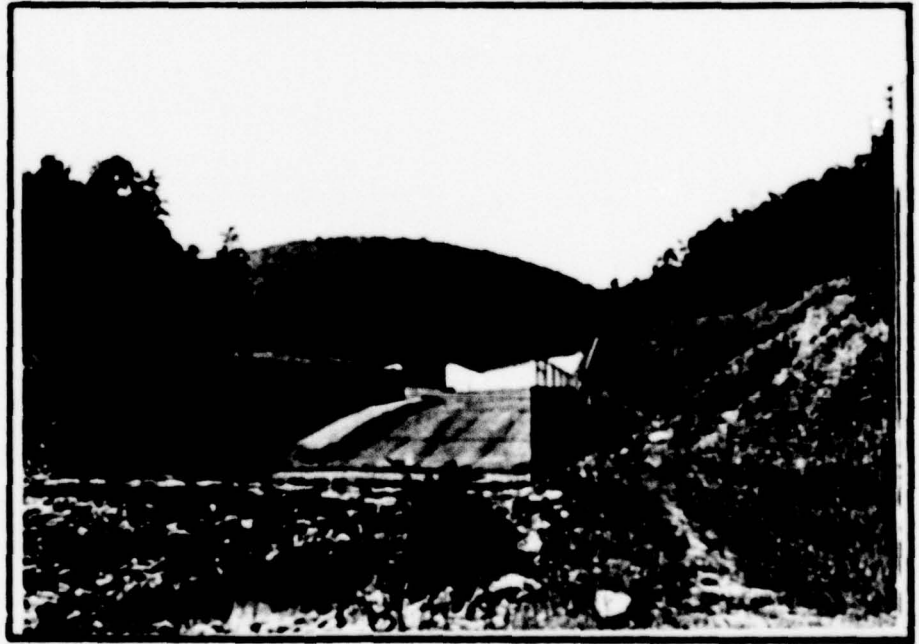
c. Appurtenant Structures. The reservoir level at the time of inspection was 1635.1. The emergency spillway and facilities appeared to be in good condition. The concrete weir appeared to be in good condition. In addition, the spillway exit channel retaining walls appeared to be in good condition and stable. Some cracks have developed in the bottom slab of the spillway exit channel.

Emergency spillway and stilling basin.

3. The cracks in the bottom of the spillway exit channel should be repaired and sealed.
