BAI CONSULTANTS INC MONROEVILLE PA
NATIONAL DAM INSPECTION PROGRAM UPPER BRIDGEPORT DAM NDI I.D. N--ETC(U)
JUN 79

PHASE I REPORT
NATIONAL DAM INSPECTION PROGRAM

Upper Bridgeport Dam: NDI I.D. No. PA-00465

Owner: Municipal Authority of Westmoreland
County

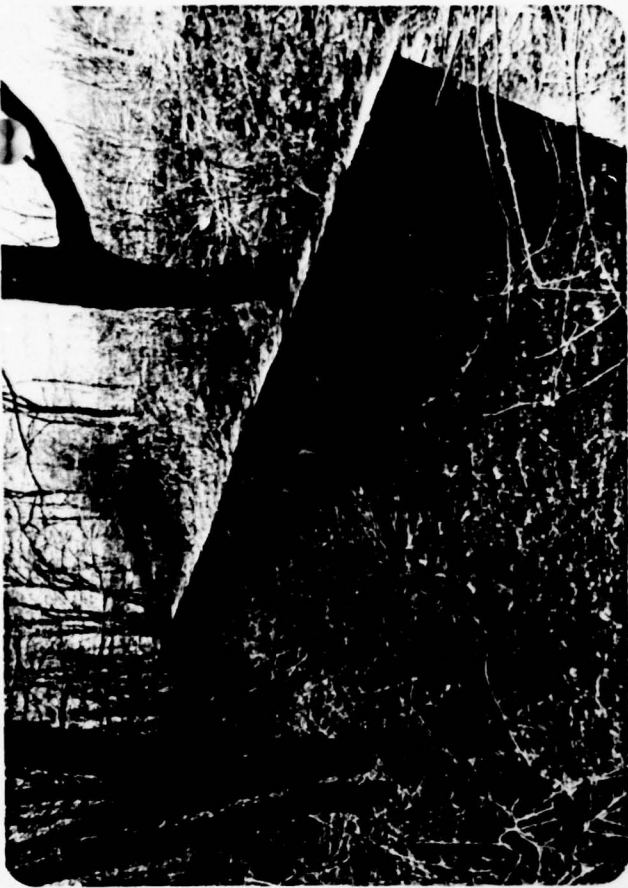
PHOTOGRAPH 6 View of the concrete retaining wall along the downstream slope of the embankment section between the two spillways. The wall extends to the right abutment but is interrupted by the emergency spillway.

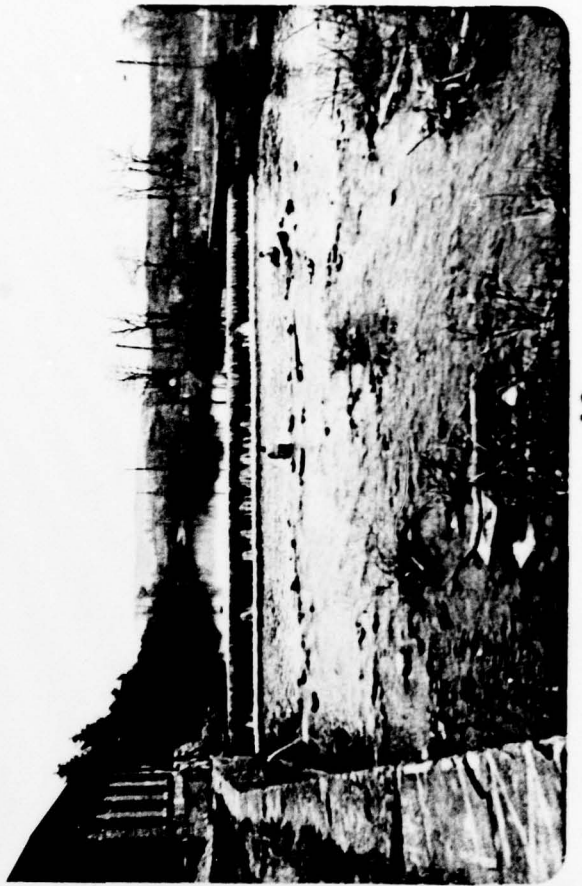
PHOTOGRAPH 12 View of Lower Bridgeport Dam situated approximately 2,400 feet downstream from Upper Bridgeport Dam.

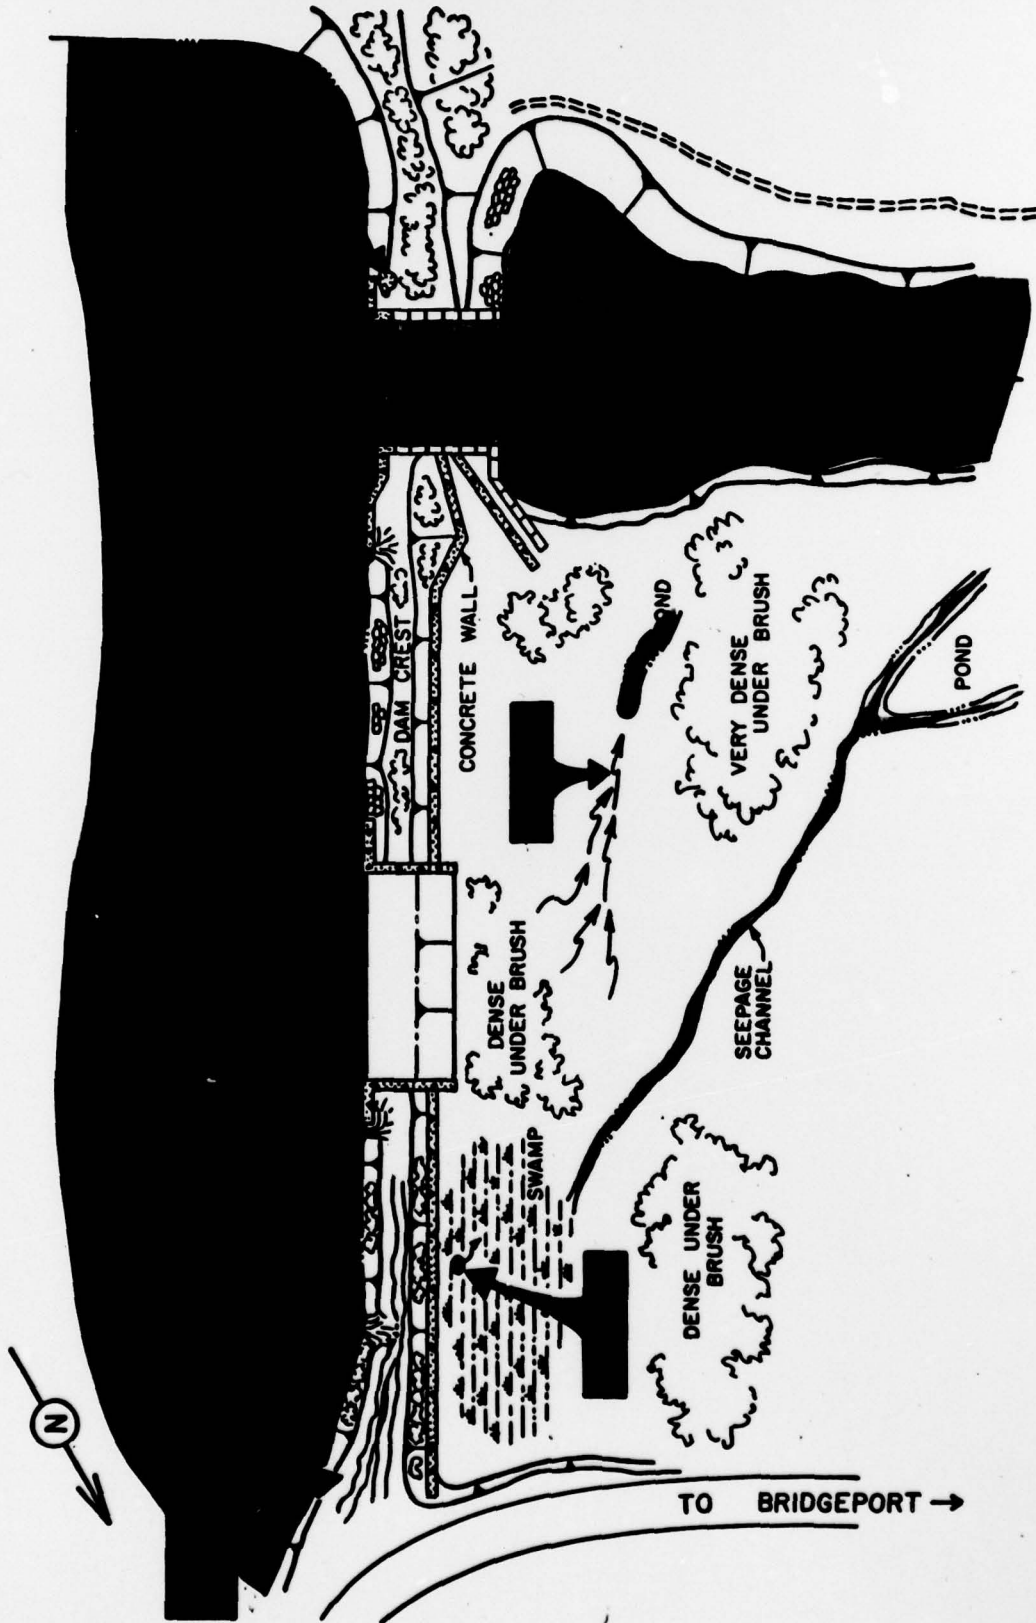
FIGURE 1 - UPPER BRIDGEPORT DAM

1. Embankment. The embankment, as shown on Figure 1, was constructed of earth atop a clay foundation. No records of compaction procedures or construction techniques are available. A concrete corewall was installed in 1894 which reportedly extends from the right abutment to the left wingwall of the service spillway, a length of about 800 feet. No outer corewall details are available. Cross-sectional dimensions, specifically, heights, crest widths, and slope angles vary significantly along the embankment.
