*(6) National Dam Inspection Report*  
**MARCEL LAKE DAM**

NDI - PA 00402,  
PA DER 52-149.

PHASE I INSPECTION REPORT,  
NATIONAL DAM INSPECTION PROGRAM

Name of Dam: Marcel Lake Dam            ID # PA-00402  
State Located: Pennsylvania  
County Located: Pike  
Stream: Dingman's Creek  
Coordinates: Latitude 41° 15.2' Longitude 74° 57.4'  
Date of Inspection: November 22, 1978

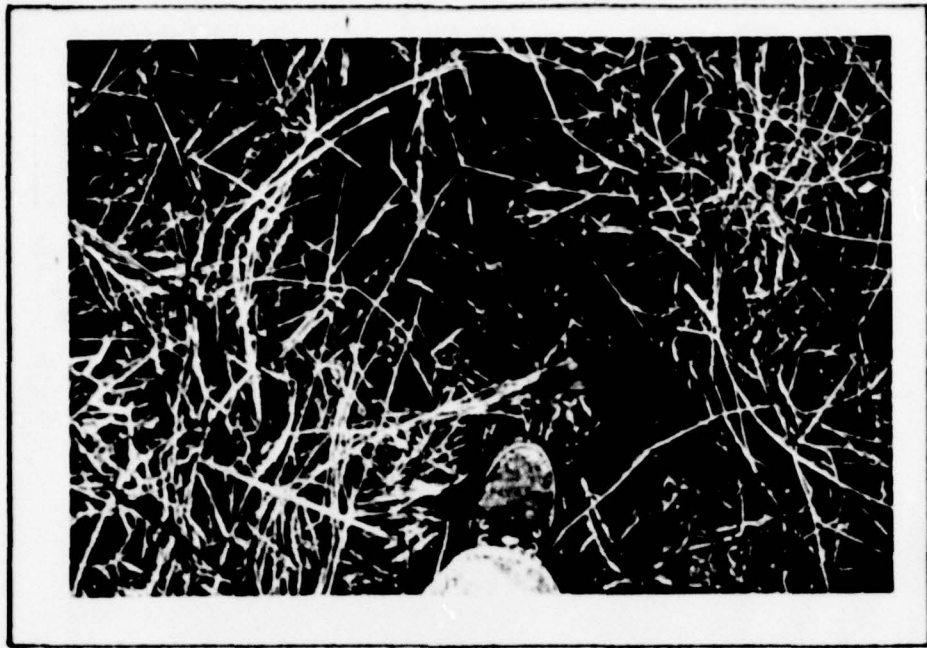
A swampy area extends from the toe of the embankment (See Plate 4 of Appendix E) for 50 to 100 feet, and along the toe from within 75 feet of the right abutment to the outlet channel. The swampy area contains approximately 12,000 square feet of saturated ground with areas of standing water 6 to 12 inches deep. In many areas, the water was discolored with brown and rusty colored deposits. The area was covered by a high, thick grass cover with clumped roots. Seepage from this area could be observed along the riprapped right bank of the outlet channel. Localized outflows of up to 15 gallons per minute (gpm) were observed, with the total outflow from the swampy area estimated at 300 to 400 gpm. Approximately 75 feet downstream of the embankment toe, an 8 inch diameter PVC pipe is constructed through the right bank of the outlet channel into the swampy area. Discharge from the pipe was estimated at 50 gpm. The origin and the purpose of the pipe could not be readily determined.

*SEEPAGE AREA DOWNSTREAM OF TOE OF DAM*

1) A subsurface investigation should be initiated at several selected sections of the dam to include, but not limited to, soil borings for determination of the composition and in situ properties of the embankment and foundation materials. The investigation should be supervised by a licensed professional engineer experienced in the design and construction of dams.

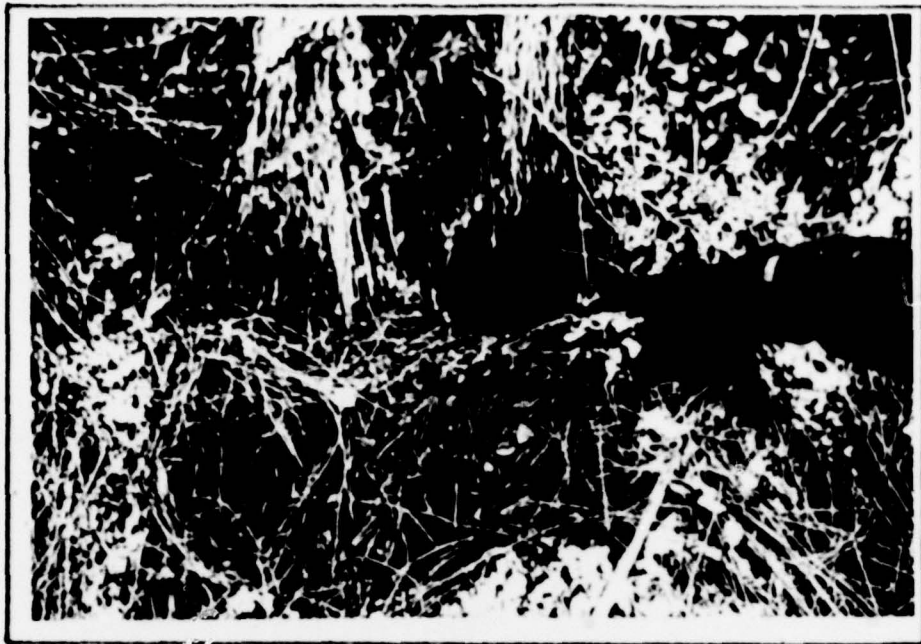
Animal burrow holes observed on both the upstream and downstream slopes could have a deleterious affect upon the seepage potential through the embankment.

*ANIMAL BURROW HOLE ON THE DOWNSTREAM  
SLOPE OF THE DAM*

6. Animal burrow holes were noted on both the upstream and downstream slopes of the dam. These holes should be filled with suitable earth materials.
7. The dam is partially overgrown with bushes and trees up to 15 feet high. The trees and bushes should be cut at the ground level.

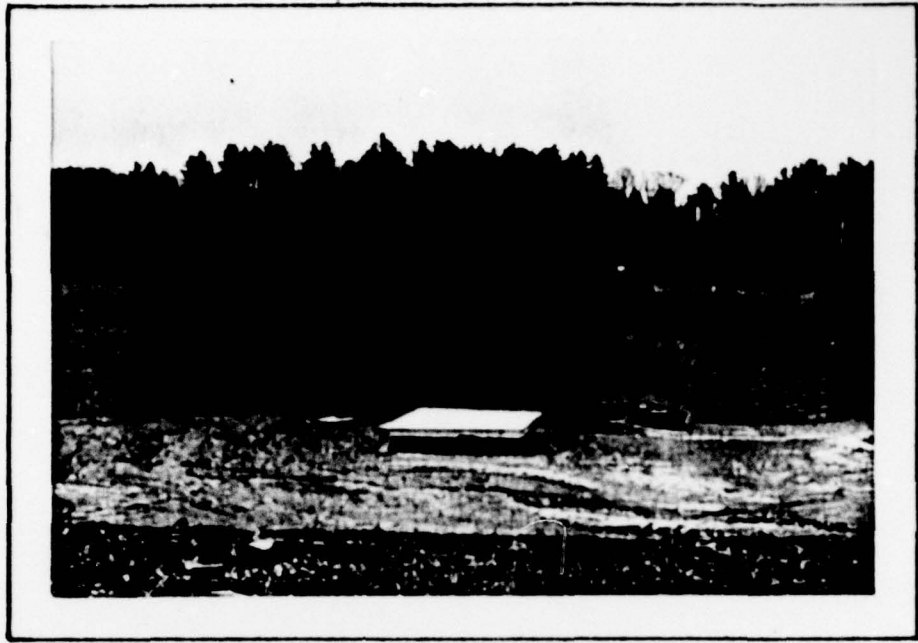
Undulating depressions were observed along the upstream face of the dam. The depressions extended from the top of dam to beneath the water surface in some locations, and extended in depth to more than 2 feet. Field measurements of the slope of the upstream face indicate local variations from 2H:1V to 4H:1V. Several animal burrow holes were noted along the upstream face.

*OVERVIEW OF THE UPSTREAM FACE  
OF THE DAM*

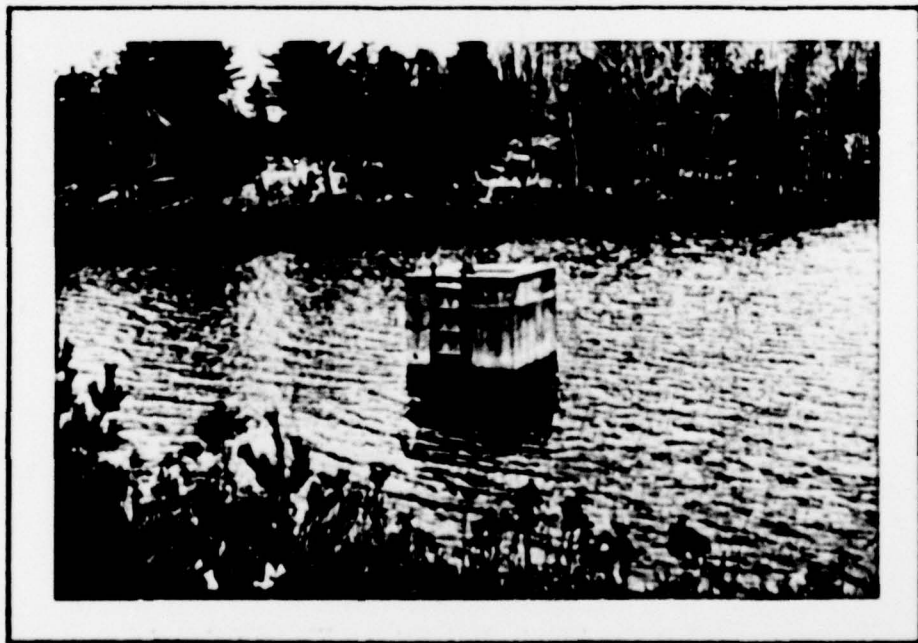
The only operating facility associated with the dam is the handwheel operated sluice gate of the low level outlet. The handwheel was in place, but was inaccessible at the time of inspection. Therefore, the operating condition of the drawdown facilities could not be assessed. The owner's representative did not know if the operating facilities were periodically exercised.

*RESERVOIR DRAIN SYSTEM  
SLUICE GATE TOWER*

The operational condition of the gate valve should be evaluated by periodic exercise of the system. The grass should be mowed at least twice annually. During periods of heavy rainfall, the dam should be monitored and downstream residents alerted in the event of an impending failure.

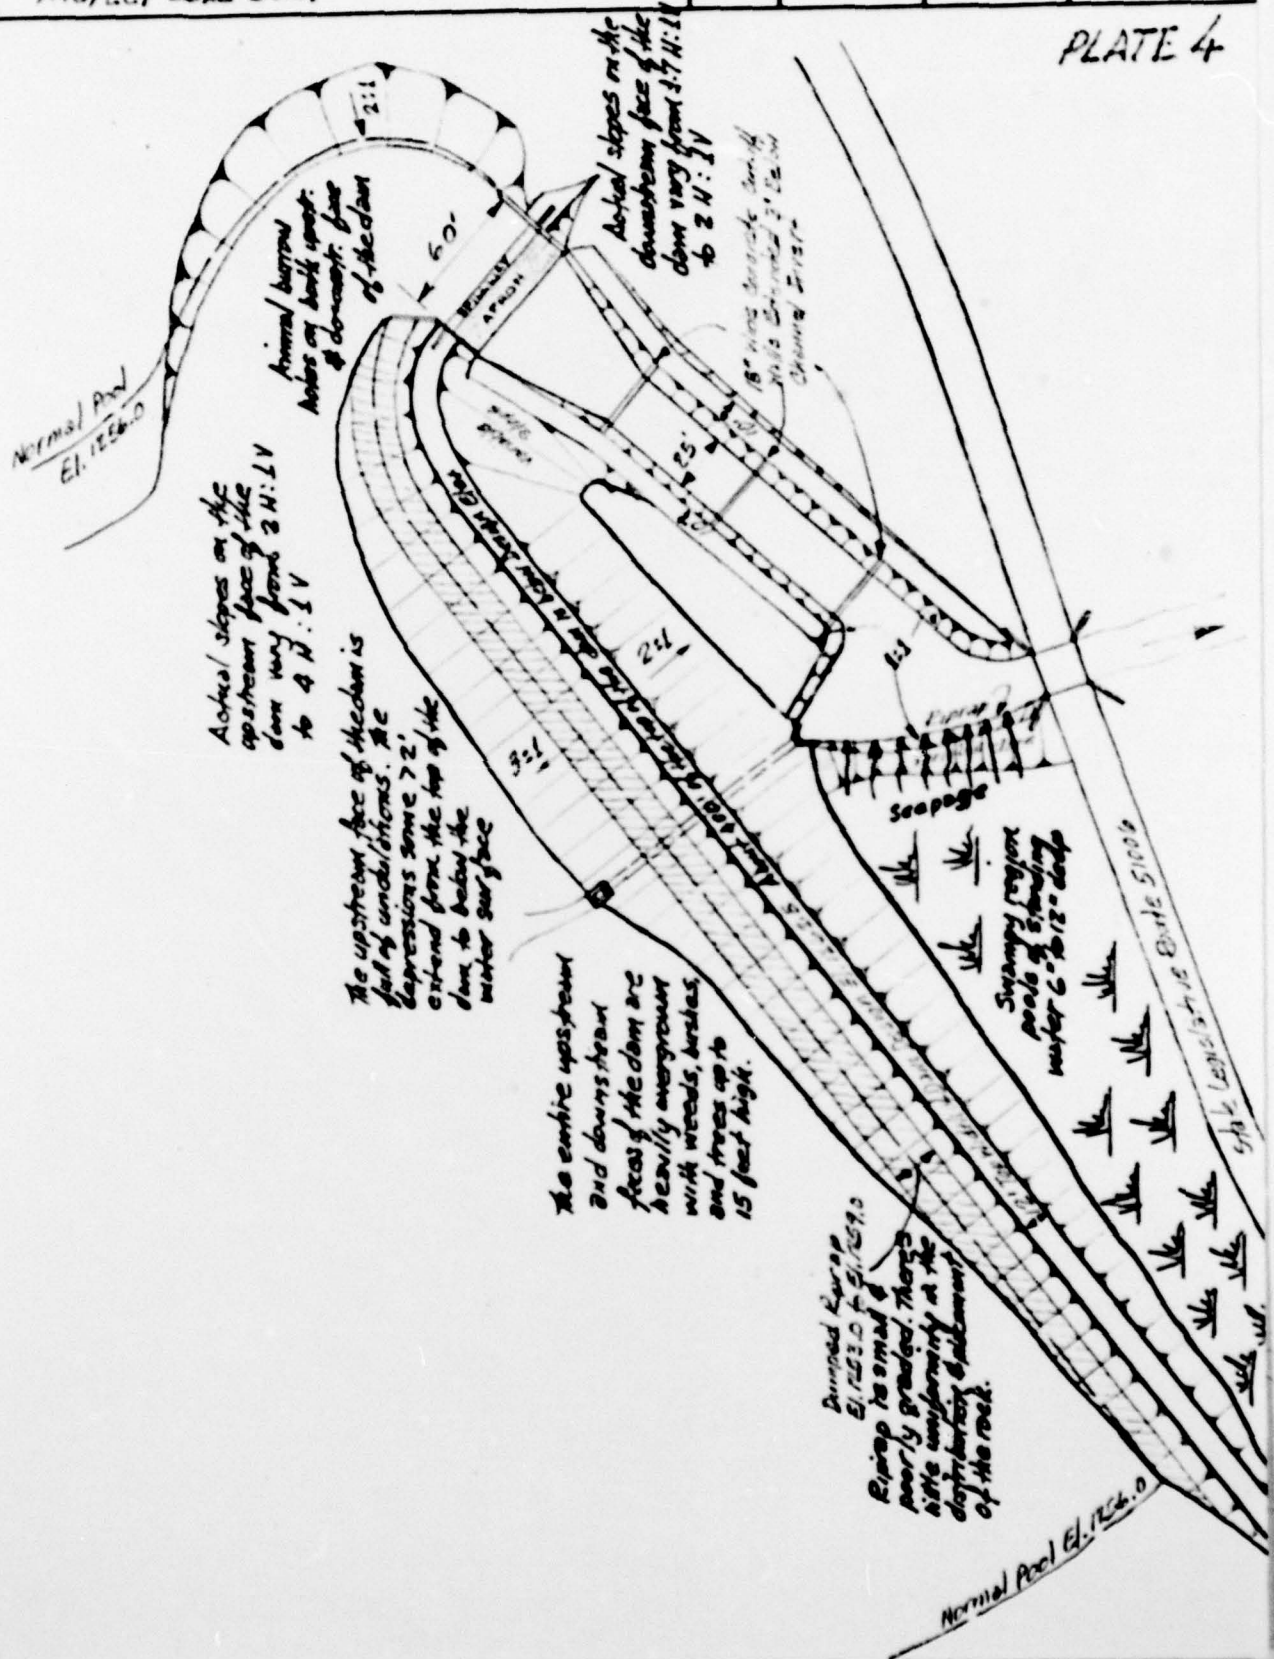
PLATE 4

Actual slopes on the upstream face of the dam vary from 2 H:1 V to 4 H:1 V

Animal burrows holes on both spots of the dam
