HUNTERS LAKE DAM

NDS ID NO. PA-356

PHASE I INSPECTION REPORT
NATIONAL DAM INSPECTION PROGRAM

80-7
AUGUST, 1979

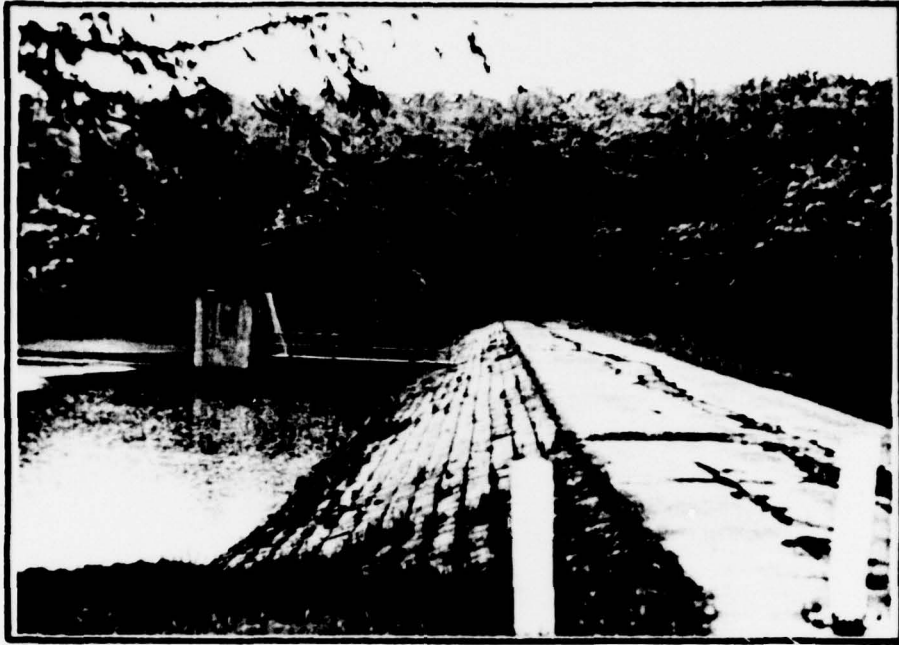
Overview of upstream slope and crest.

VISUAL EXAMINATION OF	OBSERVATIONS	REMARKS OR RECOMMENDATIONS
SURFACE CRACKS	None.	
UNUSUAL MOVEMENT OR CRACKING AT OR BEYOND THE TOE	None.	
SLOUGHING OR EROSION OF EMBANKMENT AND ABUTMENT SLOPES	None noted.	
VERTICAL AND HORIZONTAL ALIGNMENT OF THE CREST	Horizontal alignment appears to be good. Vertical alignment-near right abutment-low point equals 1568.2.	
RIPRAP FAILURES	No riprap. Concrete paving blocks act as slope protection. Displacement and distortment of concrete paving blocks near water level.

1. Repair the upstream paving.
2. Monitor the seepage exiting the rock toe at periodic intervals and during periods of high reservoir levels.
3. Institute a formal inspection program to be conducted at regular intervals.
4. A warning system should be instituted to warn downstream residents of high spillway discharges or during periods of heavy rainfall or high runoff.

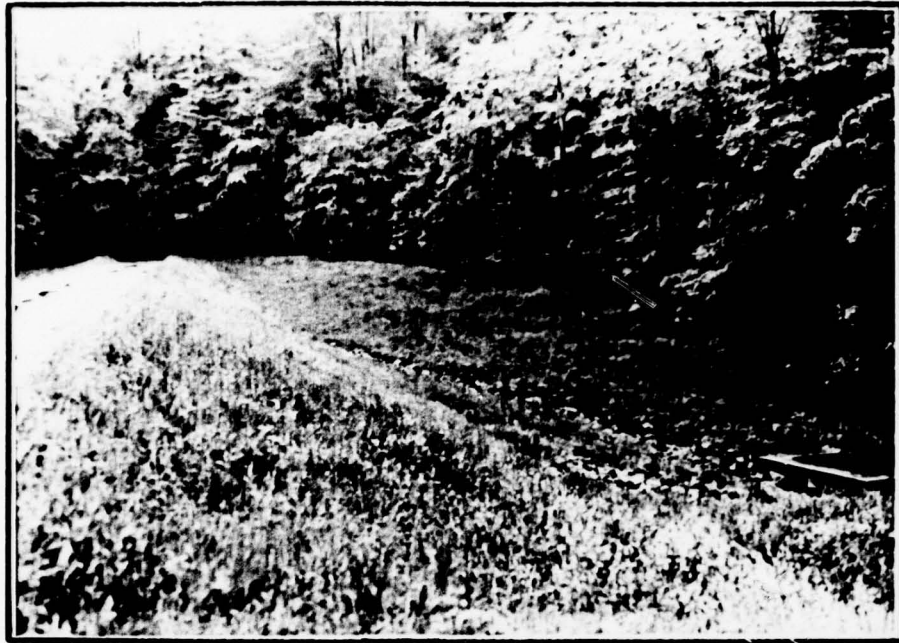
Downstream slope and left abutment.

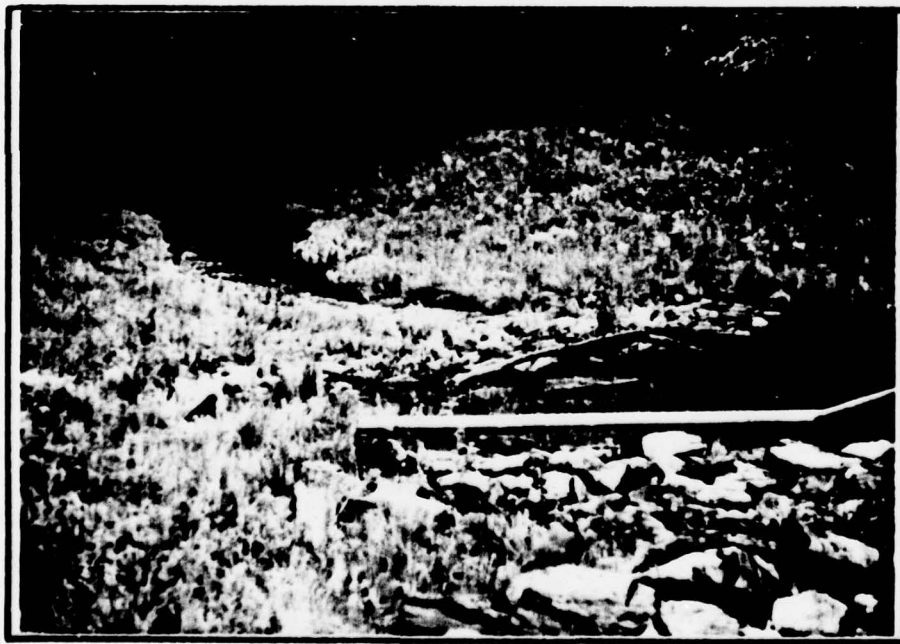
VISUAL EXAMINATION OF	OBSERVATIONS	REMARKS OR RECOMMENDATIONS
VEGETATION	Grass on downstream slope.	
JUNCTION OF EMBANKMENT AND ABUTMENT, SPILLWAY AND DAM	Both abutments appear to be good.	
ANY NOTICEABLE SEEPAGE	Seepage from rock toe. Quantity of seepage undetermined.	
STAFF GAUGE AND RECORDER	None.	
DRAINS	Underdrain in rock toe. Water was flowing out of one of these under drains to left of the impact basin.

Immediate downstream exposure.
Note perforated metal underdrain pipe.

3.2 Evaluation. In general, the embankment and appurtenant structures appear to be in very good condition and well maintained. The seepage exiting from the downstream rock toe should be monitored to determine if flow increases or is turbid. Note: Considerable precipitation occurred prior to and during the inspection possibly concealing minimum seeps or wet areas. Dry weather inspections by the owner are encouraged.

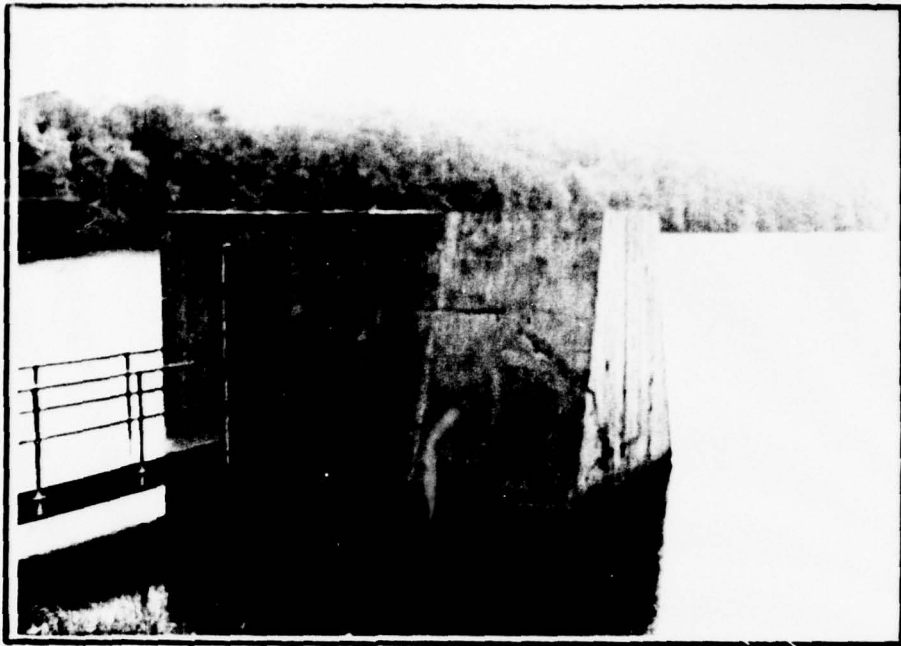
Principal spillway intake.

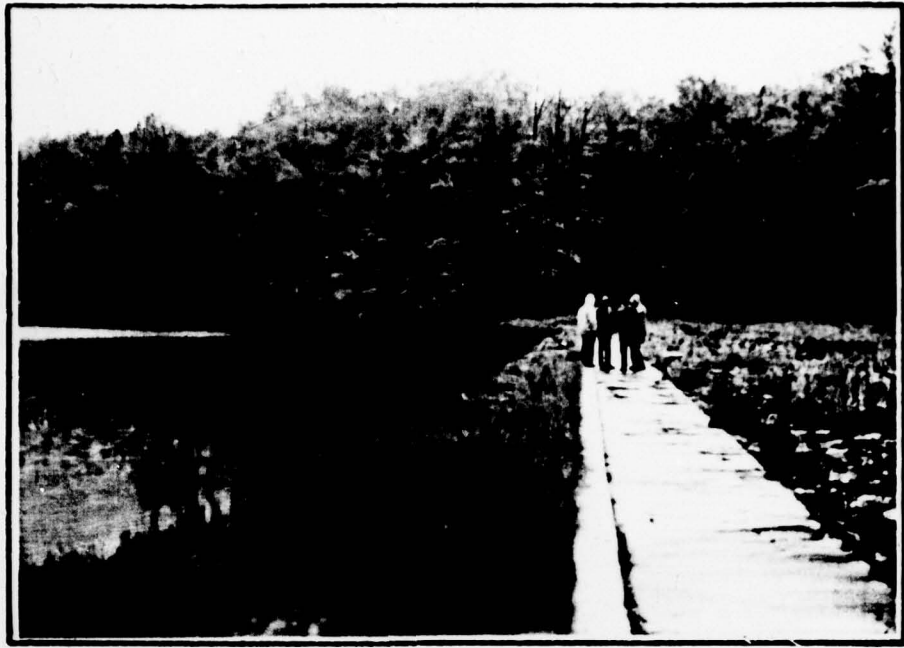
VISUAL EXAMINATION OF	OBSERVATIONS	REMARKS OR RECOMMENDATIONS
CONCRETE WEIR	Good condition.	
APPROACH CHANNEL	Lake.	
DISCHARGE CHANNEL	Discharge channel is a natural drainage way formed by a saddle.	
BRIDGE AND PIERS	None.

Spillway weir.

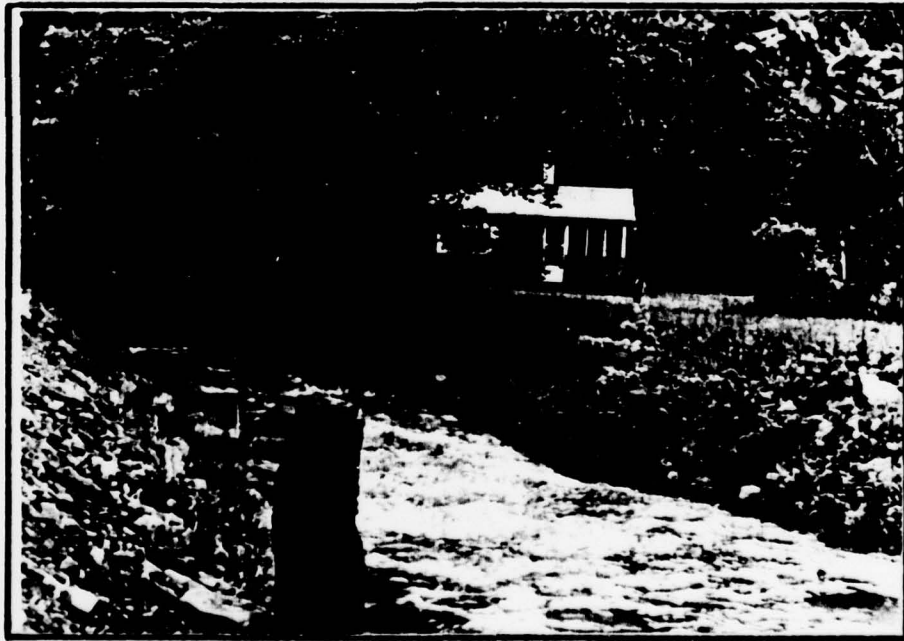
e. Downstream Channel. Trout Run downstream of Hunters Lake Dam is a steep narrow channel. Approximately 14 homes are located in the flood area approximately 2 miles downstream of the dam.

Residence downstream of dam.
