PENNSYLVANIA
NDS ID PA. 00149
DER ID 64-148

GOULDSBORO DAM

PHASE I INSPECTION REPORT
NATIONAL DAM INSPECTION PROGRAM

JULY 1979

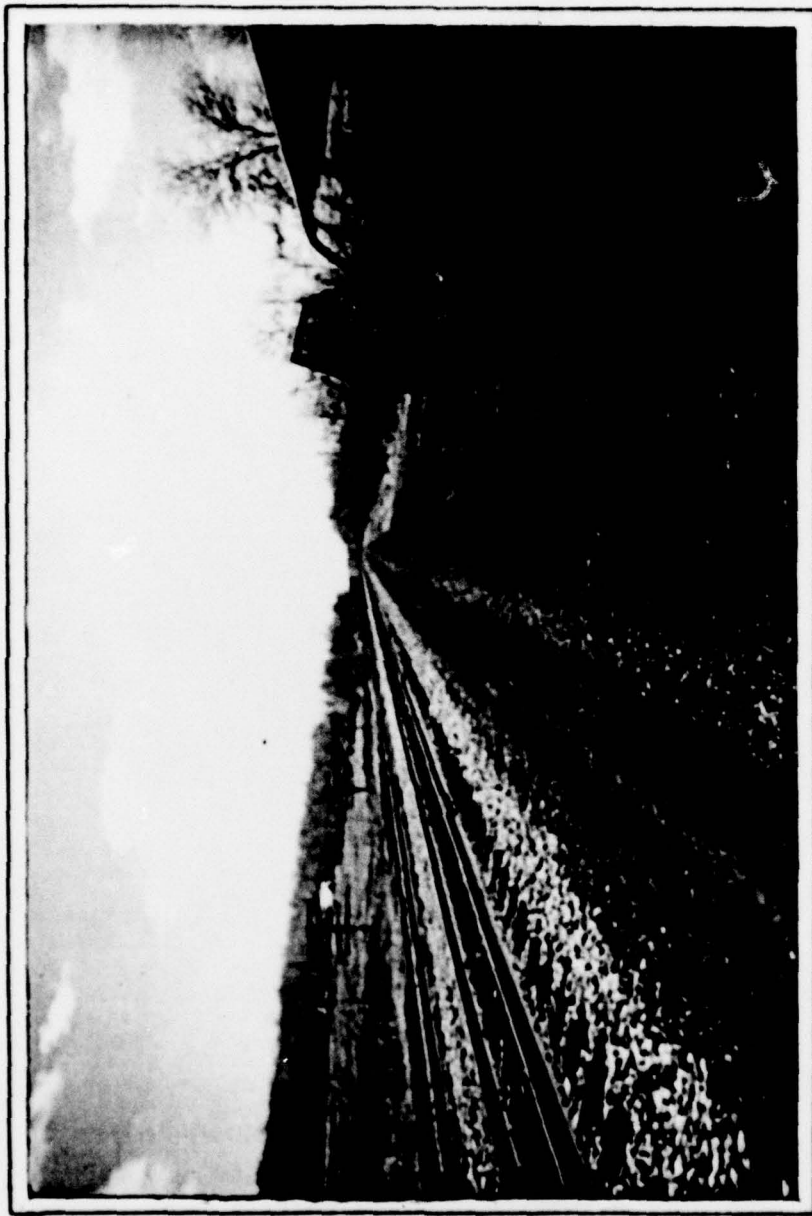
PHOTOGRAPH NO. 6

OVERVIEW OF RIGHT SIDE OF EMBANKMENT.

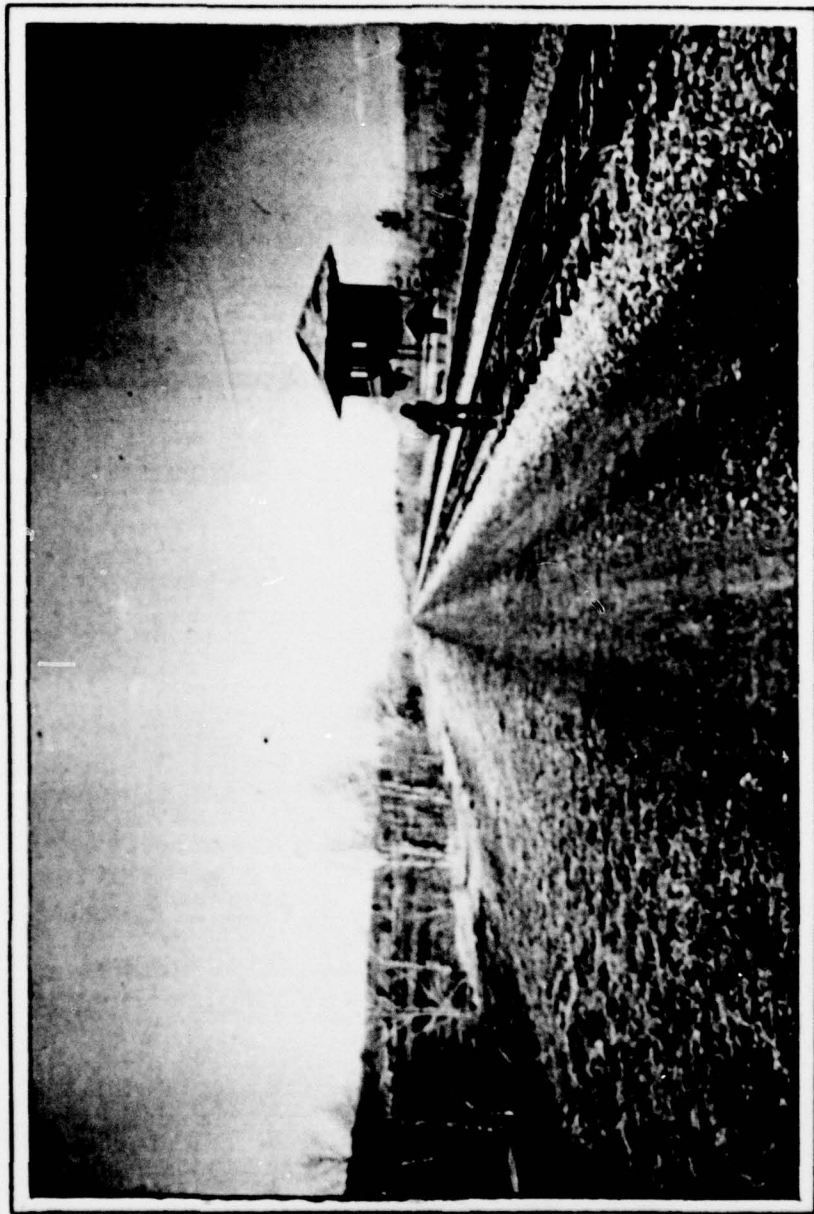
PHOTOGRAPH NO. 7

OVERVIEW OF LEFT SIDE OF EMBANKMENT.
