**PENNSYLVANIA
NDS ID PA. 00777
DER ID 45-1**

LAKE NAOMI DAM

PHASE I INSPECTION REPORT NATIONAL DAM INSPECTION PROGRAM

JULY 1979

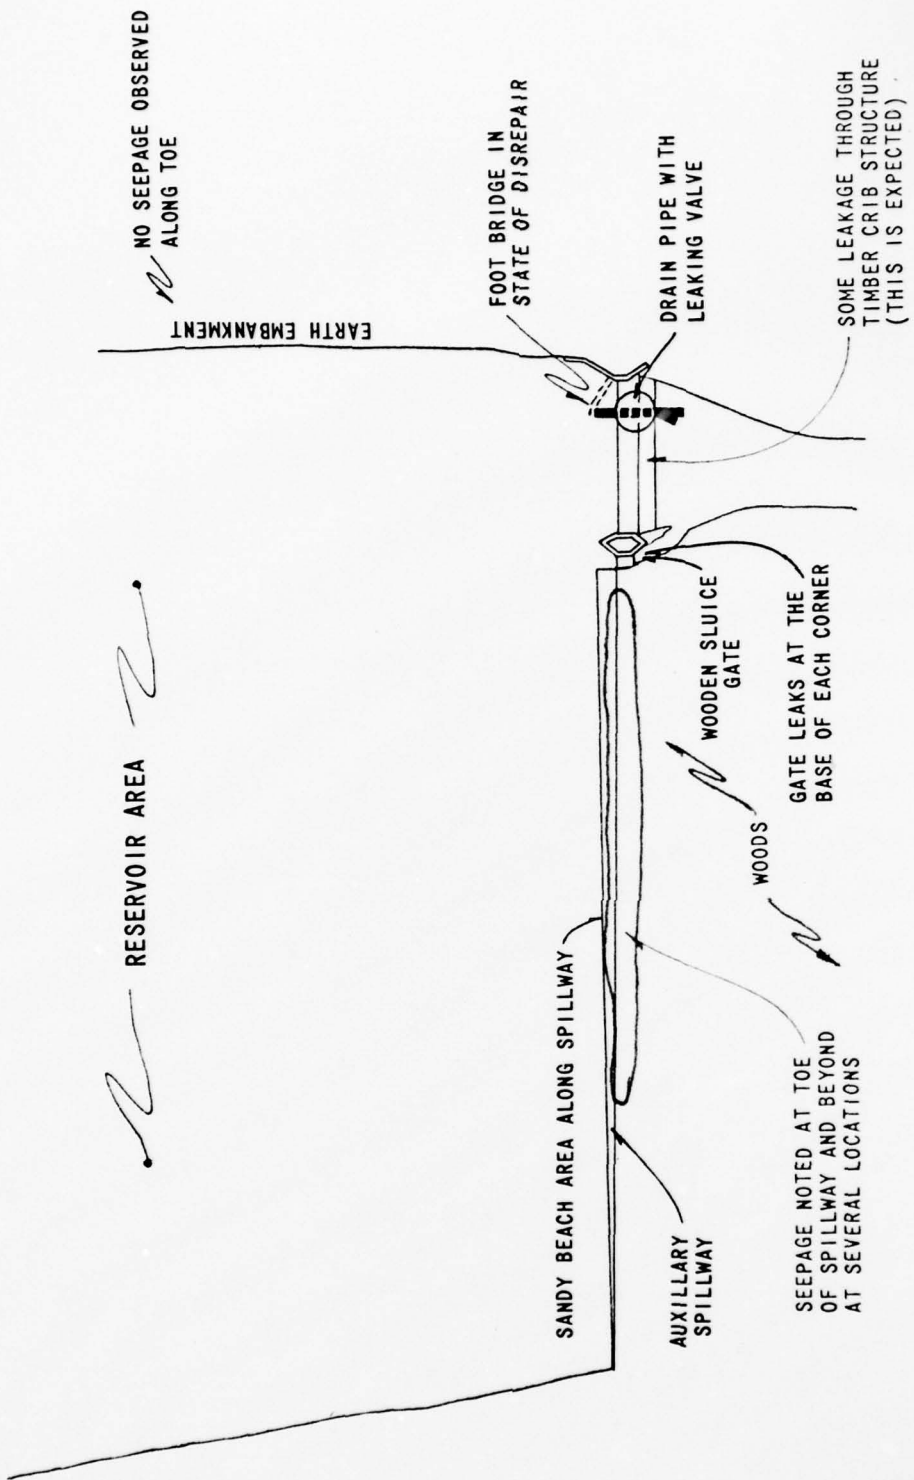
b. Dam. Vertical alignment along the crest of the embankment (dike) along Route 423 was checked and found to be reasonably uniform. The embankment appears to be in reasonably good condition and there were no signs of significant seepage. Horizontal alignments were good and the upstream riprap also appears to be in good condition. There were no surface cracks observed, and junctions between the embankment and abutment were in good condition. Although there was no seepage noted along the main embankment section, which parallels Route 423, seepage was observed downstream of the auxiliary spillway. Leakage locations are shown on sheet 5a, Appendix B.

NO SEEPAGE OBSERVED
ALONG TOE

DRAIN PIPE WITH
LEAKING VALVE

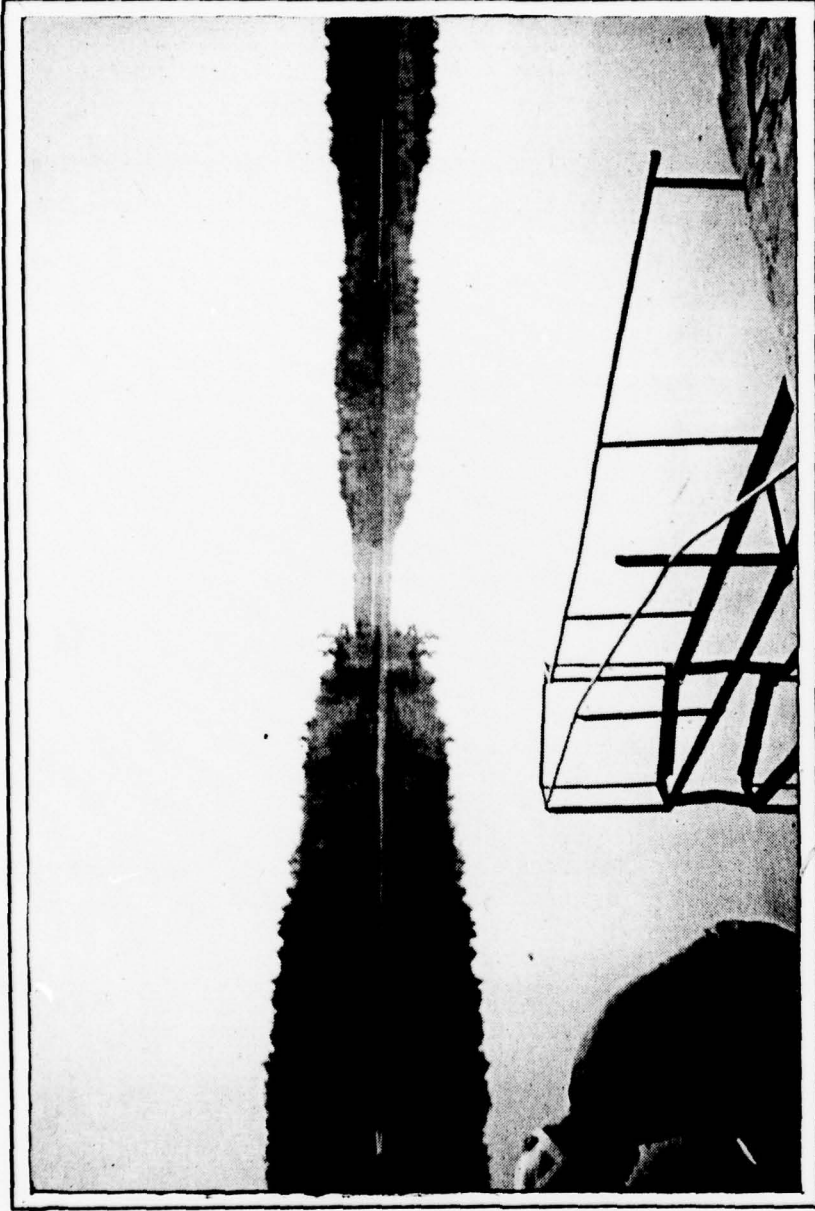
PHOTOGRAPH NO. 1

Similar to dam maintenance, there is very little evidence that operating facilities have been maintained in good condition. Specifically, the access bridge to the 30-inch discharge pipe, as shown on Photograph 1, is in poor condition. The auxiliary spillway, shown on Photographs 12 through 14, is also in poor condition, and significant quantities of leakage, as shown on Photographs 15 and 16, are present.

ACCESS BRIDGE TO OUTLET PIPE VALVE
STEM. STEM IS LOCATED BELOW WATER.
NOTE CONDITION OF BRIDGE.

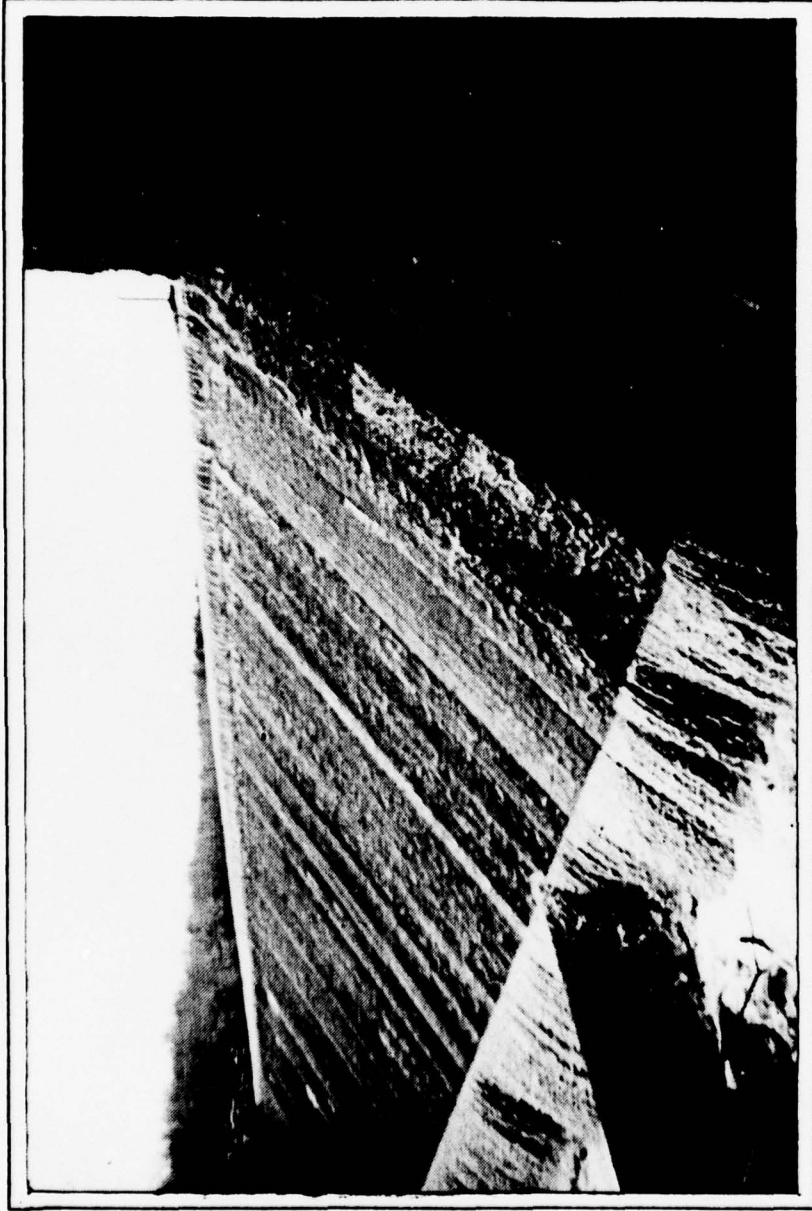
PHOTOGRAPH NO. 5

OVERVIEW OF WOODEN SPILLWAY.

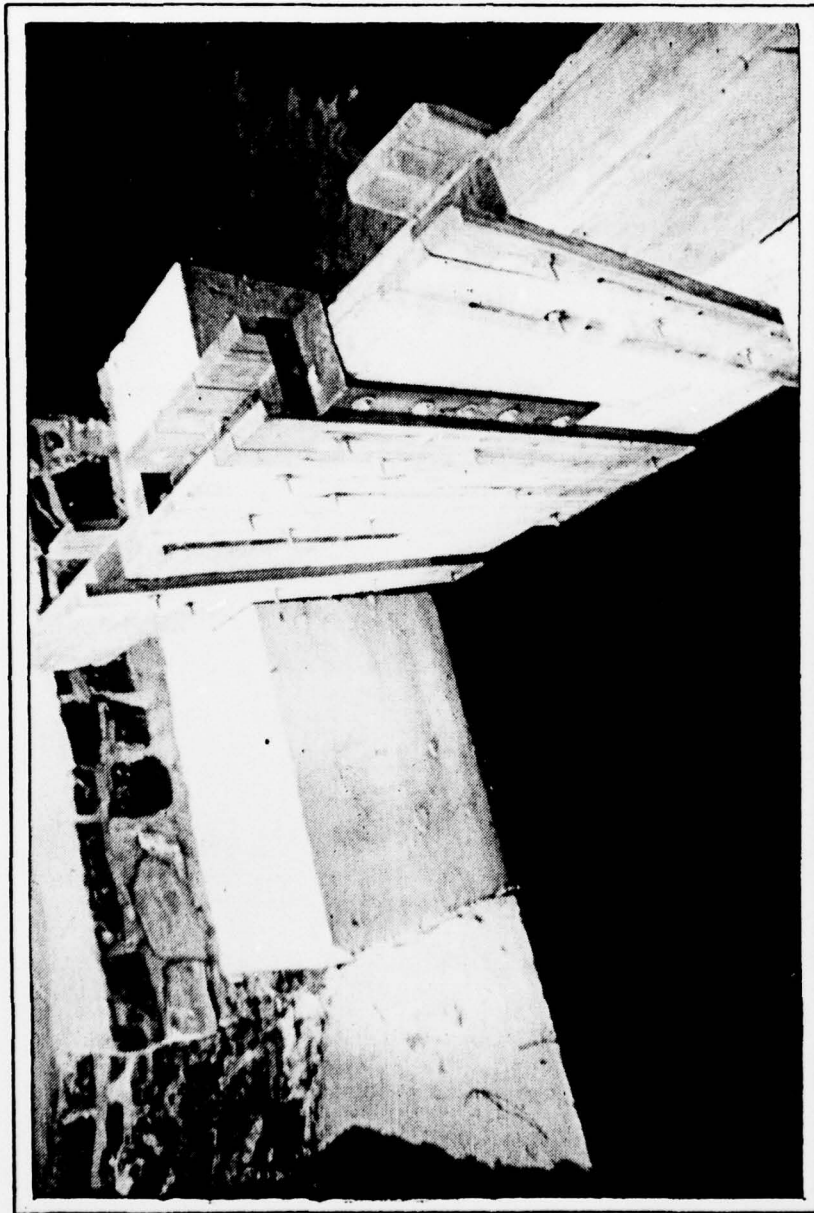
PHOTOGRAPH NO. 8

OVERVIEW OF WOODEN SLUICE GATE.

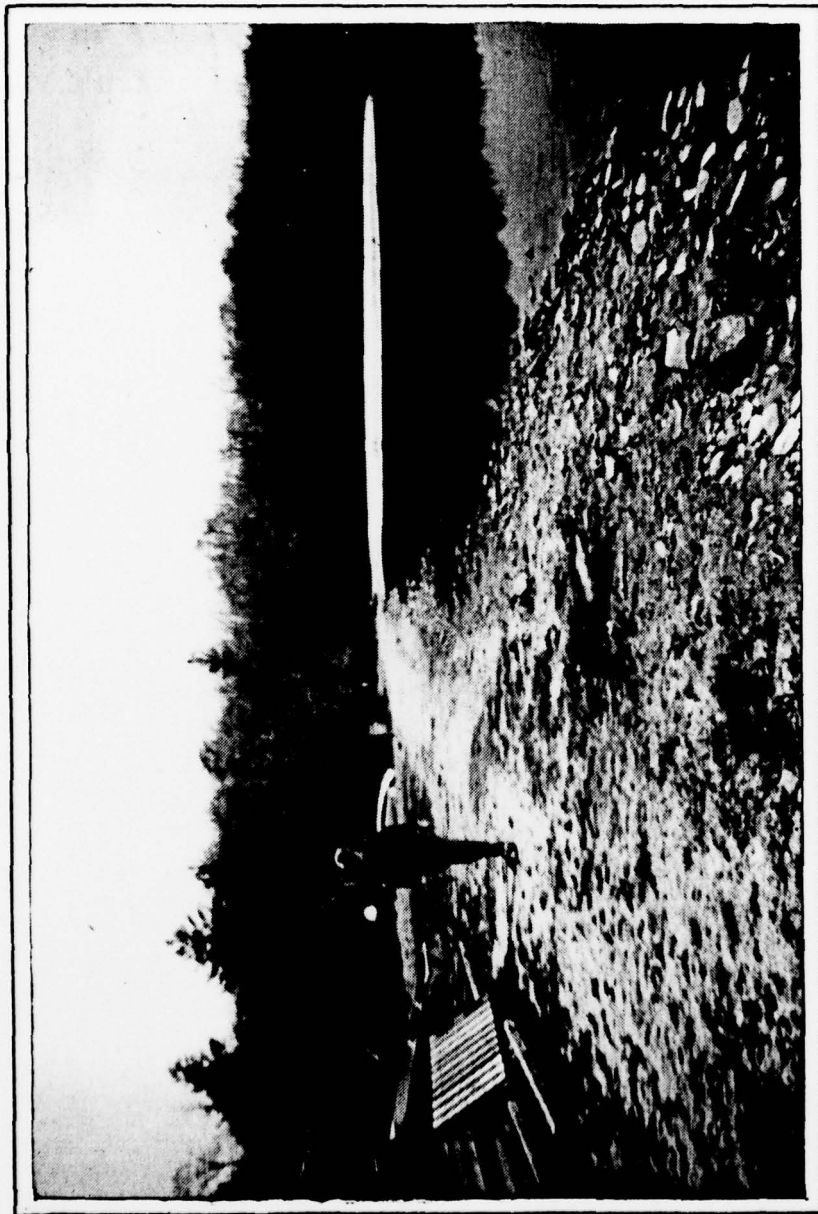
PHOTOGRAPH NO. 12

3. Auxiliary Spillway. The auxiliary spillway, located to the right of the wooden sluice gate and shown on Plate 2, is currently being used as a beach. The known construction and repair history is reported in Section 1. Visual inspection revealed a fine gravelly sand beach, 31 to 49 feet wide. The downstream slope is composed of rock, broken concrete and some brush. Significant quantities of seepage were flowing through the stone and concrete. The crest surface is not resistant to erosion and it is believed that significant erosion and failure would occur as a result of large flows through the auxiliary spillway.

SHORELINE ON RIGHT SIDE OF SPILLWAY
LOOKING FROM RIGHT ABUTMENT OF
WOODEN SLUICE GATE. THIS IS THE
AUXILIARY SPILLWAY.

1. A geotechnical investigation of the auxiliary spillway should be performed.
2. Pending the results of Recommendation 1, the spillway system should be reconstructed to meet current hydrologic/hydraulic criteria as determined from a detailed hydrologic/hydraulic analysis.

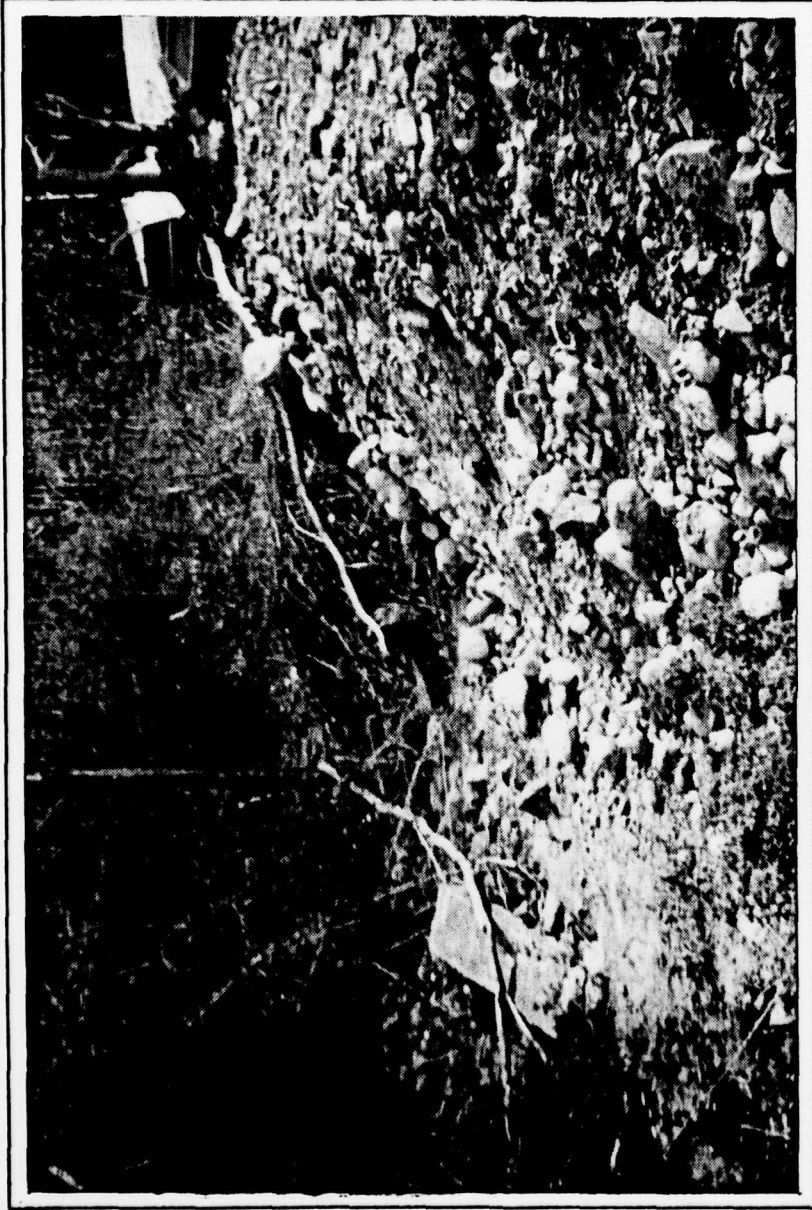
PHOTOGRAPH NO. 13

AREA DOWNSTREAM OF AUXILIARY SPILLWAY
SHOWN IN PHOTOGRAPH NO. 12. NOTE THAT
FILL WAS NOT COMPACTED OR FOUNDATION
PREPARED.

3. Trees and other vegetation downstream of the auxiliary spillway should be removed to improve hydraulic conditions.

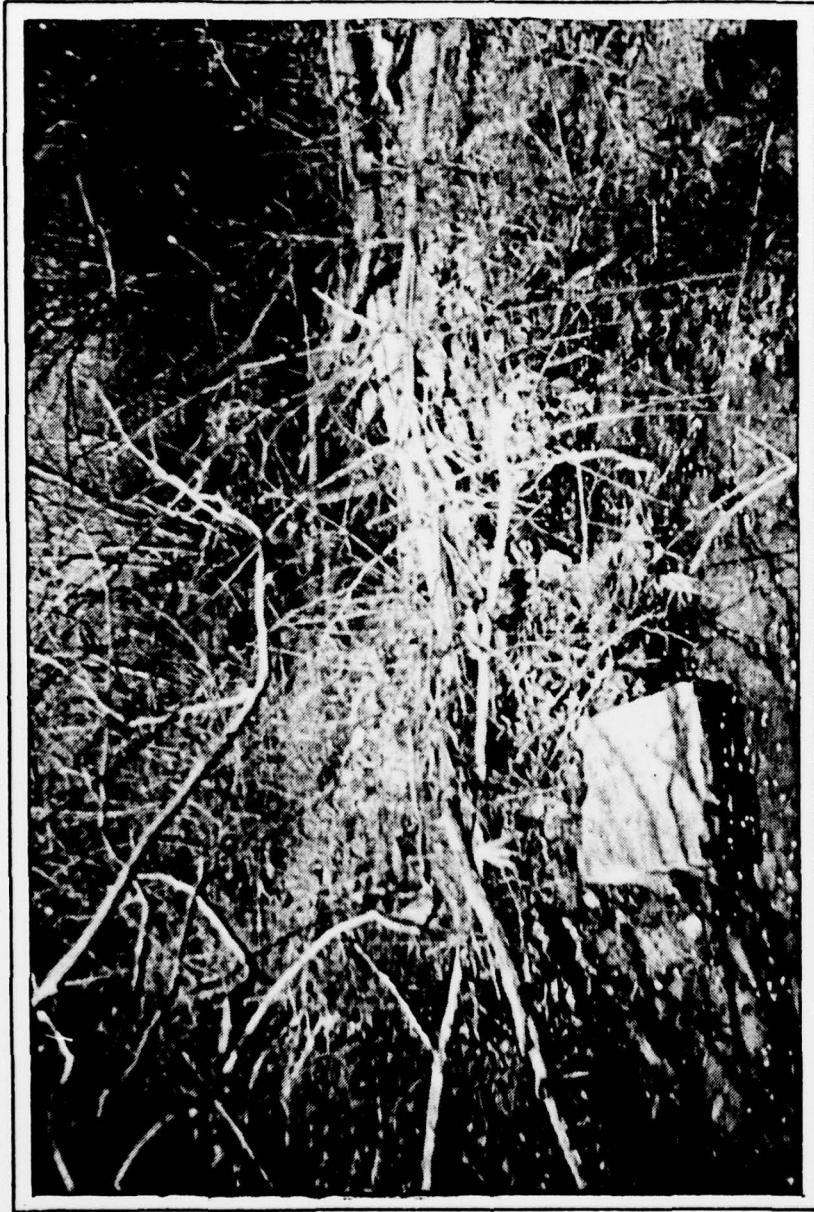
PHOTOGRAPH NO. 16

ANOTHER VIEW OF THE SEEPAGE BENEATH/
THROUGH THE AUXILLARY SPILLWAY.

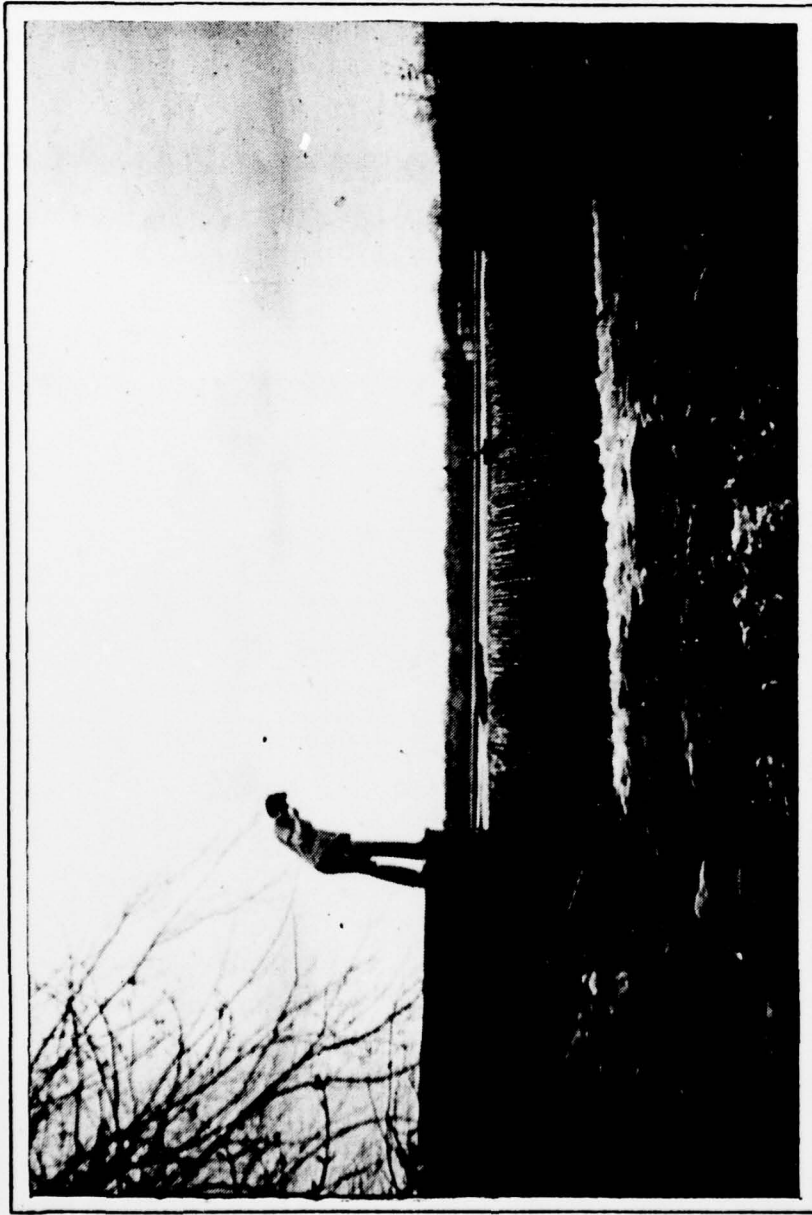
PHOTOGRAPH NO. 18

VIEW OF POCONO SUMMIT DAM WHICH DRAINS
INTO STILLWATER LAKE DAM.

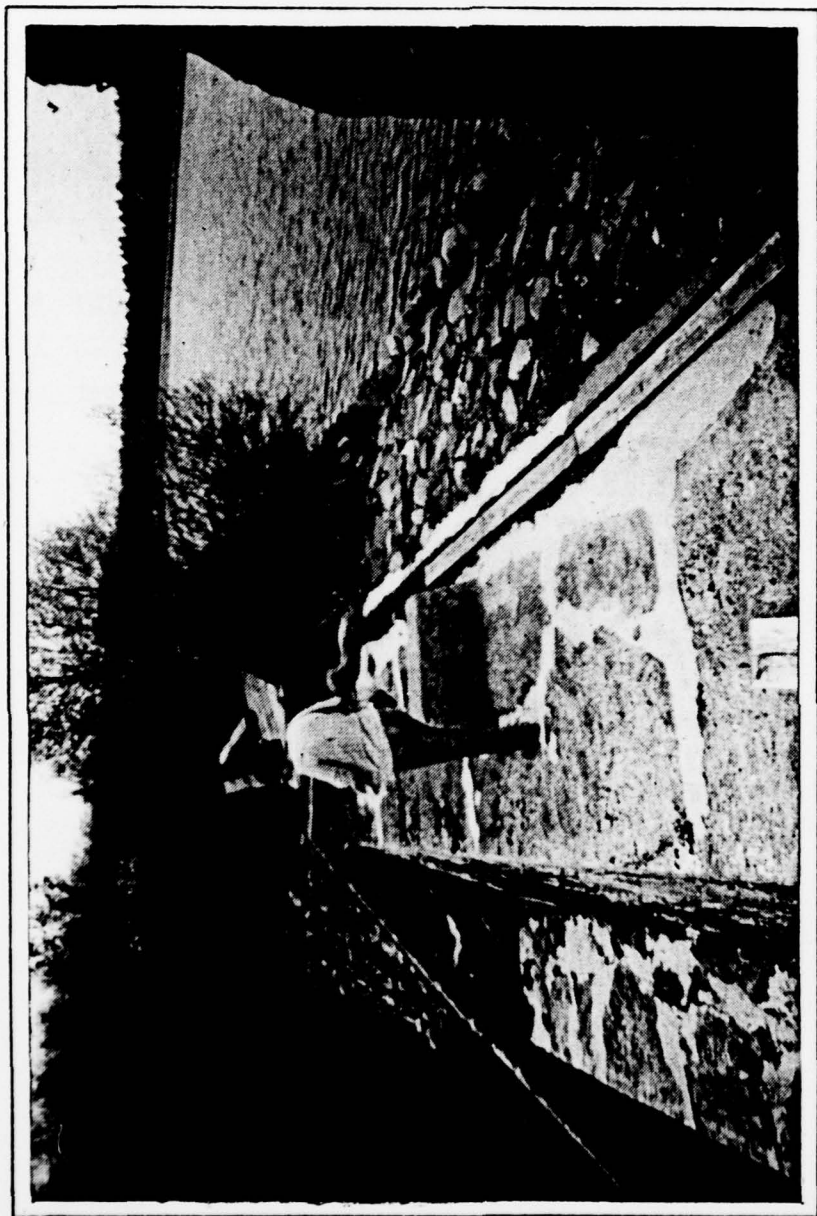
PHOTOGRAPH NO. 19

VIEW OF LYNCHWOOD LAKE DAM WHICH
DRAINS INTO STILLWATER LAKE DAM.

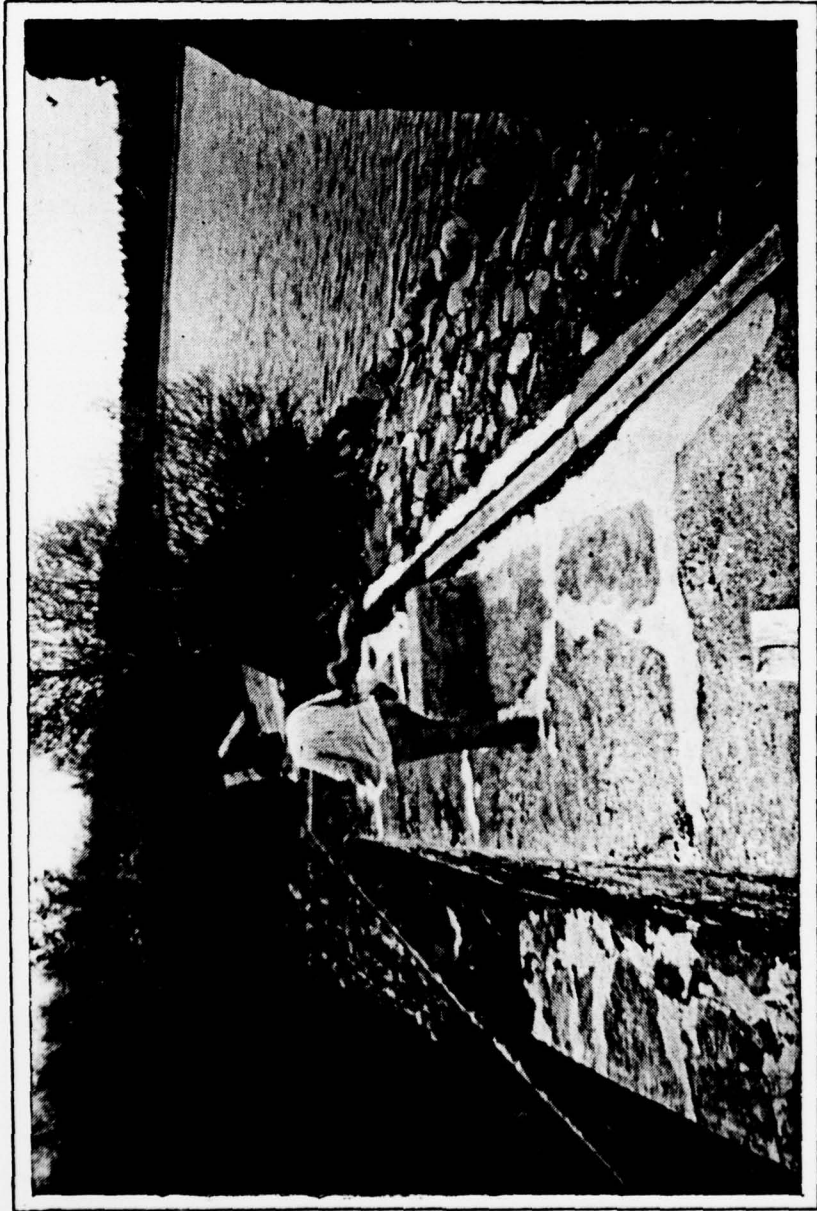
PHOTOGRAPH NO. 19

VIEW OF LYNCHWOOD LAKE DAM WHICH
DRAINS INTO STILLWATER LAKE DAM.
