HUMBOLDT DAM
NDI ID NO. PA-00646
DER ID NO. 40-61

HAZLETON CITY AUTHORITY

PHASE I INSPECTION REPORT
NATIONAL DAM INSPECTION PROGRAM

MAY 1979

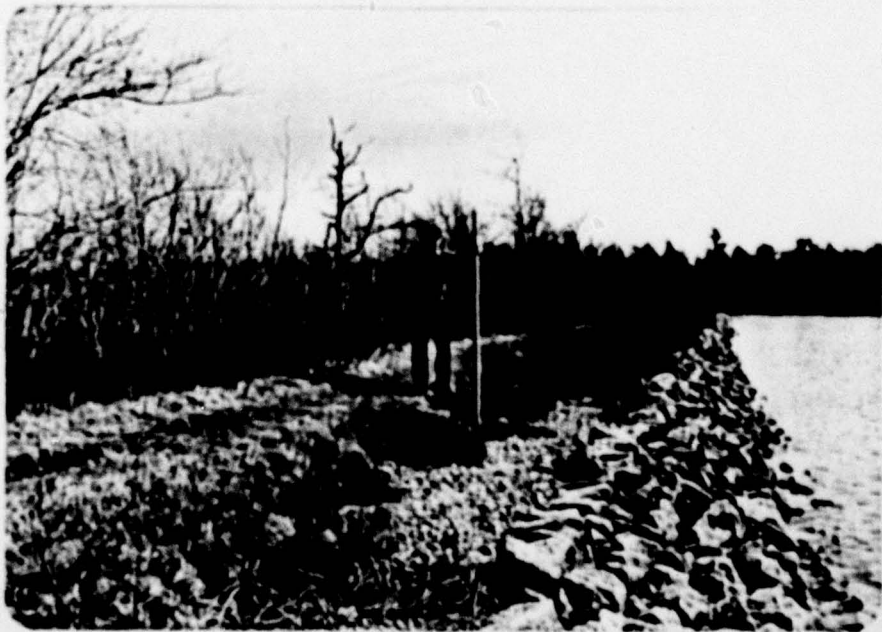
B. Upstream Slope

b. Embankment. The embankment is in poor condition. Brush extends along the upstream slope. The riprap along the upstream slope is either washed out, leaving the bedding material exposed, or weathering has deteriorated the riprap to the extent that it is no larger than gravel. The upstream edge of the top of the dam is eroded. The erosion has resulted in the top of the slope being vertical in many places. A maximum height of 1.5 feet was measured at one of these areas.

(2) Embankment. The brush on the upstream slope is undesirable. The deteriorated or washed out riprap is an erosion hazard. The trees on the downstream slope are of serious concern. Their large size indicates that brush cutting has not been accomplished on the downstream slope for many years.

(5) Replace the riprap on the upstream slope.

- (5) Replace the riprap on the upstream slope.
- (6) Remove the debris from the spillway outlet channel and the outlet works channel.

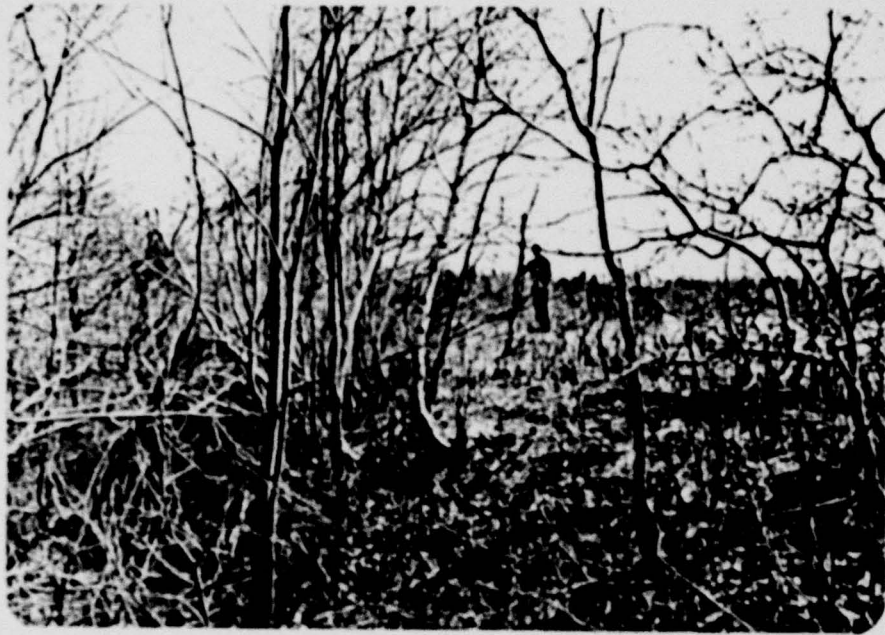
C. Downstream Slope

The downstream slope is thickly covered with mature trees. Near the right abutment, there is a discontinuity in the slope. The area is sketched on Detail A of Plate B-1. There are numerous wet areas along the toe of the dam. Clear seepage was observed at some of the wet areas. The approximate location of the conditions is shown on Plate B-1. The growth along the toe hindered the inspection of these areas. It should be noted that heavy rains occurred three days previously. There are mounds along some of the toe. A typical area is sketched on Detail B on Plate B-1.

- (3) Engage the services of a professional engineer experienced in the design and construction of dams to determine the best method of removing the trees on the downstream slope and near the toe and to determine measures necessary to ensure that the integrity of the dam is preserved. Implement his recommendations.

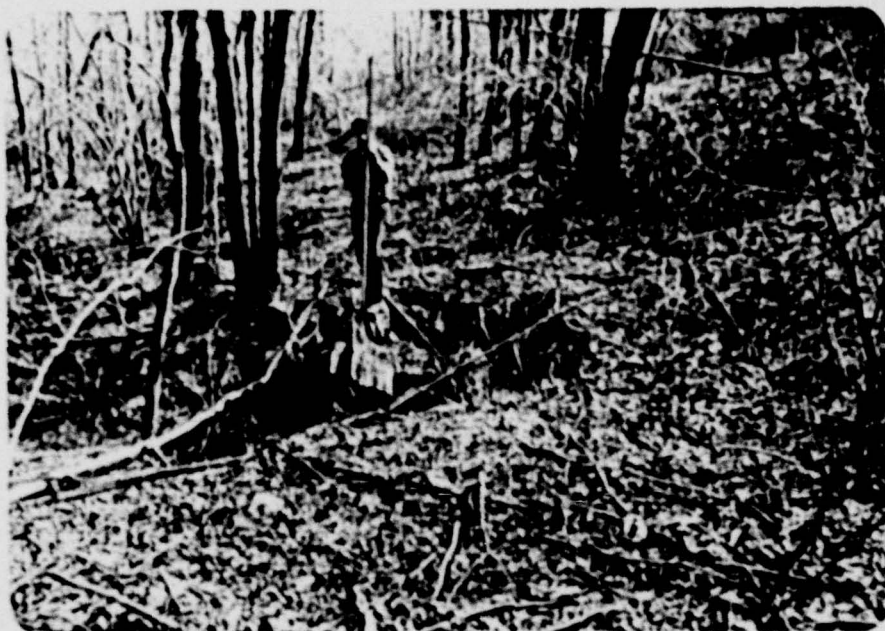
E. Downstream Toe and Outlet Works

Upstream closure for the outlet works is provided by a sluice gate in the intake structure. Its operation was not observed on the day of the inspection. There is no apparent access to the outlet works valve at the downstream toe of the dam, since the roof is caved in. The debris in the outlet channel indicates that flow has not recently occurred in the channel; the debris may also prevent proper operation of the valve. There is no evidence to suggest that the outlet works is operational.

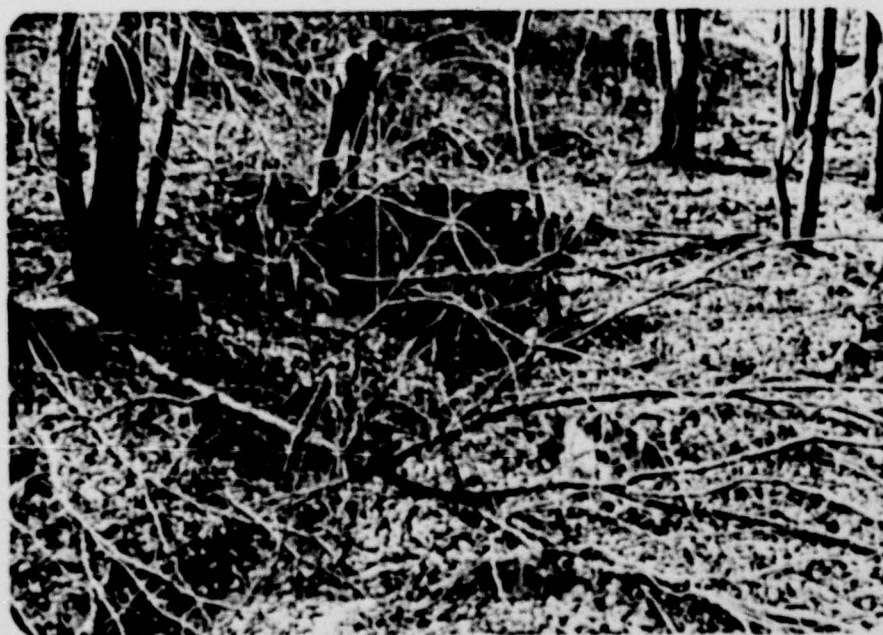
F. Downstream Outlet Works Valve House

The outlet works is in poor condition. The intake structure is in good condition, as is the access bridge. The valve house at the downstream toe of the embankment is in poor condition. The roof is collapsed; it fills the interior of the valve house. There appears to be no ready access to the valves therein. The downstream channel is filled to the axis of the outlet pipe with muck and small debris. The Owner declined to operate the valve. He was concerned that the valve would remain in the open position, thus draining the reservoir.

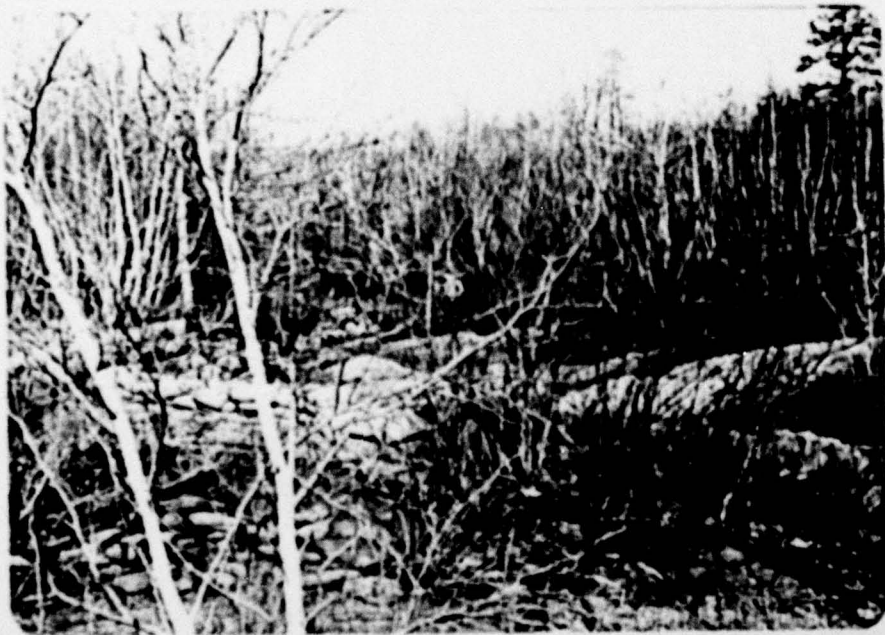
H. Spillway Approach and Exit Channels

(3) Appurtenant Structures. The offset and shifted approach wall was probably caused by frost action. The other conditions at the spillway are an indication of a lack of maintenance. The outlet works is evaluated in Section 5.
