BOYDSTOWN DAM

NDI No. PA 00270
PennDER No. 10-1

PHASE I INSPECTION REPORT
NATIONAL DAM INSPECTION PROGRAM

AUGUST 1979

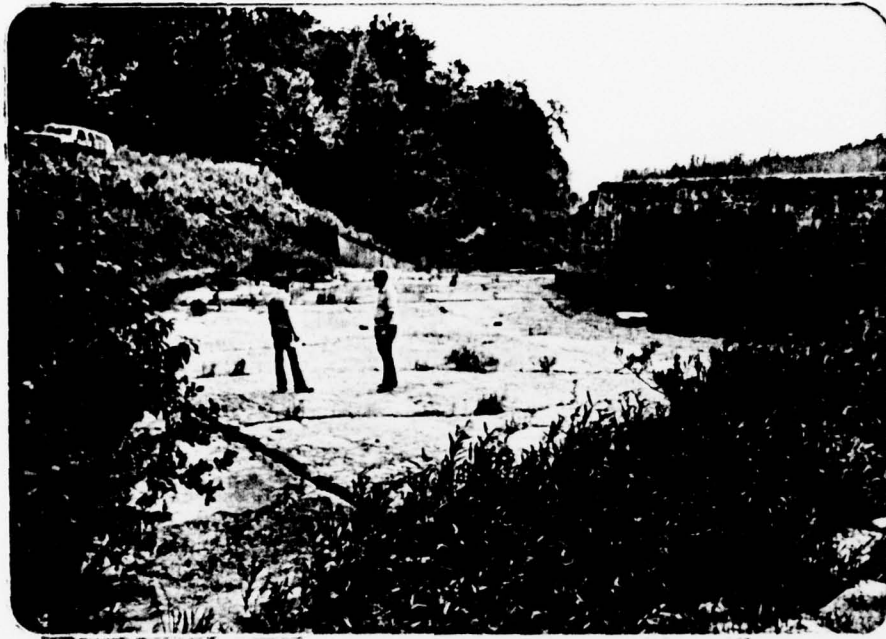
PHOTO 1. View of Spillway Looking Downstream

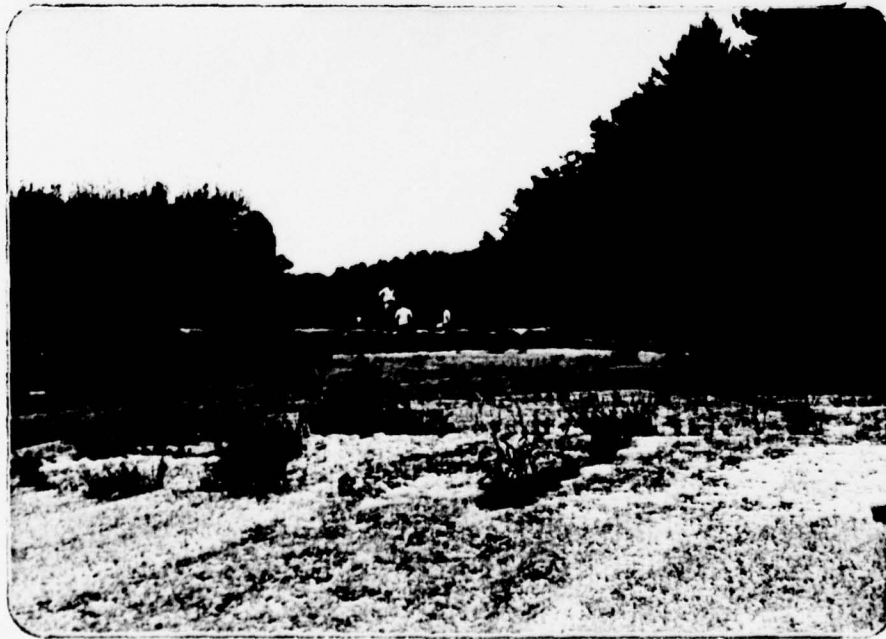
PHOTO 2. View Looking Upstream at Crest of Spillway

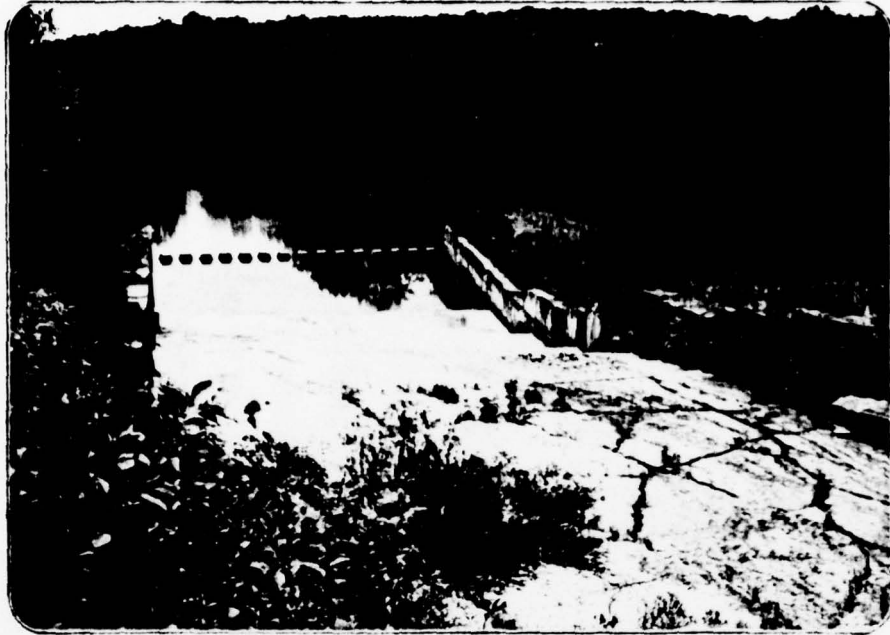
PHOTO 3. View Looking Downstream at Spillway Discharge Channel and Stilling Basin

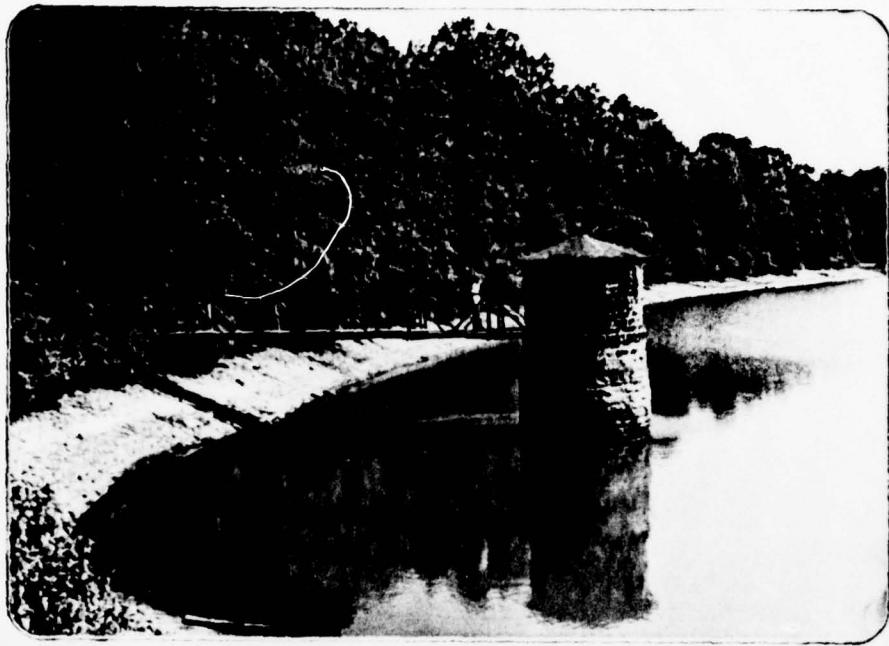
The intake tower was in fair condition with only a couple of boards on the walkway to the tower starting to rot away. The mortar between the

stones appeared to be in fair condition; however, the submerged portion of the tower could not be checked. The valve stem for the lowest level intake was disconnected at the time of the inspection. The remainder of the valves (gates) appeared to be functional but in need of preventive maintenance.

PHOTO 5. View Looking Upstream at Intake Tower

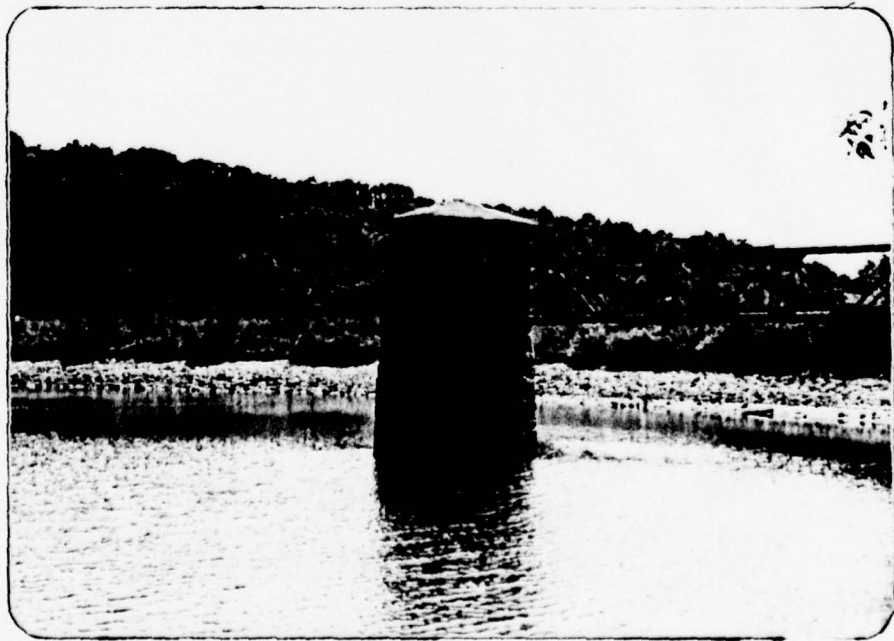
PHOTO 6. View Looking Downstream at Intake Tower and Upstream Slope of Embankment

- 4) The dense vegetation on the dam should be cleared and replaced with well maintained grass.
- 5) Riprap or other types of erosion control should be placed on the upstream slope to protect against erosion.

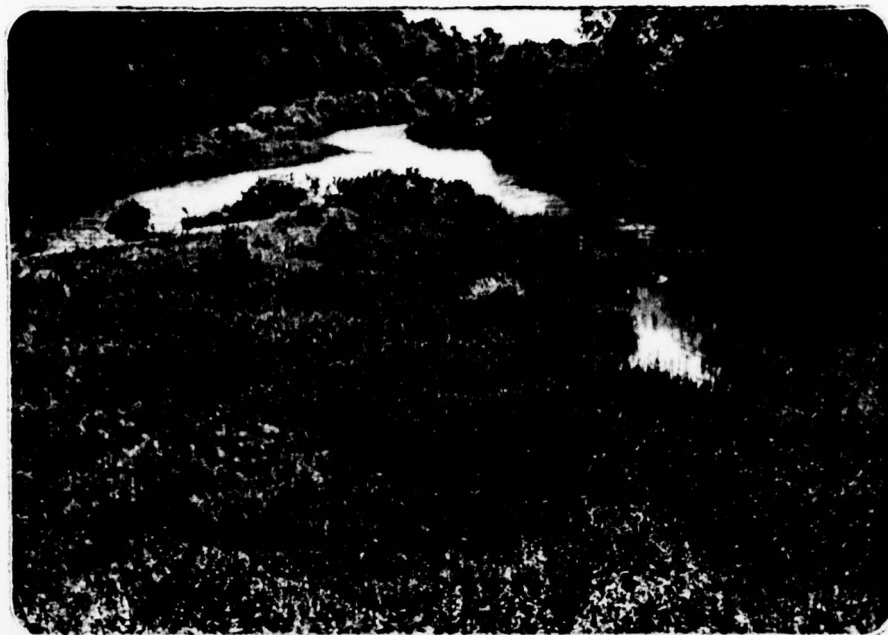
**PHOTO 7. View Looking Downstream from Crest of Embankment
(Note: Tailwater level is controlled by the level of Lake Onelda.)**

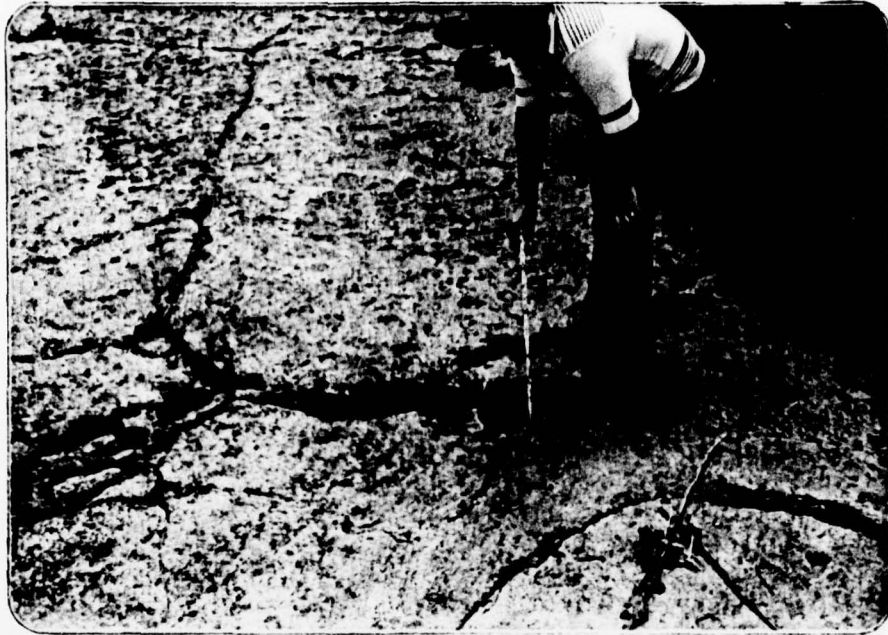
c. Appurtenant Structures - The spillway, especially the upstream half of the discharge channel and the right training wall, is very deteriorated. Cracking and undermining of the concrete slab has occurred (see Photo 9 for an example). Also, the right training wall at the entrance to the spillway has several of the sandstone blocks missing and is tilted into the spillway several inches (see Photo 10). The downstream half of the discharge channel and the stilling basin appeared to be in good condition; however, some cracking has occurred on the vertical face of several of the steps.

PHOTO 9. Close-up View of Cracking and Loss of Material Beneath Spillway Slab

- 1) Recommendations for reducing the overtopping potential of the dam should be developed and implemented. (Raising the top of dam without reconstructing the upper half of the spillway would not be acceptable because the spillway in its present condition would not withstand any high velocity discharges.)

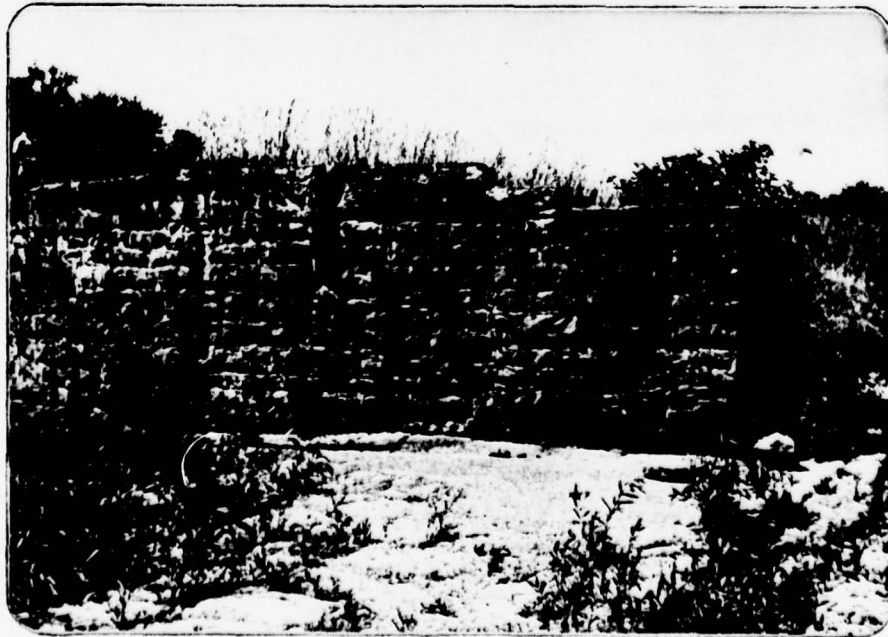
PHOTO 10. Close-up View of Right Training Wall at the Entrance to Spillway Channel

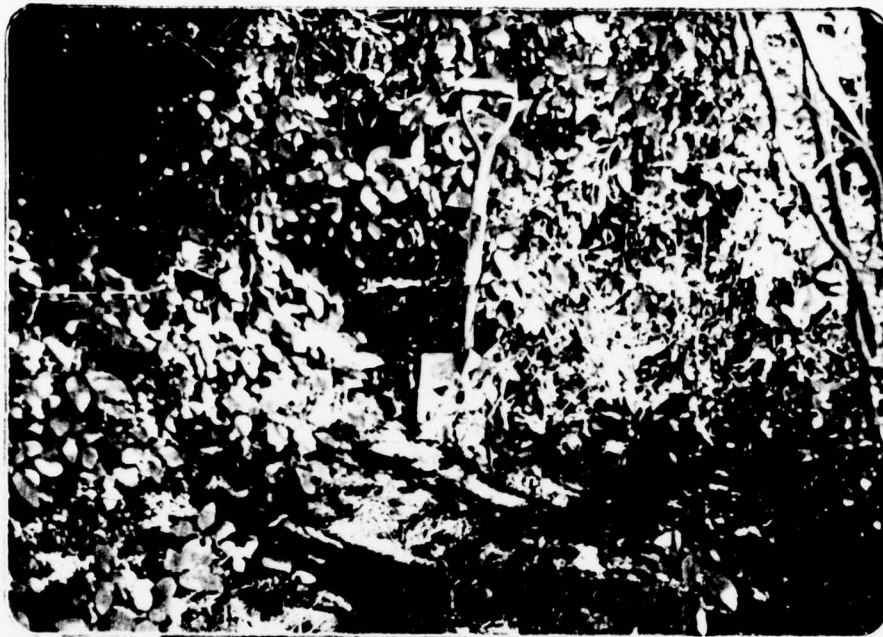
b. Dam - Clear seepage was observed exiting from the toe of the right hillside approximately 50 feet downstream from the junction of the embankment and right abutment. The estimated rate of flow was 2 g.p.m. from a fractured sandstone formation.

PHOTO 11. View of Seepage from Right Abutment Toe Area

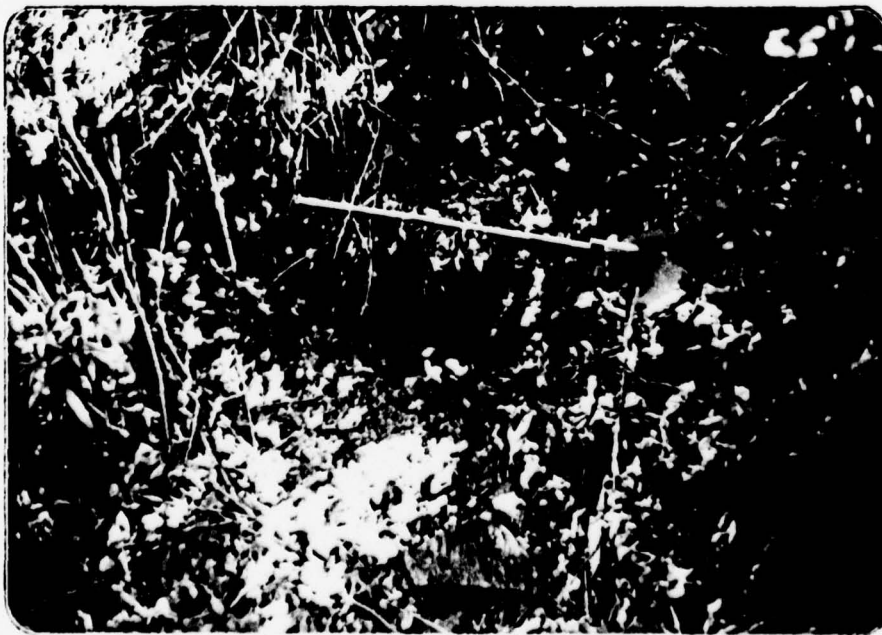
**PHOTO 12. Close-up of Right Abutment Toe Area
(Note: Seepage is located near fragmented sandstone.)**
