BOYERTOWN RESERVOIR DAM

NDI-PA 00707
PA DER 6-344

PHASE I INSPECTION REPORT NATIONAL DAM INSPECTION PROGRAM

80-7
AUGUST 1979

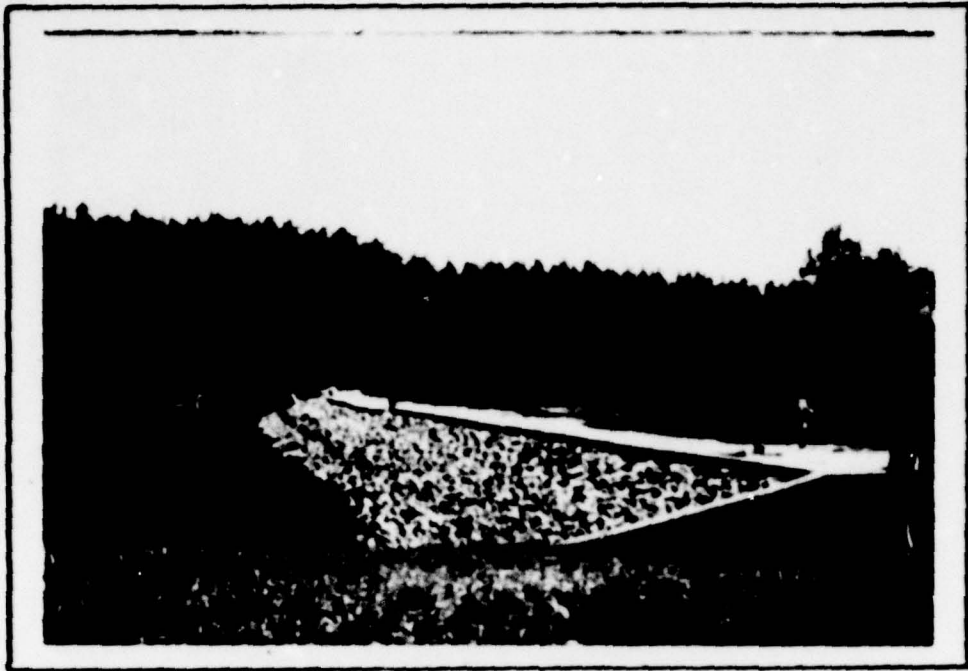
*OVERVIEW OF THE UPSTREAM
FACE OF THE BOYERTOWN DAM*

The riprap cover on the upstream face of the embankment appears to be in good condition. The riprap is fairly well graded, consisting of 6-inch to 2-foot rounded stone.

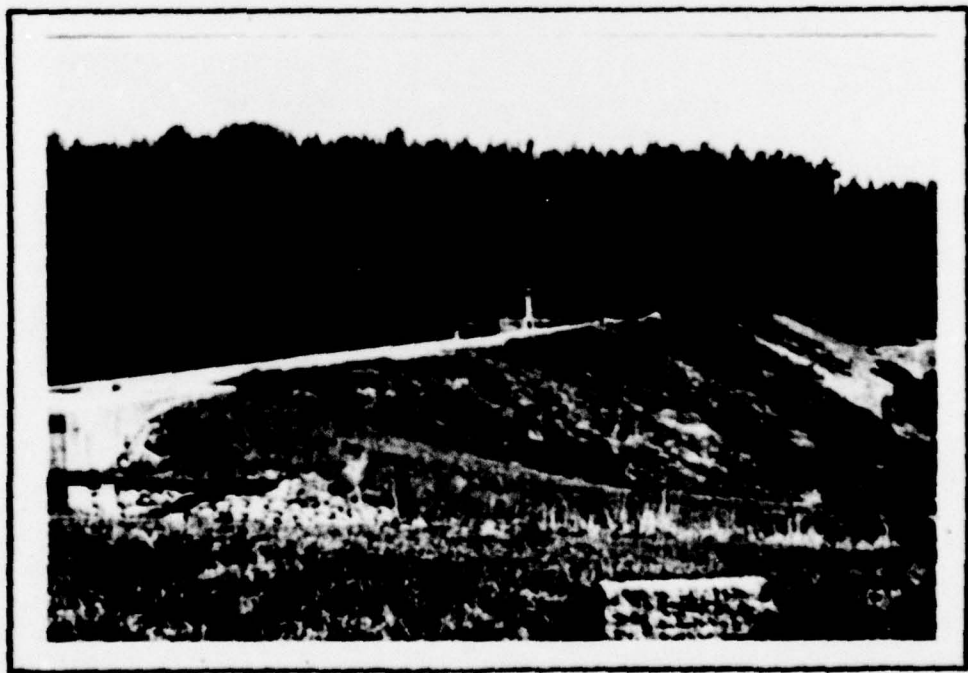
*OVERVIEW OF THE DOWNSTREAM
FACE OF THE BOYERTOWN DAM*

The downstream slope of the embankment supports a good cover consisting mainly of crown vetch. A bare spot about 50 feet by 100 feet was observed near the downstream toe approximately 200 feet from the left abutment. This bare spot was apparently related to the construction work on the new water treatment plant.

3. A bare spot on the downstream slope should be reseeded to prevent erosion from surface runoff.

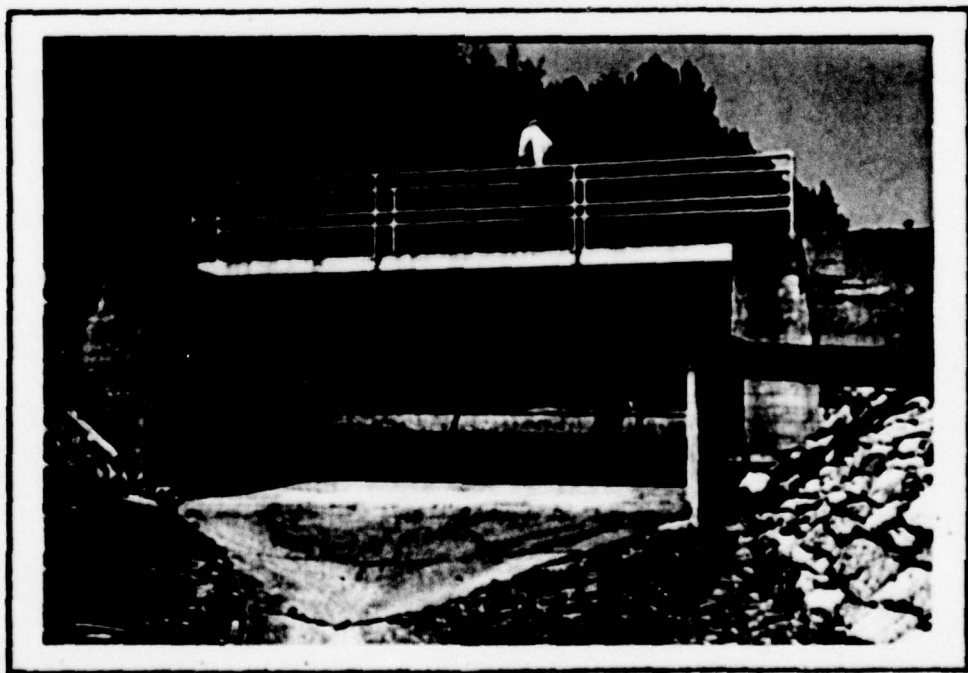
DOWNSTREAM VIEW OF THE SPILLWAY

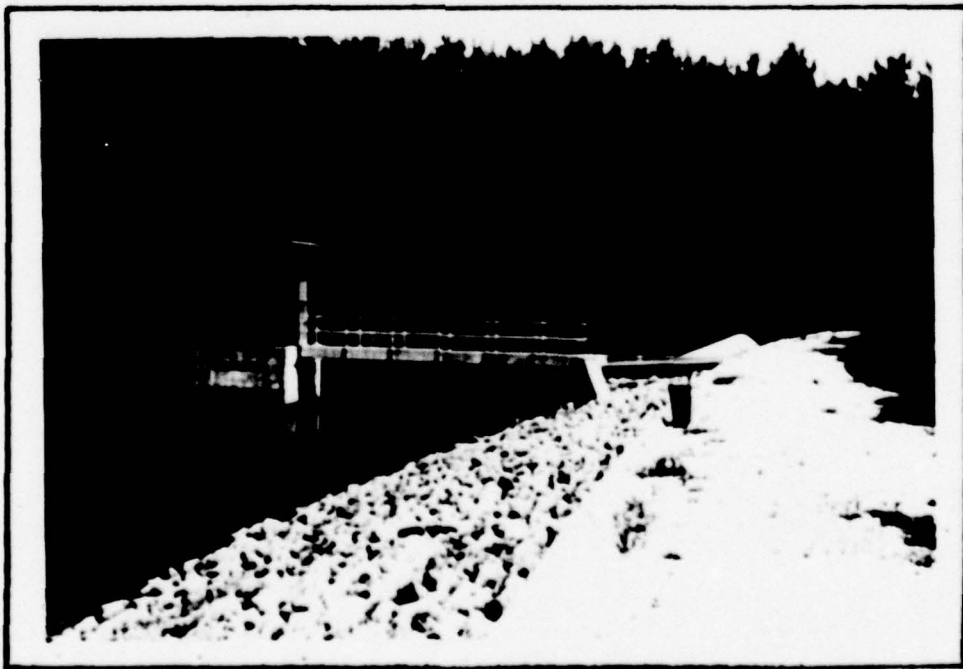
Gravel bordered by concrete curbing on either side covers the top of the dam. The curbing is about 5 inches thick and extends approximately 6 inches above the top of the dam. The curbing is out of alignment near the center of the embankment.

*UPSTREAM FACE AND CREST OF THE DAM
SHOWING THE GATEHOUSE, CATWALK AND
CURBING ALONG THE TOP OF THE DAM*

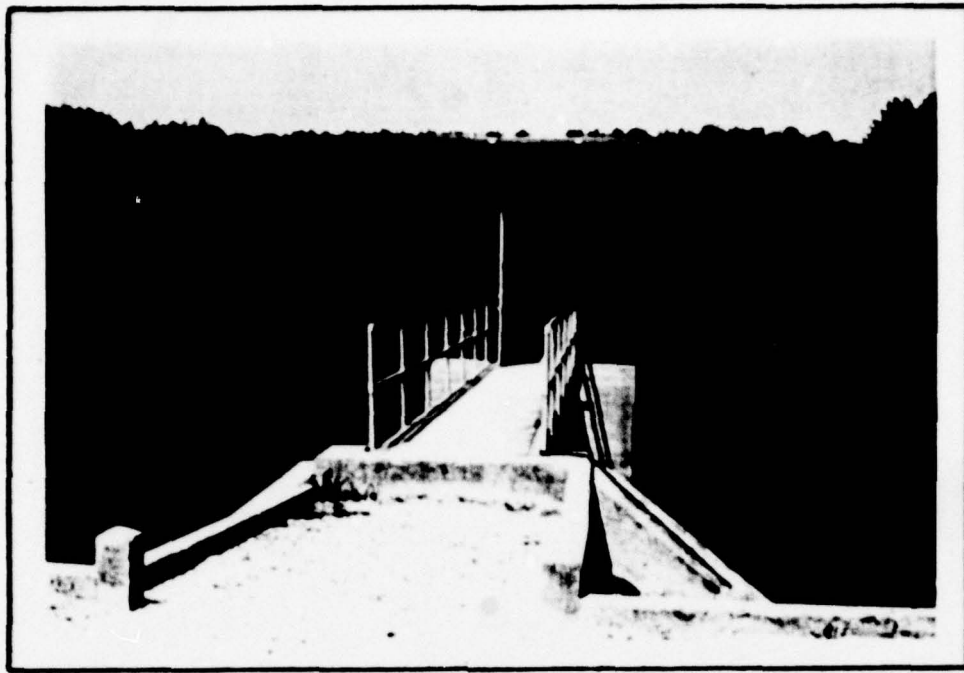
*VIEW OF THE GATEHOUSE LOOKING
TOWARDS THE RESERVOIR*

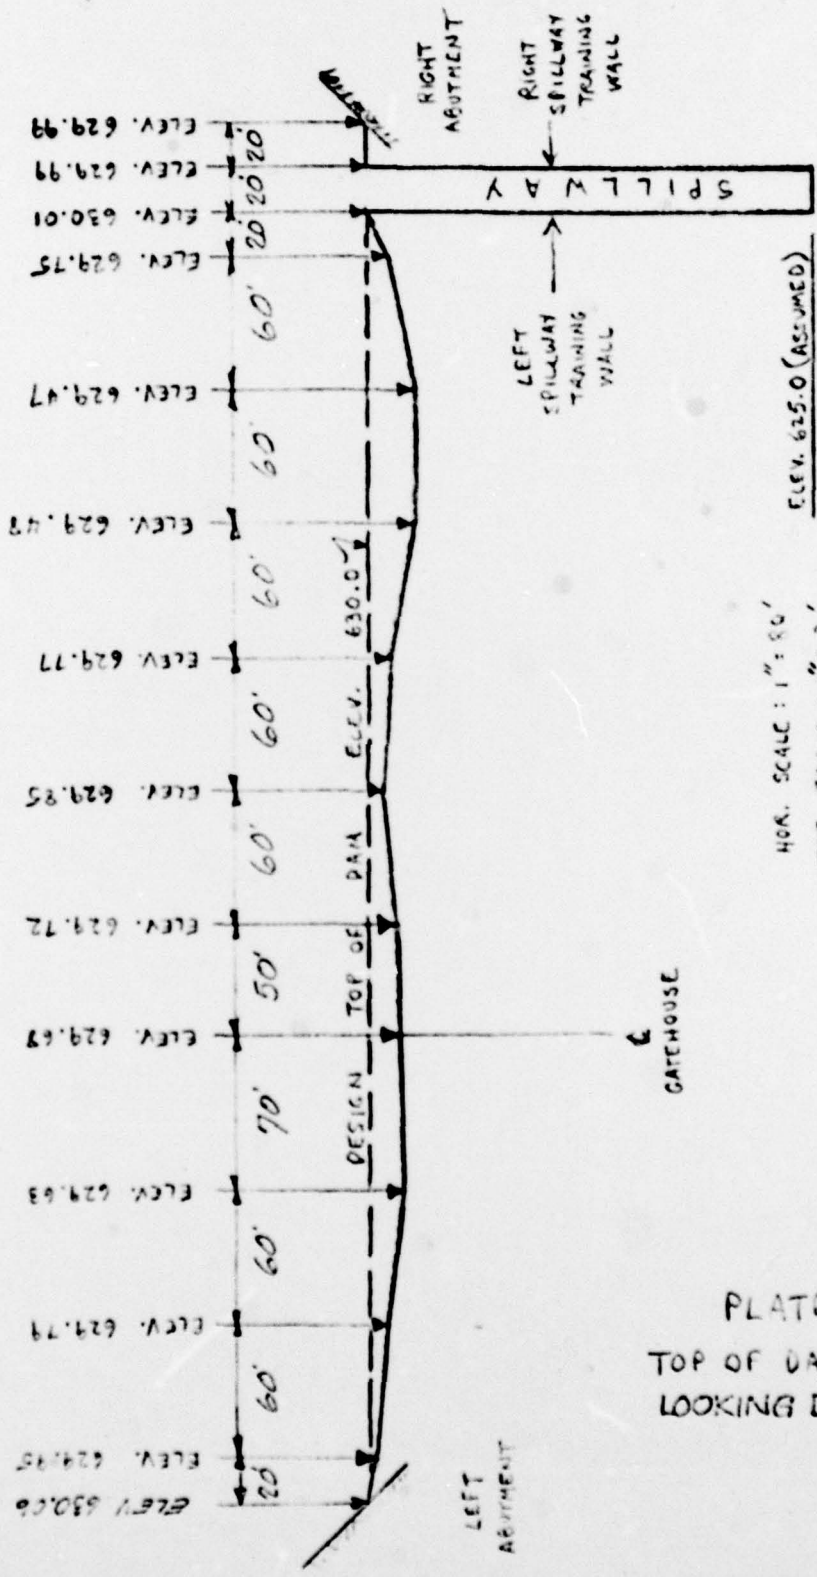
b. Dam. A survey revealed that the top of dam has settled several inches below design elevation along most of its length. A maximum depression of about six inches was observed from approximately 80 to 140 feet to the left of the spillway.

1. The top of the dam should be restored to design elevation as determined by a detailed survey. As a result, the hydraulic capacity of the spillway would be increased by about 60 cfs so that about 45 percent of the PMF could be discharged. Surface monuments should be placed along the top of the dam to monitor any future settlement.
2. Detailed hydrologic and hydraulic analyses should be performed and the spillway capacity should be further increased to make the spillway hydraulically adequate.
