# TOWNSHIP LINE DAM

NDI - PA 00625  
PA DER 15-266

PHASE I INSPECTION REPORT  
NATIONAL DAM INSPECTION PROGRAM

FOR  
DEPARTMENT OF THE ARMY  
BALTIMORE DISTRICT CORPS OF ENGINEERS  
BALTIMORE, MARYLAND  
21203

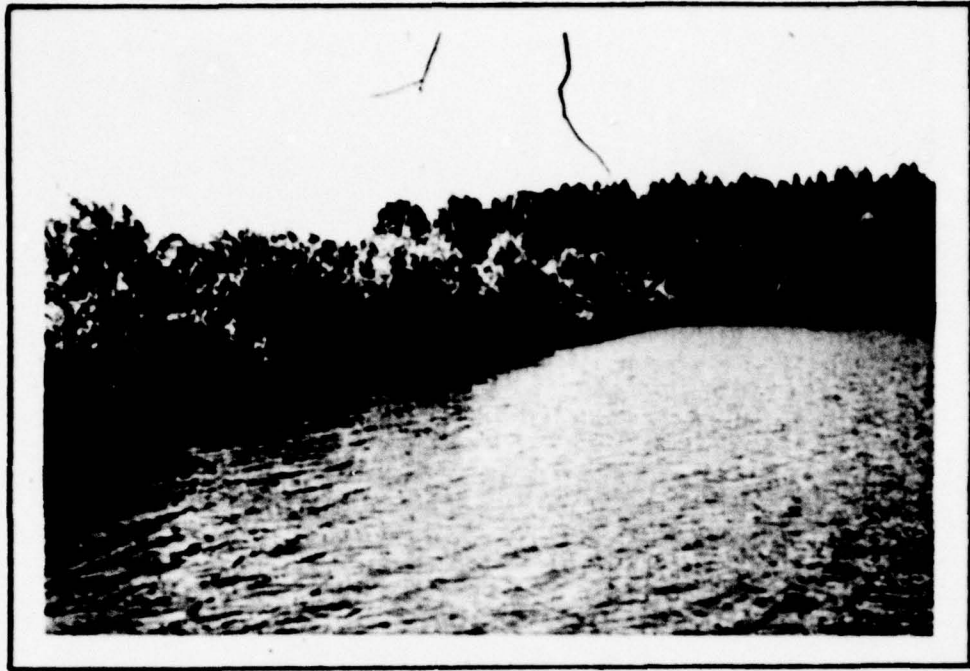
b. Dam. The entire earth embankment is overgrown with heavy brush and tall grass. A few trees up to 25 feet tall are growing on the downstream embankment slope adjacent to the spillway. The hand-placed riprap on the upstream slope exhibits evidence of displacement perpendicular to the prevailing grade line. The riprap is missing on the upstream slope from the dam crest to the water line in the vicinity of the intake tower access bridge. It is apparent, at many locations, that the riprap had been reset since the dam was put in service. There is no evidence of uncontrolled seepage or slope misalignments, however, observations were severely limited due to dense vegetation. Visual inspection of the structure was limited to walking in a foot path along the top of dam and inspecting the upstream and downstream slopes at randomly selected locations. An aerial photo was made for the overall view.

*VIEW SHOWING THE IMPOUNDMENT, GATEHOUSE,  
CATWALK AND THE HEAVILY OVERGROWN  
EMBANKMENT OF THE DAM*

1. The capacity of the spillway should be increased in accordance with the results of further hydrologic and hydraulic studies.
2. The thick vegetation and trees should be removed from the embankment crest and slopes under the guidance of an engineer. If any signs of distress such as seepage, sloughing or cracking are revealed, the stability of the embankment should be reevaluated by a licensed

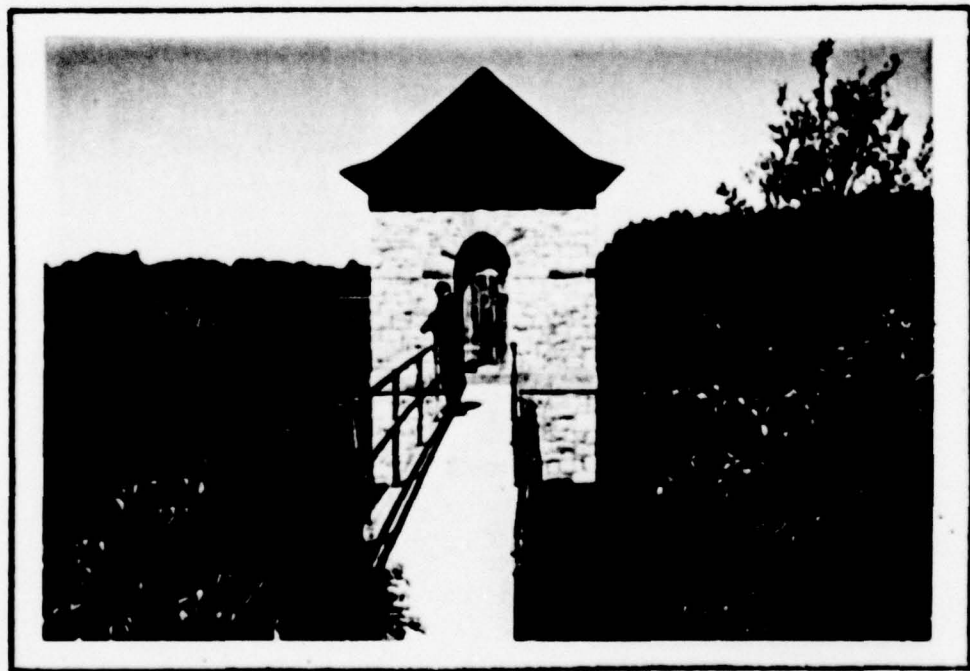
c. Appurtenant Structures. The concrete access bridge to the intake tower is in good condition, however, the steel pipe railing is severely rusted and some sections are missing. The concrete and masonry intake tower, above the water line, is in good condition with no indications of vertical or horizontal misalignments. The gate hoist mechanism could not be observed because the door to the intake tower was locked and the Owner's representative, Mr. David Hughes, did not have the key. According to Mr. Hughes, the gate is operated periodically.

*CATWALK AND GATEHOUSE WITH BROKEN  
RAILING ON THE RIGHT SIDE OF THE CATWALK*

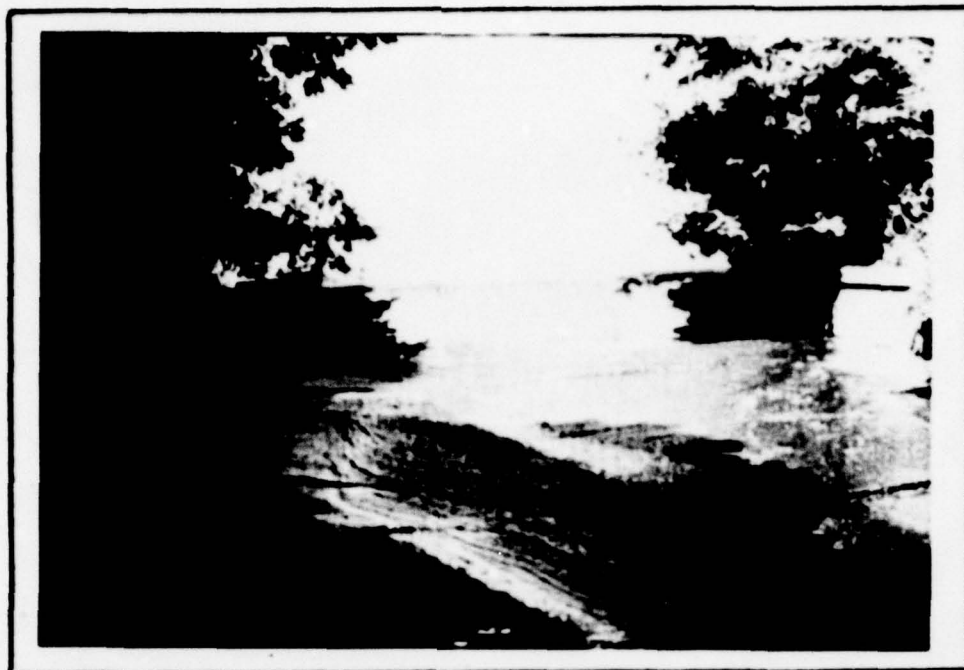
*LOOKING UPSTREAM IN THE SPILLWAY  
OUTLET CHANNEL AT THE SPILLWAY*

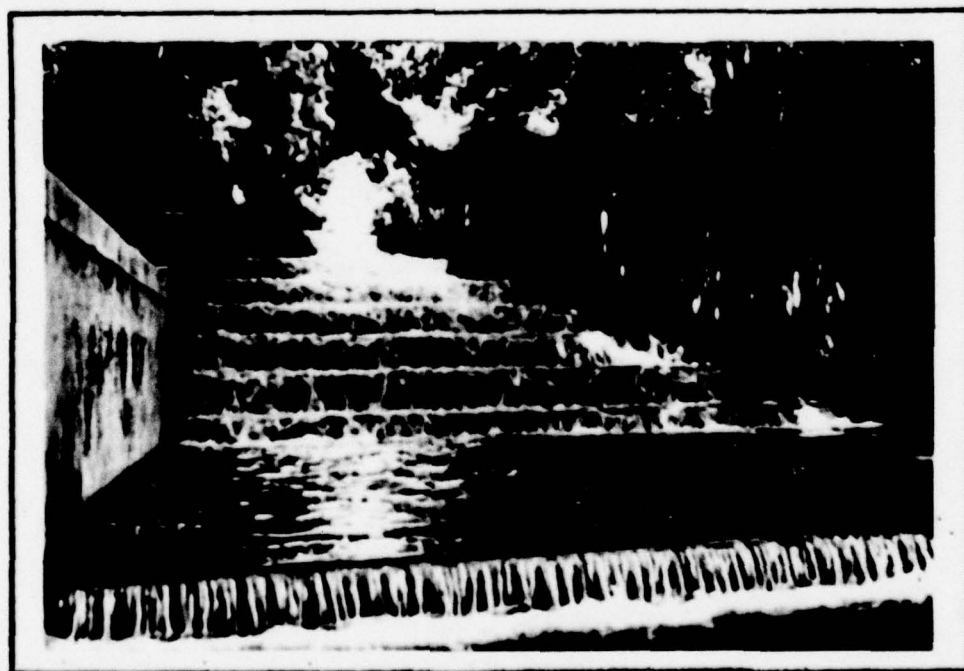
*STEPPED PORTION OF THE SPILLWAY  
OUTLET CHANNEL ABOUT 200 FEET  
DOWNSTREAM OF THE SPILLWAY*

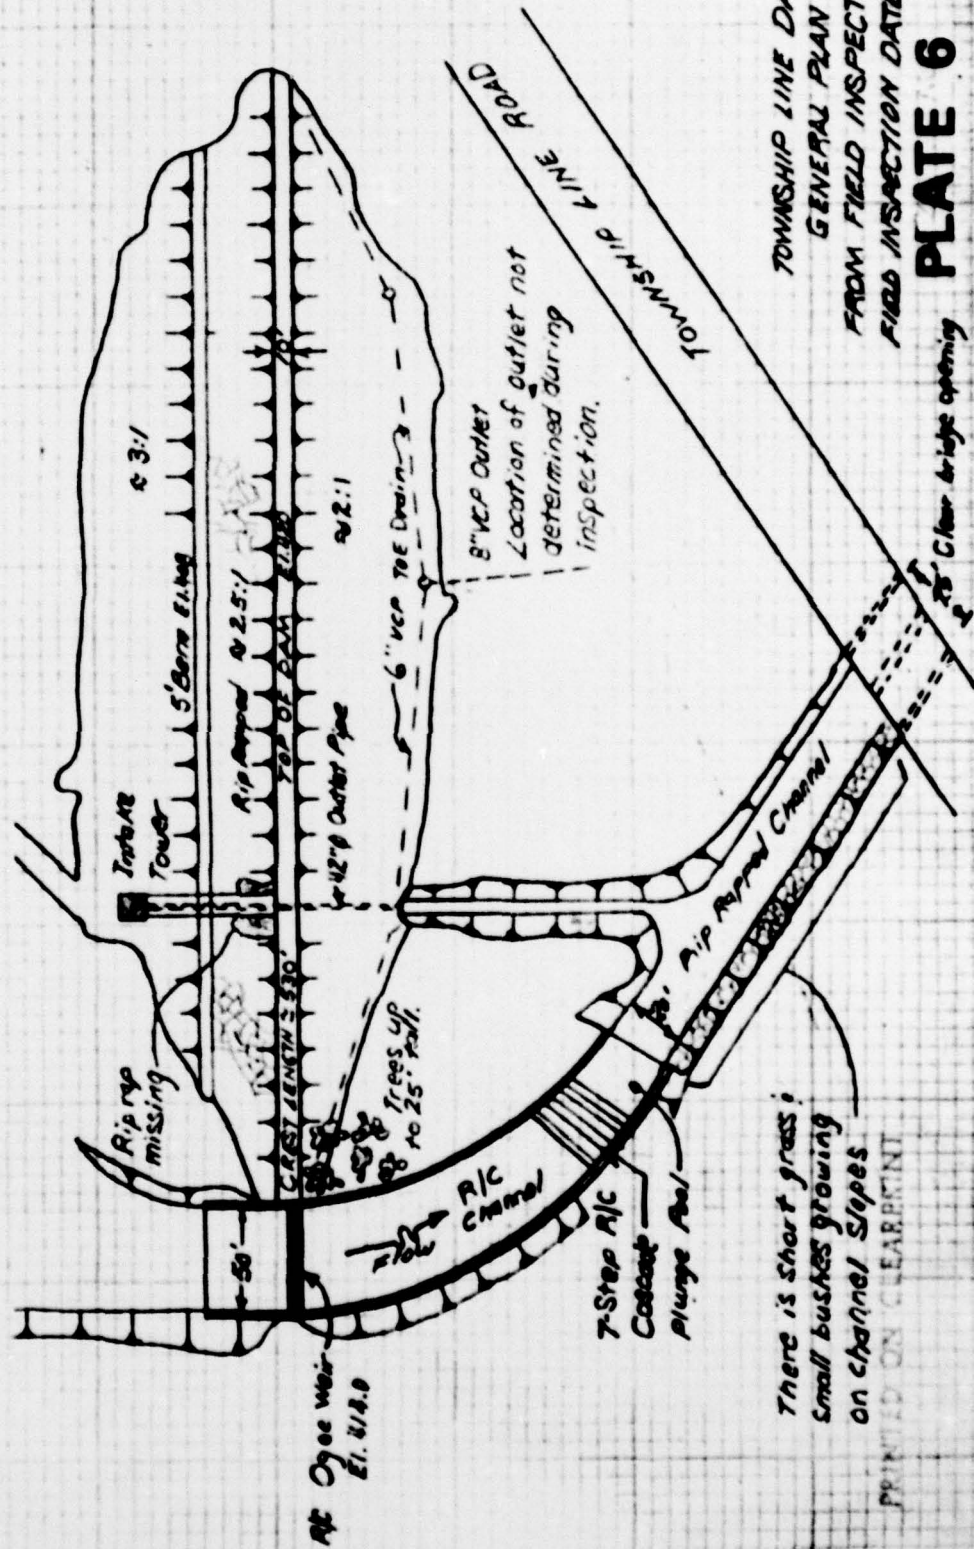
\* The entire embankment is overgrown \*  
with brush, tall grass and small trees.

There is short grass &  
small bushes growing  
on channel slopes
