CRUM CREEK DAM

NDI - PA 00350
PA DER 23-20

PHASE I INSPECTION REPORT
NATIONAL DAM INSPECTION PROGRAM

AUGUST 1979

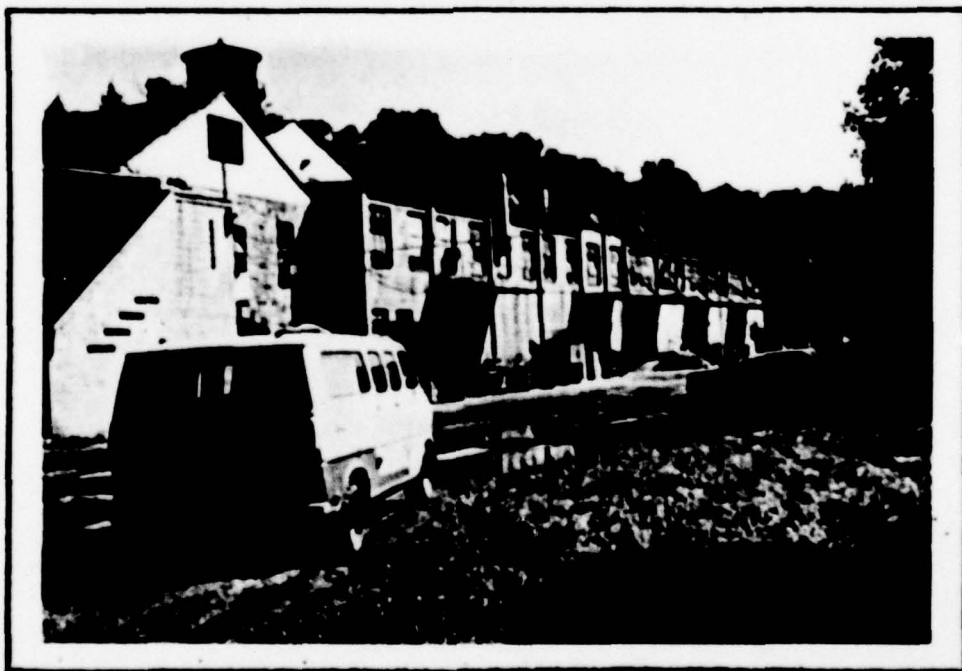
*POTENTIAL DAMAGE AREA APPROXIMATELY
2,000 YARDS DOWNSTREAM OF THE DAM*

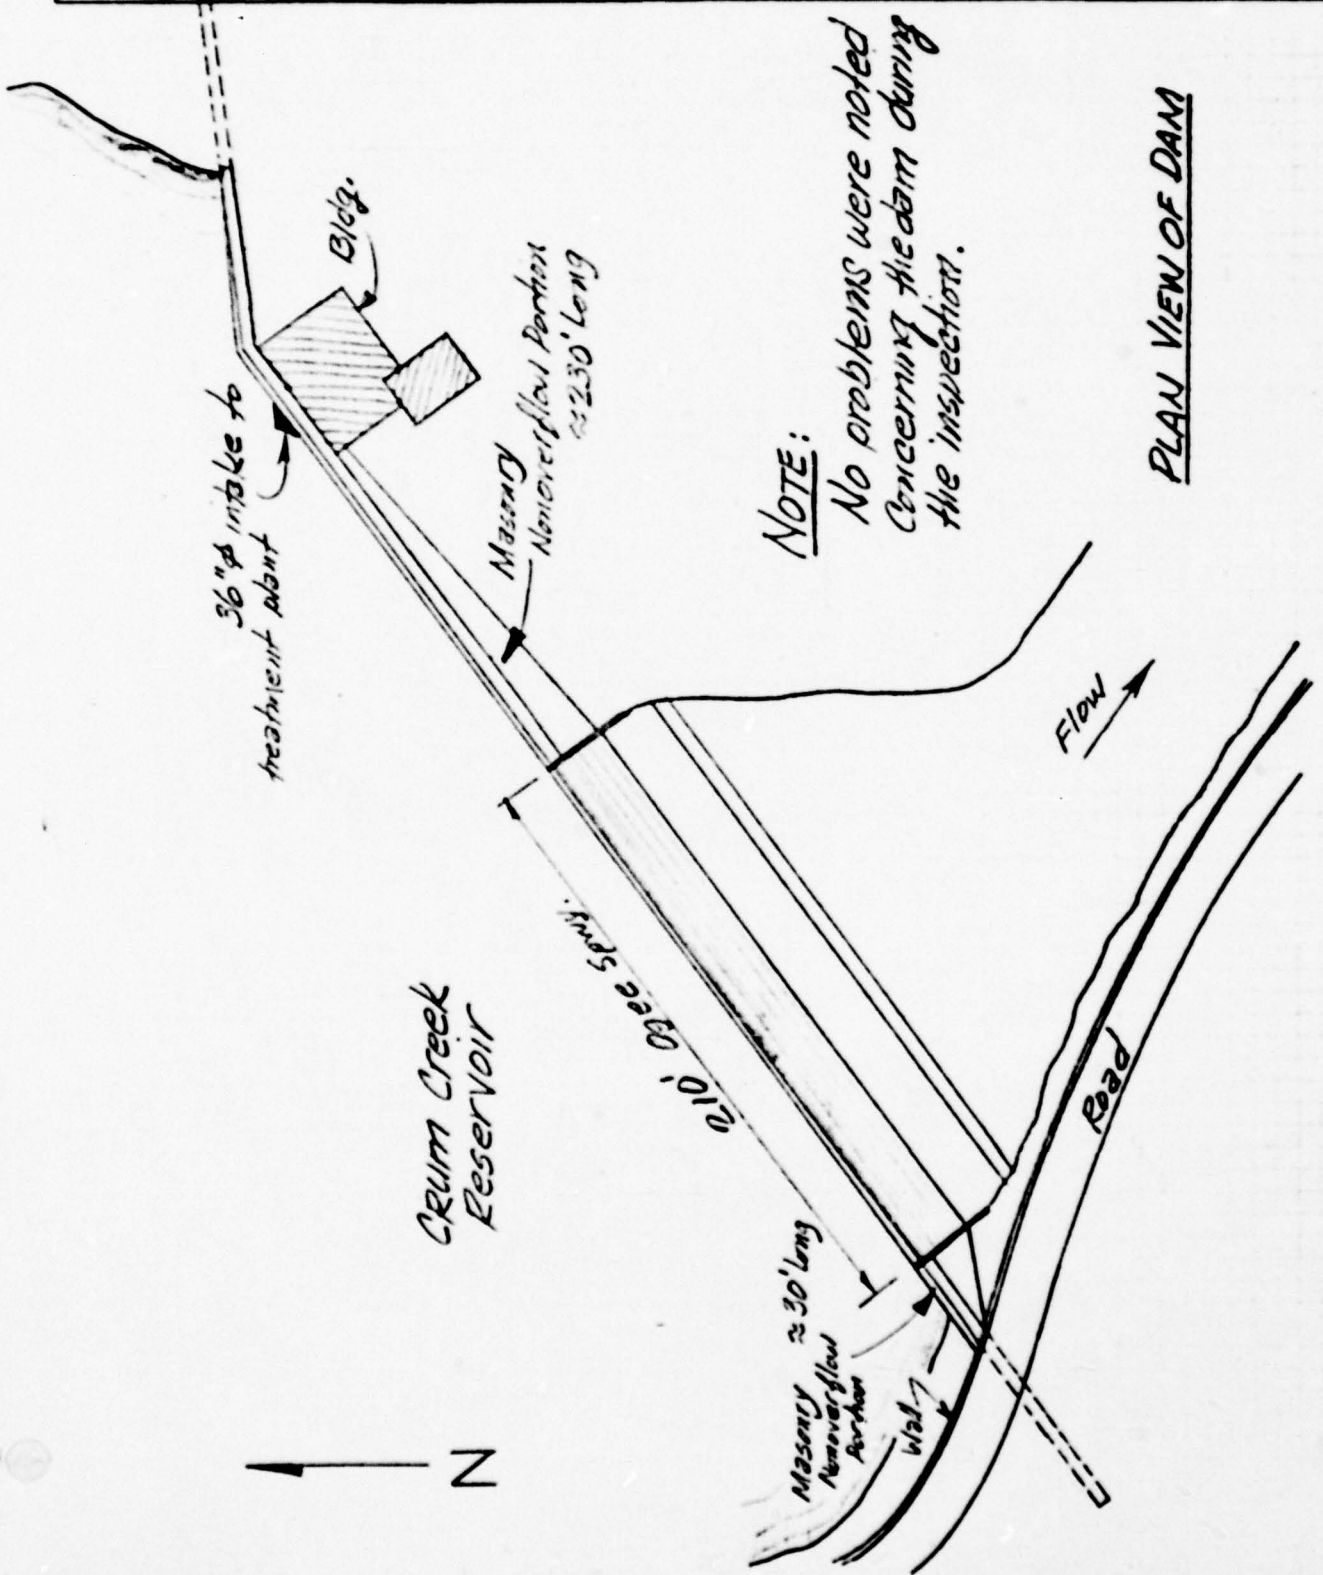
PLAN VIEW OF DAM

NOTE:
No problems were noted concerning the dam during the inspection.
