PHASE I REPORT  
NATIONAL DAM INSPECTION PROGRAM

NAME OF DAM: Raccoon Creek State Park Dam  
STATE LOCATED: Pennsylvania  
COUNTY LOCATED: Beaver County  
STREAM: Traverse Creek, a tributary of Raccoon Creek  
SIZE CLASSIFICATION: Intermediate  
HAZARD CLASSIFICATION: High  
DATE OF INSPECTION: December 13, 1978 and April 16, 1979

RACCOON CREEK STATE PARK DAM  
NDI I.D. NO. PA-262  
DECEMBER 13, 1978

PHASE I REPORT  
NATIONAL DAM INSPECTION PROGRAM  
RACCOON CREEK STATE PARK DAM  
NDI I.D. NO. PA-262  
DER I.D. NO. 4-34

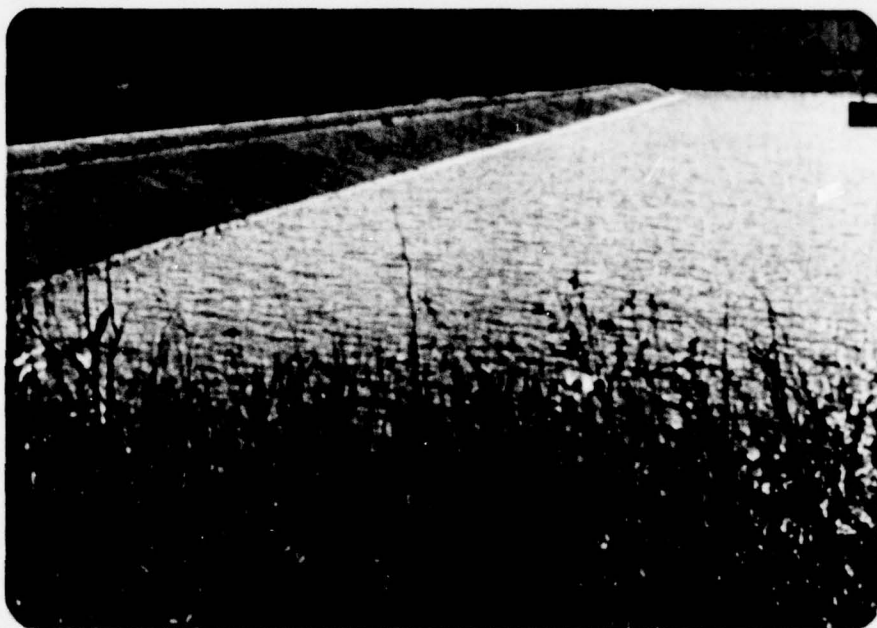
Upstream Face

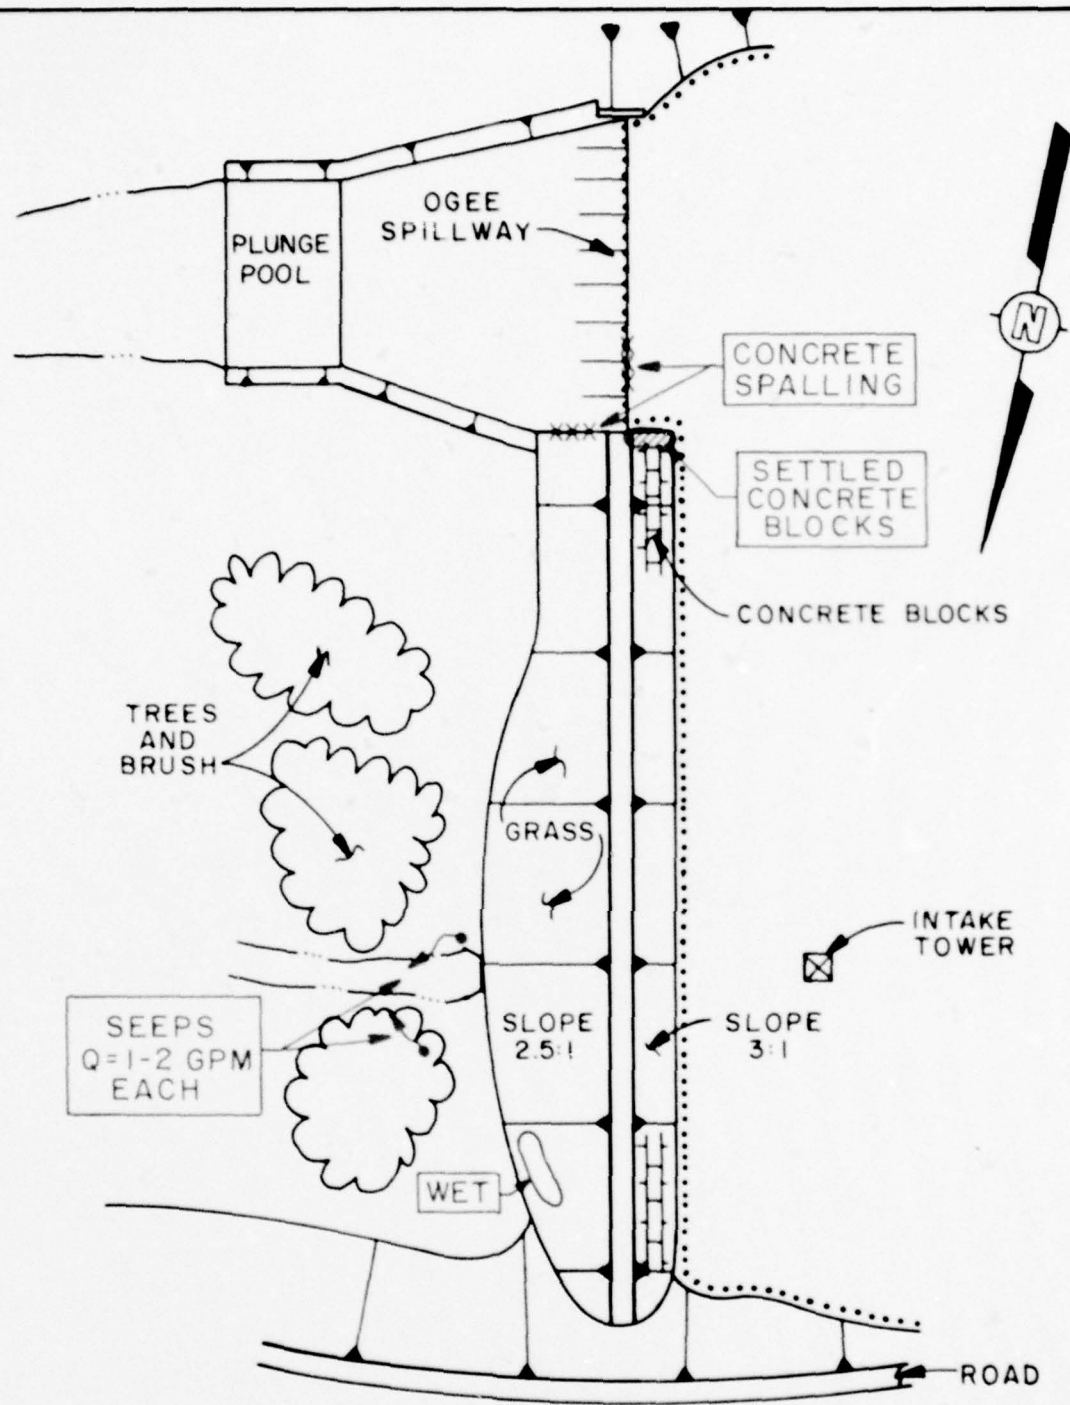
PLATE 9  
 RACON CREEK STATE PARK DAM  
 GENERAL PLAN  
 FIELD INSPECTION NOTES  
 FIELD INSPECTION DATE: DEC. 13, 1978

In general, the condition of the dam is considered to be good. One wet area was found along the toe of the dam near the left abutment. No measurable seepage was found to be associated with this wet area. Two seepage points were identified in the vicinity of the outlet conduit discharge structure. The quantity of seepage was estimated to be one to two gallons per minute. The seepages were clear and no indication of internal erosion was found. A portion of the upstream erosion protection adjacent to the spillway sidewall was found to be settled. The settlement does not appear to be due to recent movements.

- NOTES:**
1. SPILLWAY FREEBOARD = 8.0 FEET.
  2. POOL LEVEL DATE OF INSPECTION: 0.1 FT. ABOVE SPILLWAY CREST.

1. Seepage points and the wet areas along the downstream toe of the dam should be periodically visually monitored.
2. The dam and appurtenant structures should continue to be inspected regularly and necessary maintenance should be performed.

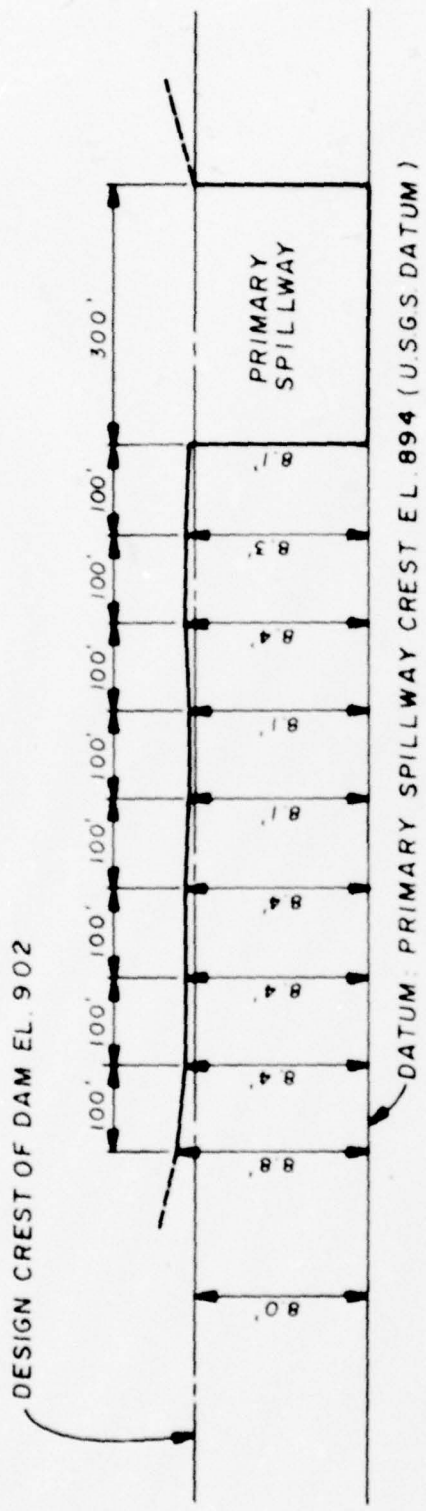
DAM CREST PROFILE  
( LOOKING UPSTREAM )

The crest of the embankment was surveyed relative to the spillway crest level and was found to be at or slightly above the design crest level. The profile of the crest is illustrated on Plate 10.

NOTE  
DAM CREST IS SURVEYED RELATIVE  
TO PRIMARY SPILLWAY CREST LEVEL

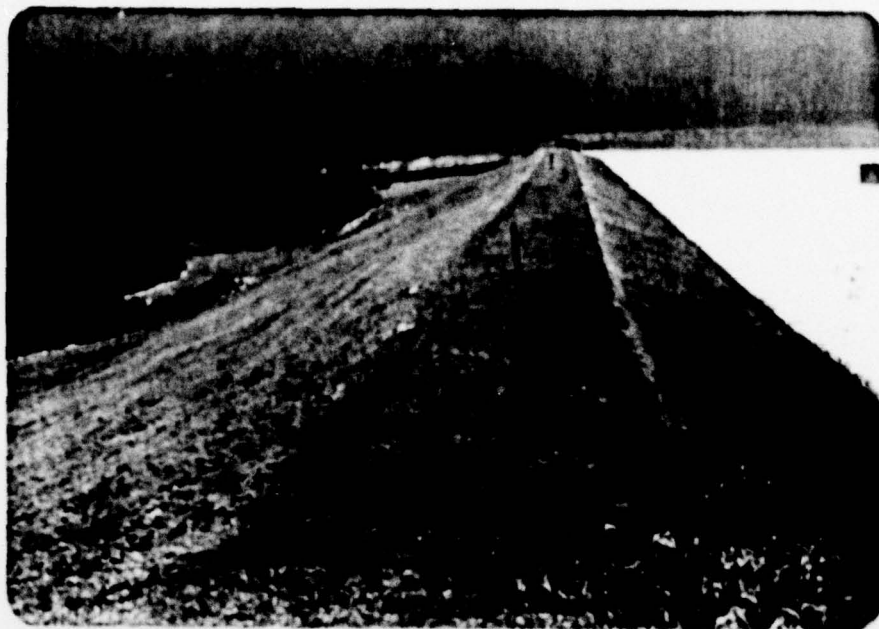
Photograph No. 1  
Crest (looking south).

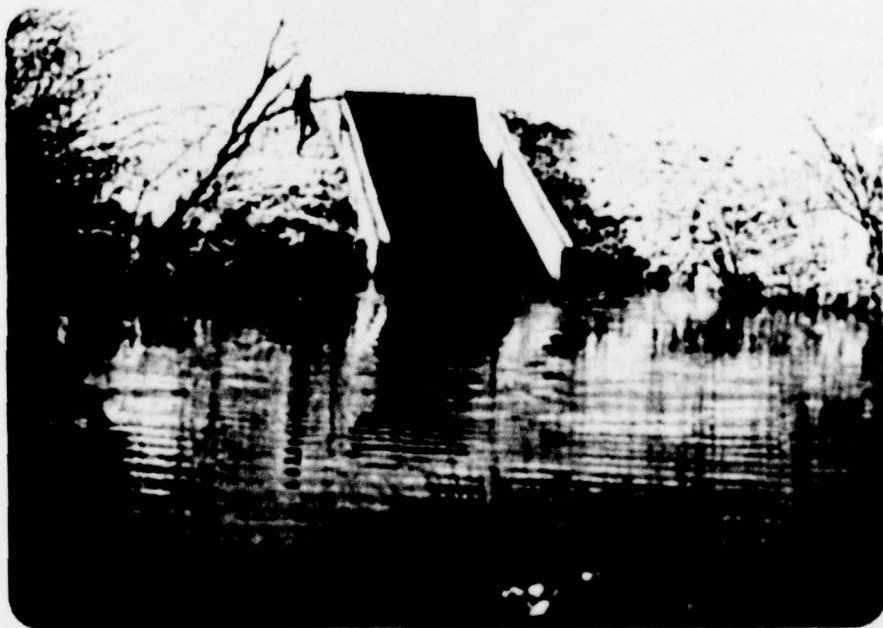
VISUAL EXAMINATION OF CRACKING AND SPALLING OF CONCRETE SURFACES IN OUTLET CONDUIT	OBSERVATIONS	REPAIRS OR RECOMMENDATIONS
INTAKE STRUCTURE	The outlet conduit was inspected and was found to be in good condition.	
OUTLET STRUCTURE	In good condition.	
OUTLET CHANNEL	No significant obstructions.	
EMERGENCY GATE	The emergency gate was operated by park personnel and was observed to be functional.

Photograph No. 6  
Downstream end of outlet conduit.
