GLADES DAM

NDI No. PA 00804
PennDER No. 10-72

PHASE I INSPECTION REPORT
NATIONAL DAM INSPECTION PROGRAM

AUGUST 1979

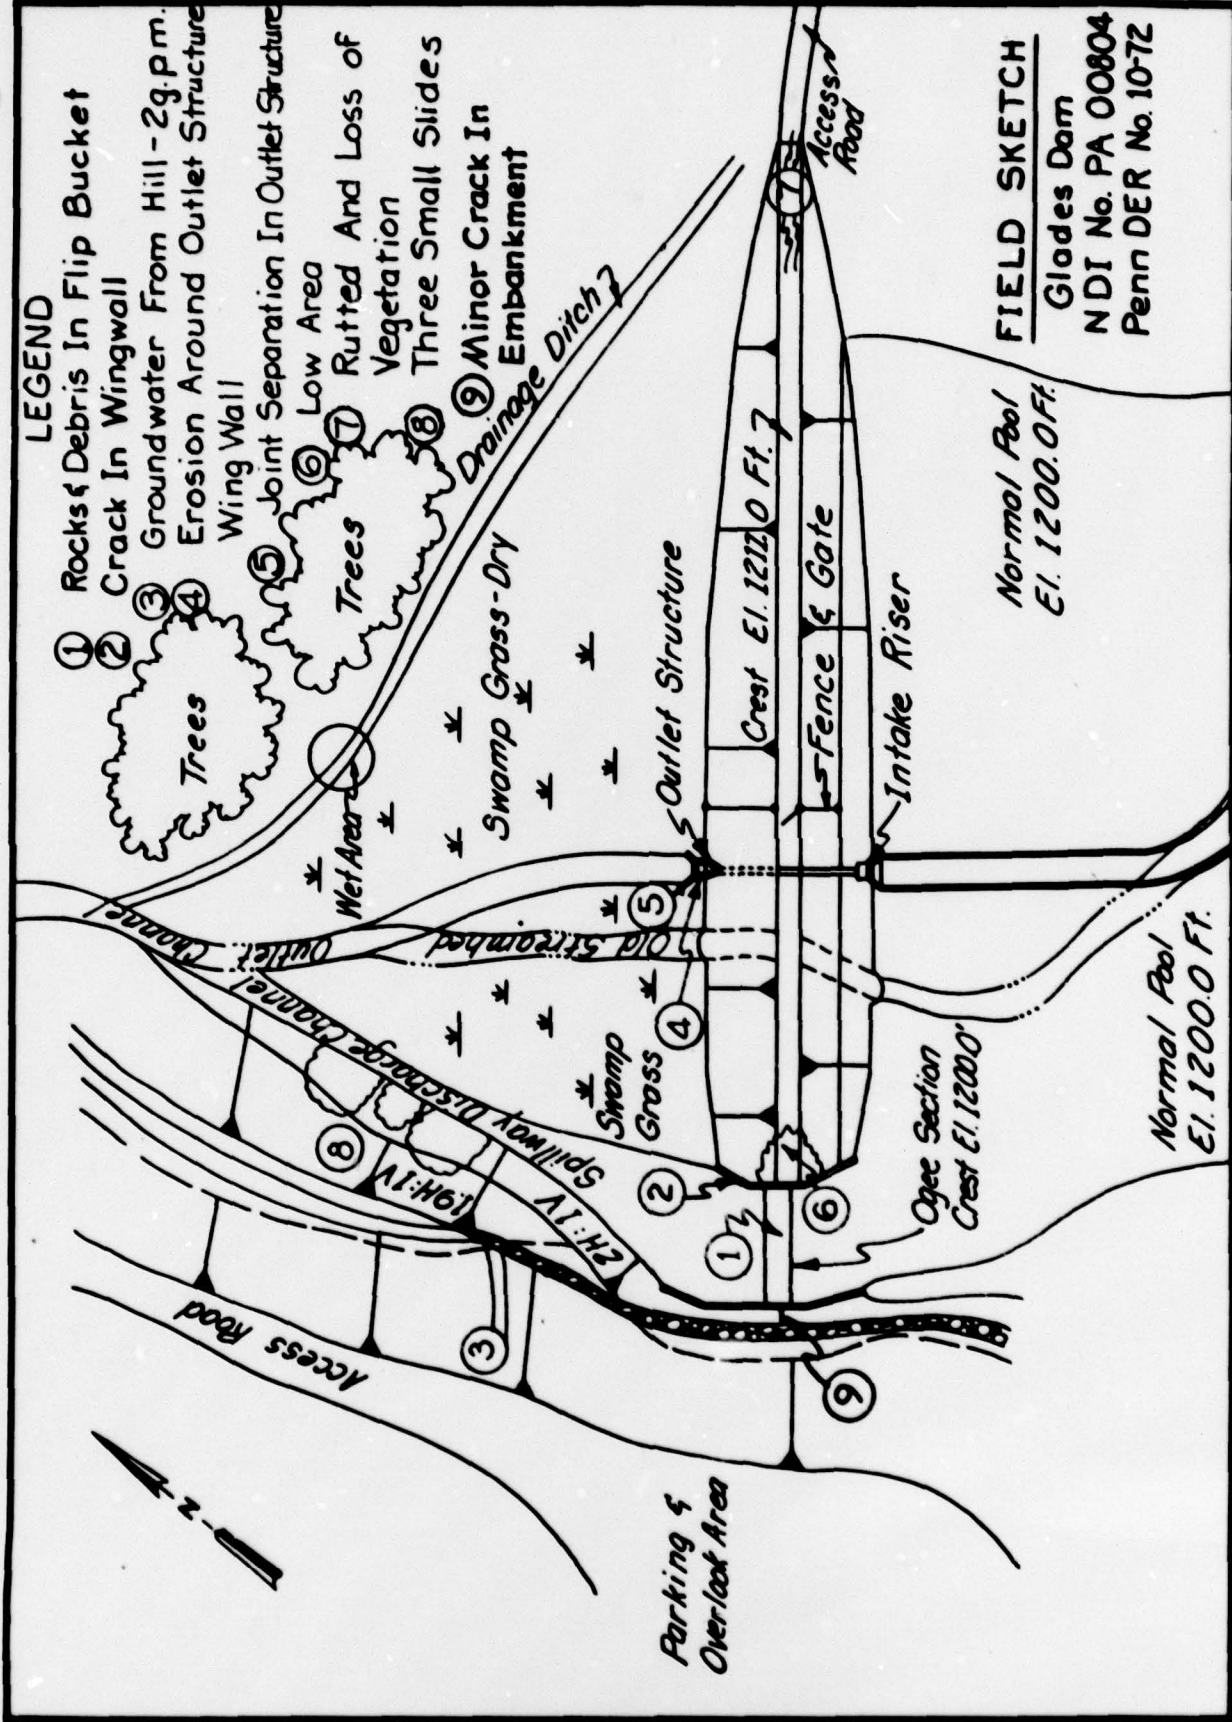
FIELD SKETCH

- ① Rocks & Debris In Flip Bucket
- ② Crack In Wingwall
- ③ Groundwater From Hill - 2g.p.m.
- ④ Erosion Around Outlet Structure
- ⑤ Joint Separation In Outlet Structure
- ⑥ Low Area
- ⑦ Rutted And Loss Of Vegetation
- ⑧ Three Small Slides
- ⑨ Minor Crack In Embankment

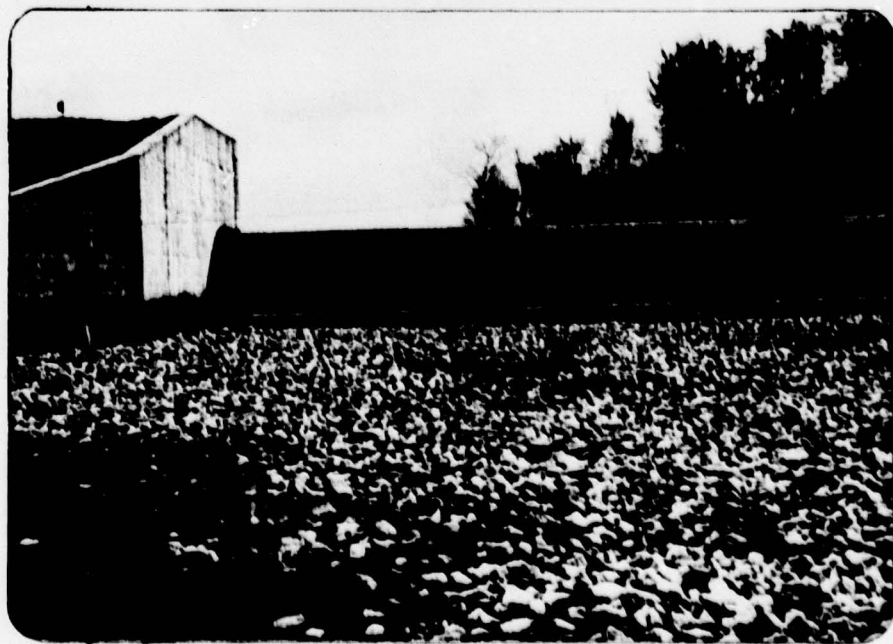
- c. Appurtenant Structures - The overall condition of the appurtenant structures was good at the time of the inspection. However, minor debris was present in the slotted flip bucket energy dissipator. Cracks were observed in the right training wall of the spillway. The wing wall of the discharge basin was separated from the head wall of this structure and minor erosion was occurring behind the wing wall. Three slide areas (see Photos 11 and 12) have occurred in the slope adjacent to the discharge channel of the spillway.

PHOTO 2. Close-up View of Spillway and Slotted Flip Bucket Energy Dissipater

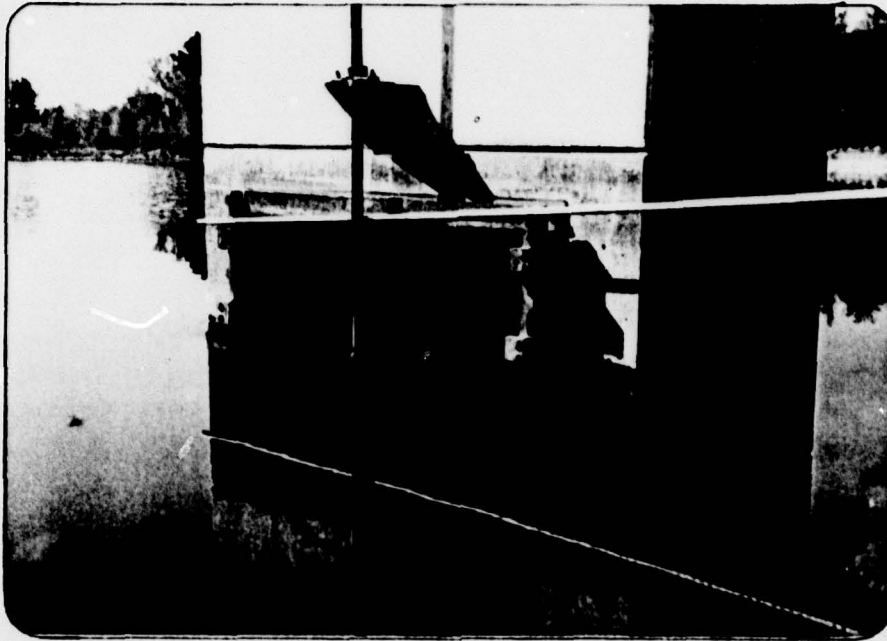
**PHOTO 5. Close-up View of Three Foot by Five Foot Intake at El. 1197.0 feet
(The sluice gate was designed to be in the inverted position.)**
