**KAHLE LAKE DAM**

NDI No. PA 00825  
PennDER No. 61-20

**PHASE I INSPECTION REPORT**  
**NATIONAL DAM INSPECTION PROGRAM**

Kahle Lake Dam (PA No Name No. 151)  
NDI No. PA 00825, PennDER No. 61-20  
Mill Creek  
Inspected 10 May 1979 and 28 June 1979

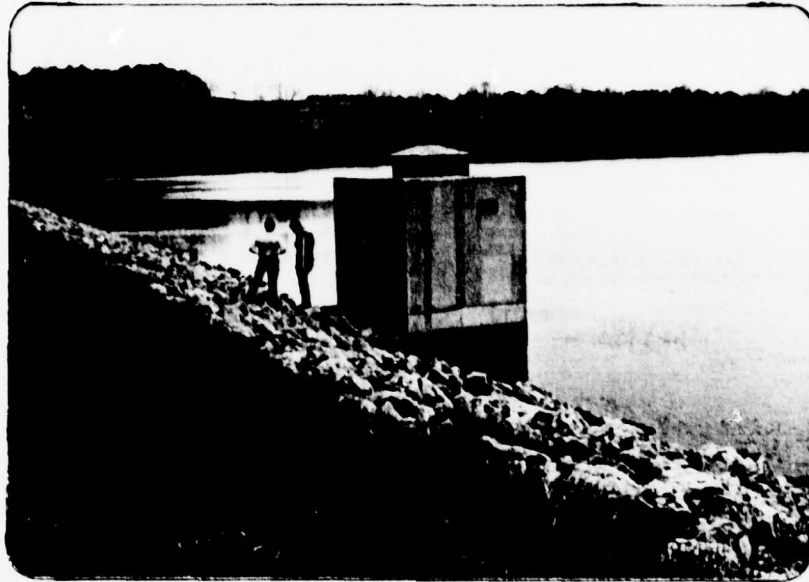
**PHOTO 1. Control Tower on Upstream Slope**

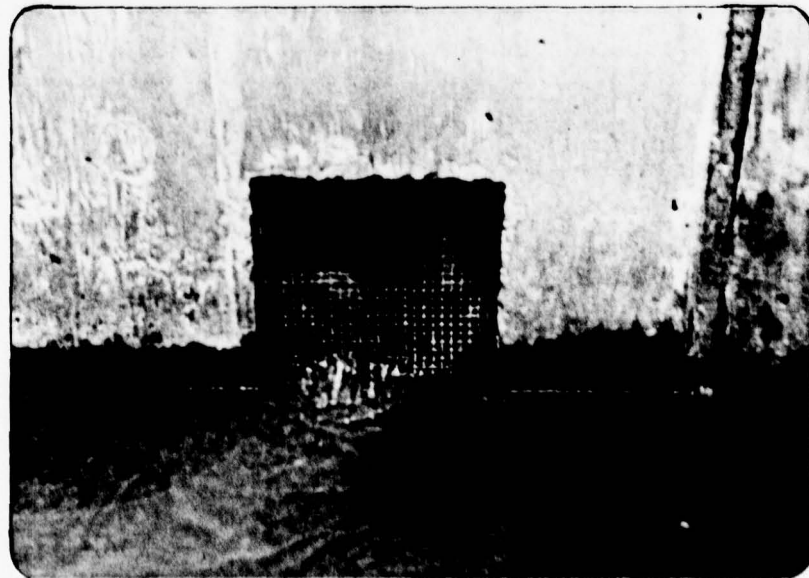
**PHOTO 2. Toe Drain Outlet at Outlet Discharge Basin**

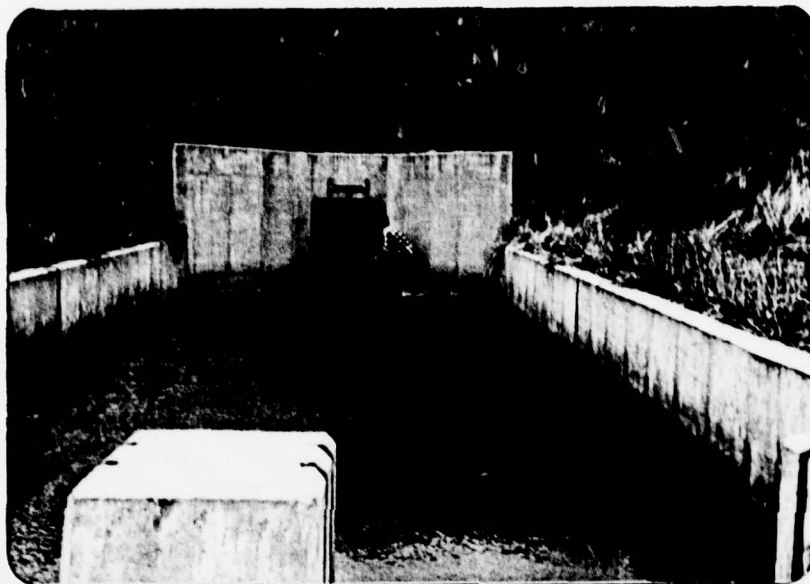
- c. Appurtenant Structures - A few minor cracks were noted along the walls of the outlet discharge basin of the principal spillway. Also, a small ditch was noted to the right of the outlet channel undercutting the riprap.

**PHOTO 3. Outlet of Principal Spillway (Outlet Discharge Basin)**

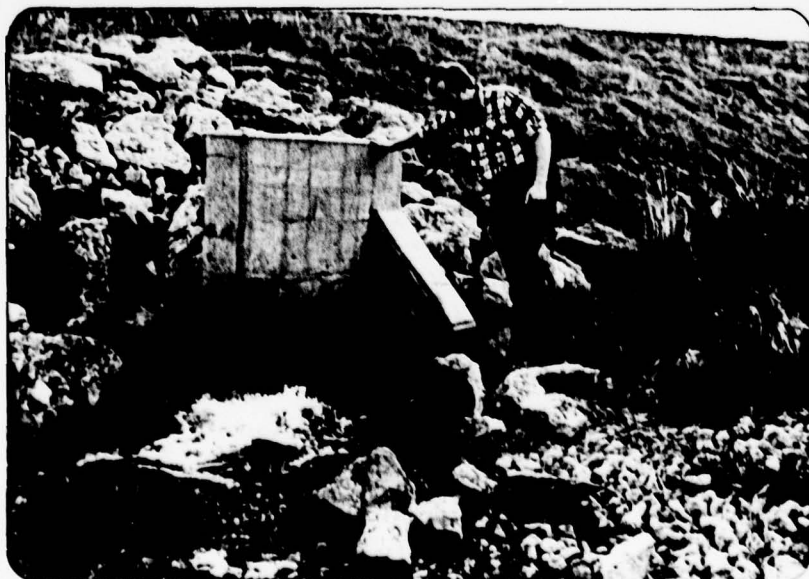
**PHOTO 6. Head Wall for 12 inch A.C.C.M.P. from Stilling Basin**

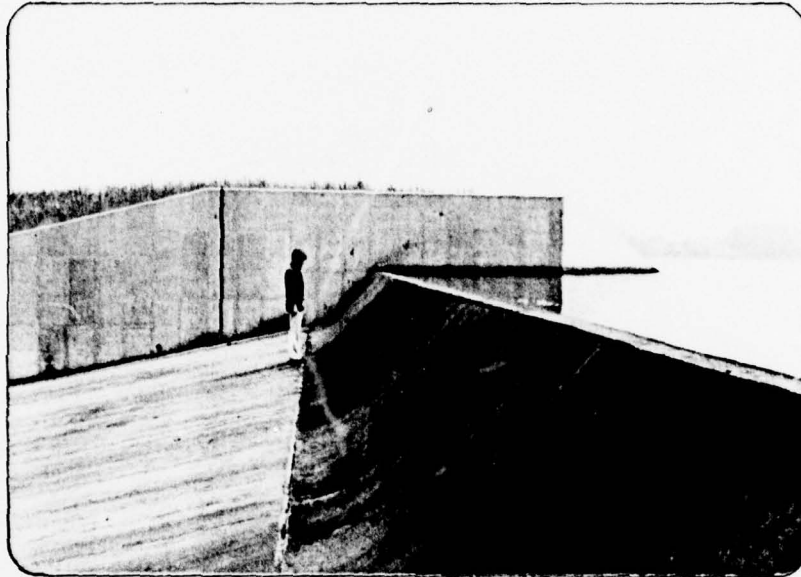
The auxiliary spillway was observed to be in good overall condition with only minor deficiencies. A portion of the joint sealer at the base of the overflow weir was missing. Minor cracking was noted along the walls of the concrete chute. Several weep holes in the stilling basin were plugged.

**PHOTO 7. Concrete Weir Section of Auxiliary Spillway**

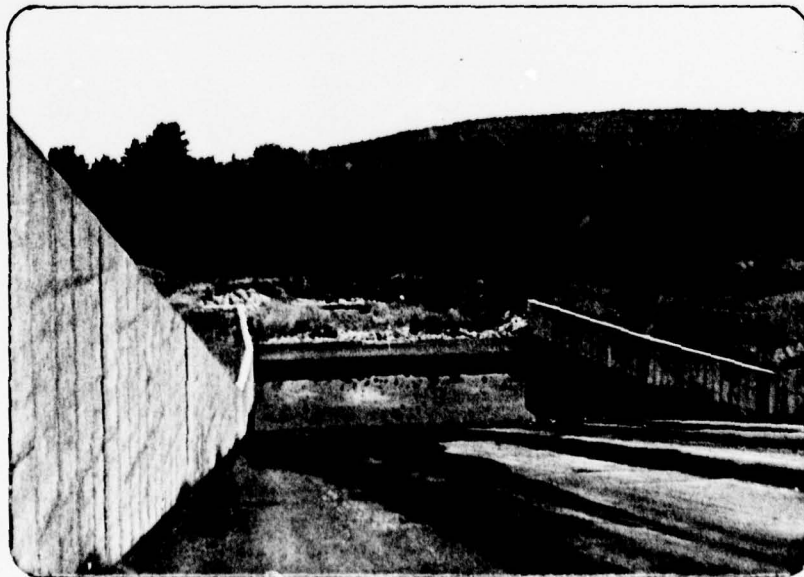
**PHOTO 8. View of Stilling Basin and Concrete Chute Looking Downstream**
