NEW KERNSVILLE DAM, BERKS COUNTY,
PENNSYLVANIA

NDS I.D. NO. PA 00723
DER I.D. NO. 6-434

PHASE I INSPECTION REPORT
NATIONAL DAM INSPECTION PROGRAM

PHASE I INSPECTION REPORT
NATIONAL DAM INSPECTION PROGRAM
NEW KERNSVILLE DAM
NATIONAL ID #PA 00723
DER #6-434

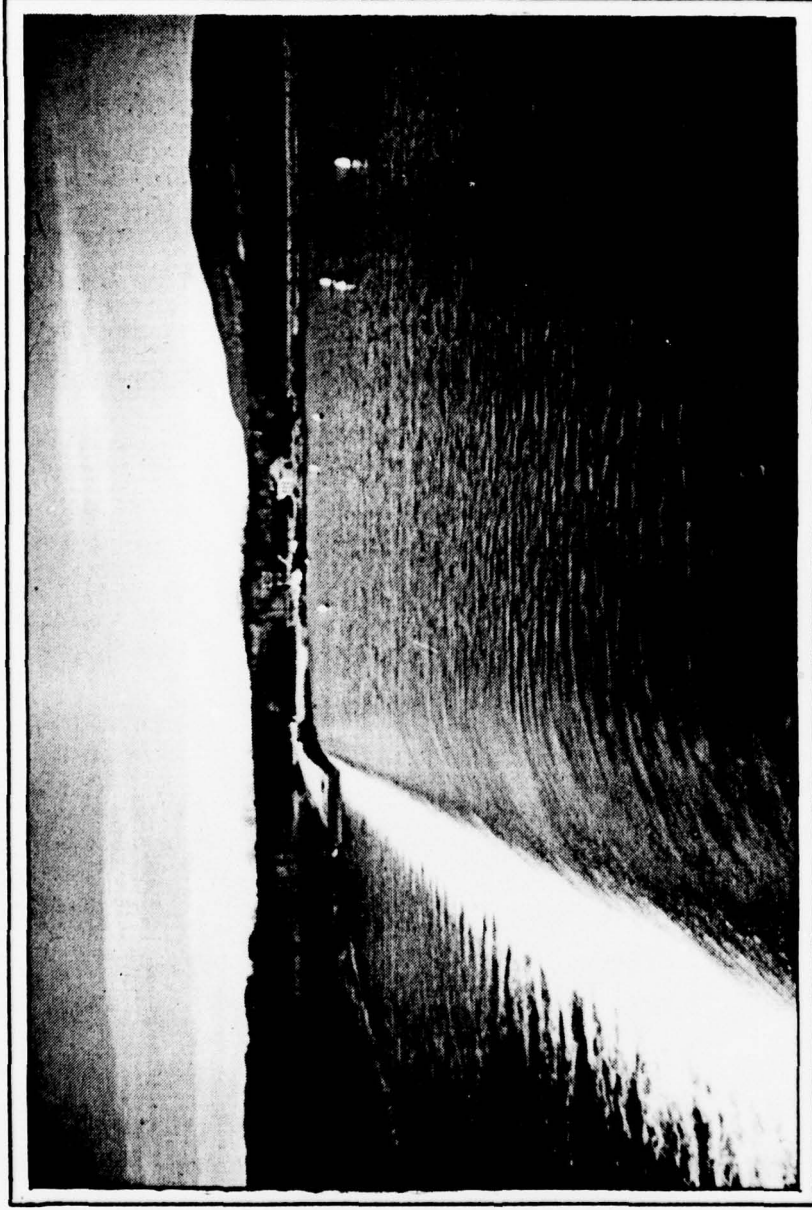
PHOTOGRAPH NO. 1

1. Ogee Spillway. The exposed portions of the ogee spillway were limited to the retaining walls of the structure. These retaining walls are in good condition with no significant cracks or deterioration. Water flowing over the spillway crest was smooth with no indications of cracks or displacements between monoliths.

OVERVIEW OF SPILLWAY LOOKING FROM
LEFT ABUTMENT TOWARDS RIGHT ABUTMENT.

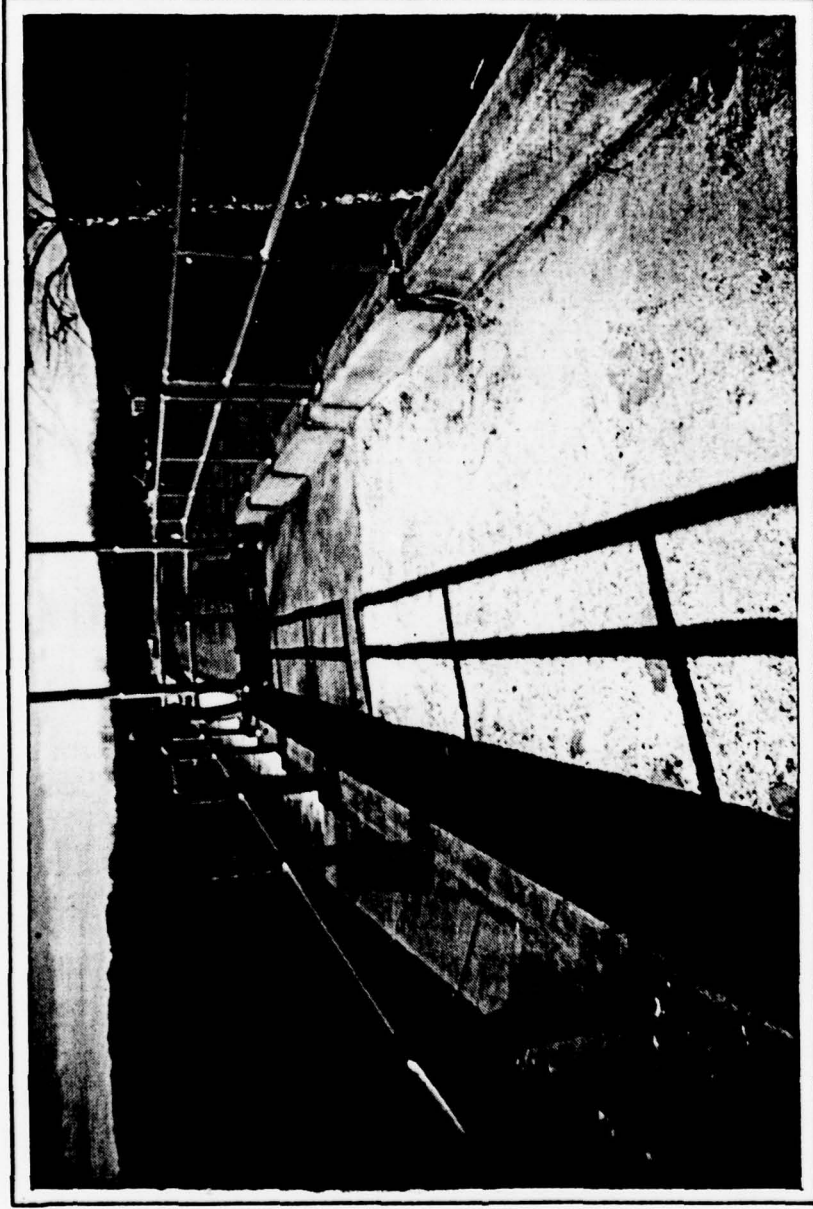
PHOTOGRAPH NO. 2

2. Nonoverflow Sections. Nonoverflow sections at each abutment were inspected and found to be in good condition, as shown in Photographs 2, 5 and 6. Some minor cracking and joint deterioration is occurring, as shown in Photographs 9 and 10, but this has no effect on the structural integrity of the section.

OBSERVATION PLATFORM ON LEFT SIDE
OF RIVER. NOTE SPALLED CONCRETE
SURFACE OF WALKWAY.

and below the walkway and nonoverflow section should be periodically inspected. If deterioration of these zones becomes excessive, they should be cleaned and patched.

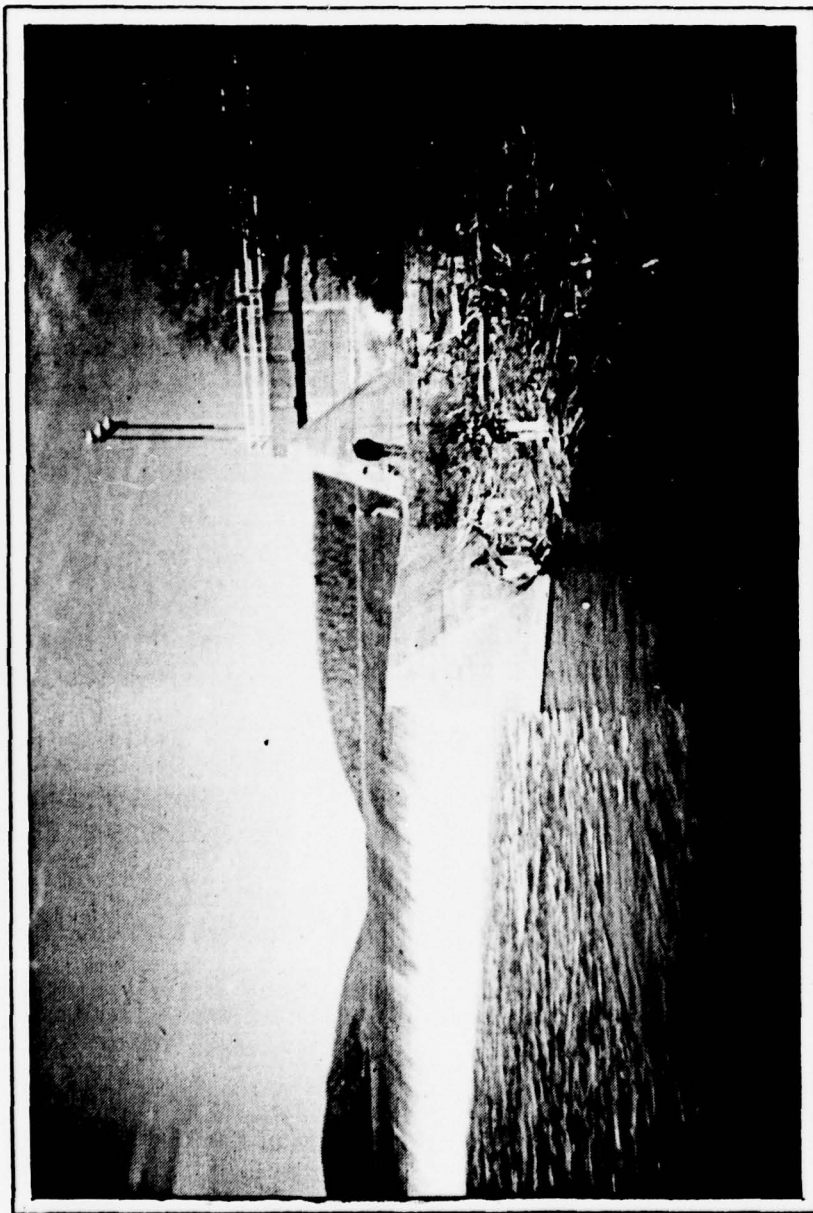
PHOTOGRAPH NO. 3

VIEW OF LEFT ABUTMENT LOOKING UPSTREAM.
NOTE DEBRIS ON INSIDE OF ABUTMENT.

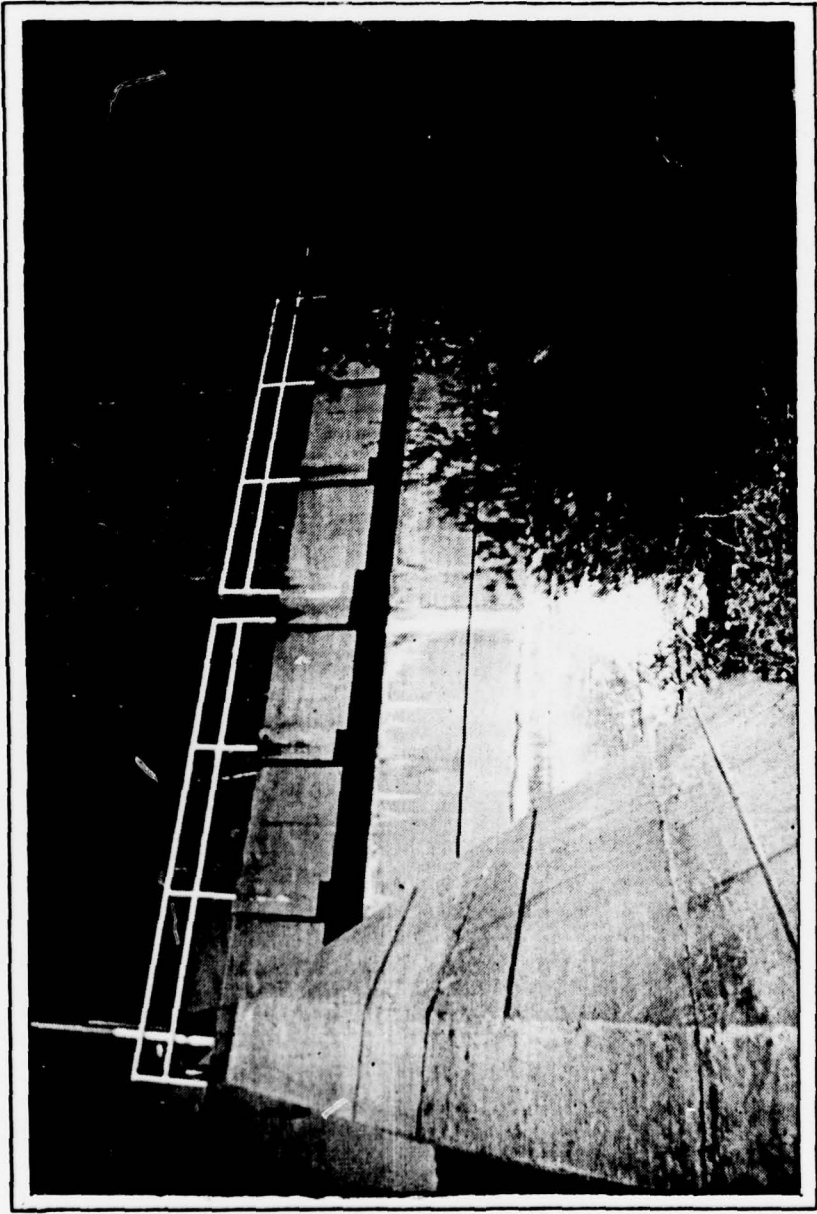
PHOTOGRAPH NO. 5

OVERVIEW OF LEFT ABUTMENT.

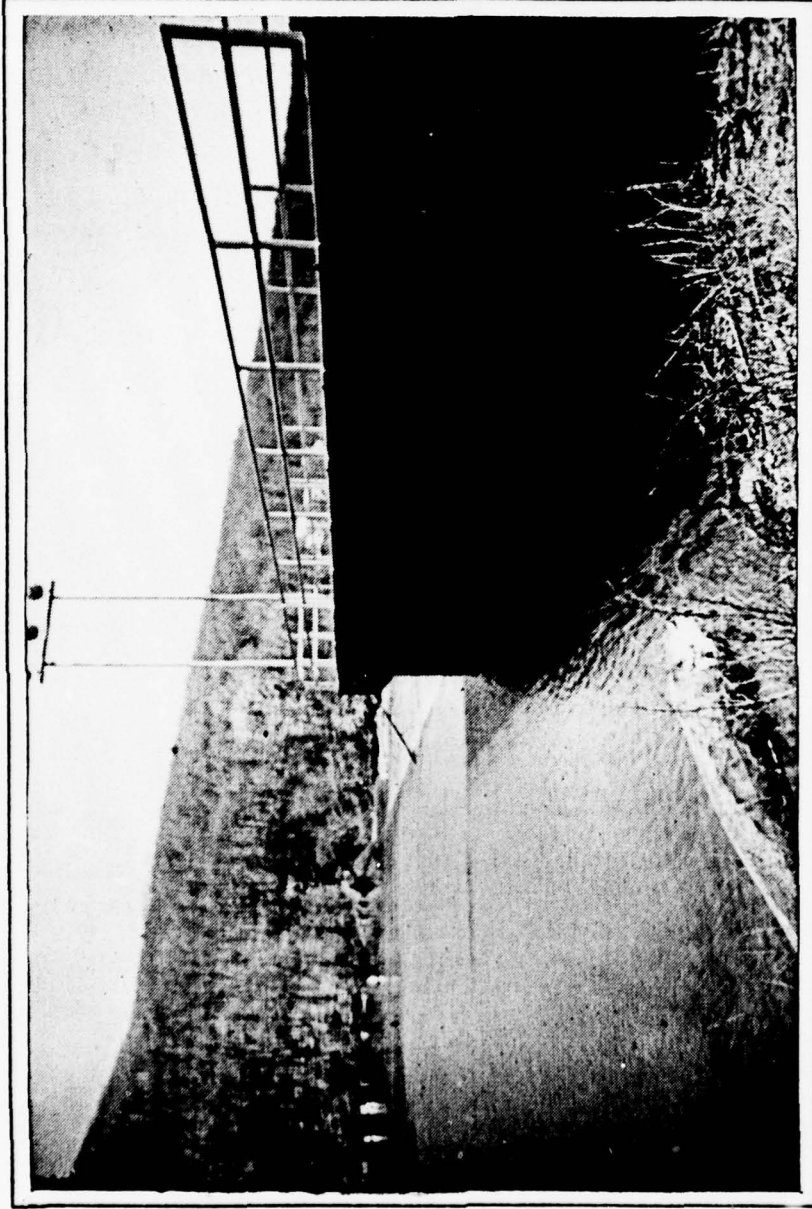
PHOTOGRAPH NO. 6

OVERVIEW OF RIGHT ABUTMENT FROM THE
UPSTREAM SIDE.

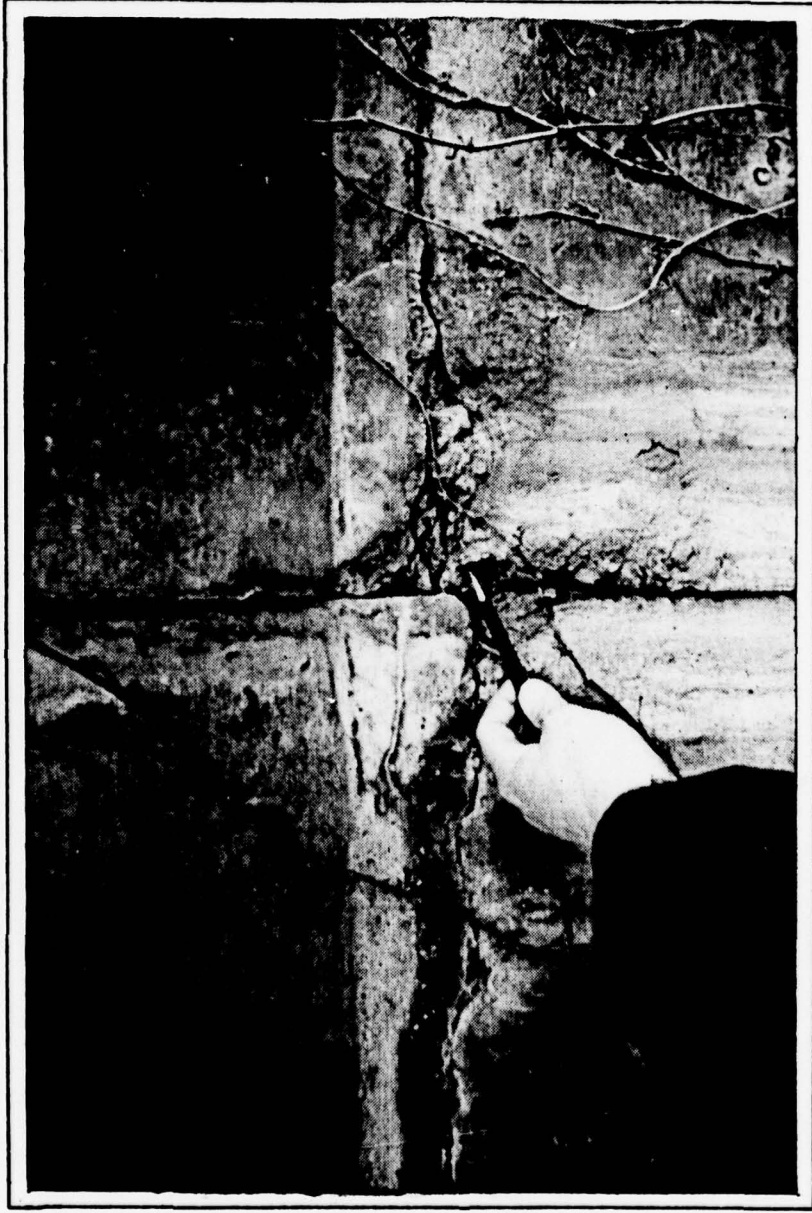
PHOTOGRAPH NO. 10

TYPICAL CONDITION OF ABUTMENT
CONSTRUCTION JOINTS.
