PENNSYLVANIA
DEER VALLEY LAKE DAM

NDS I.D. No. PA - 00230
PENNDER I.D. No. 56 - 76

PHASE I INSPECTION REPORT
NATIONAL DAM INSPECTION PROGRAM

AUGUST 1979

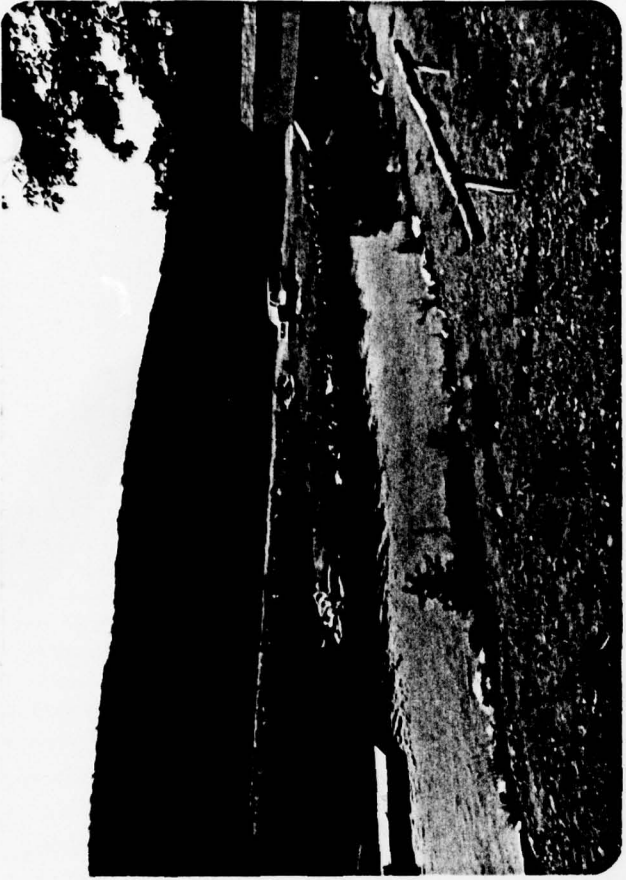
b. Embankment. Observations made during the visual inspection revealed the embankment to be in fair condition. The upstream slope is protected by durable, well-graded riprap (see Photographs 2 and 6). The downstream slope is heavily vegetated with high grass, weeds and small shrubs and appears infrequently maintained (see Photograph 5). No seepage was observed through the downstream face; however, seepage, ponding, and swamp-like conditions occur along the downstream toe throughout the area from the outlet conduit to within 100 feet of the left abutment (see Photographs 7 and 8). No other deficiencies were observed.

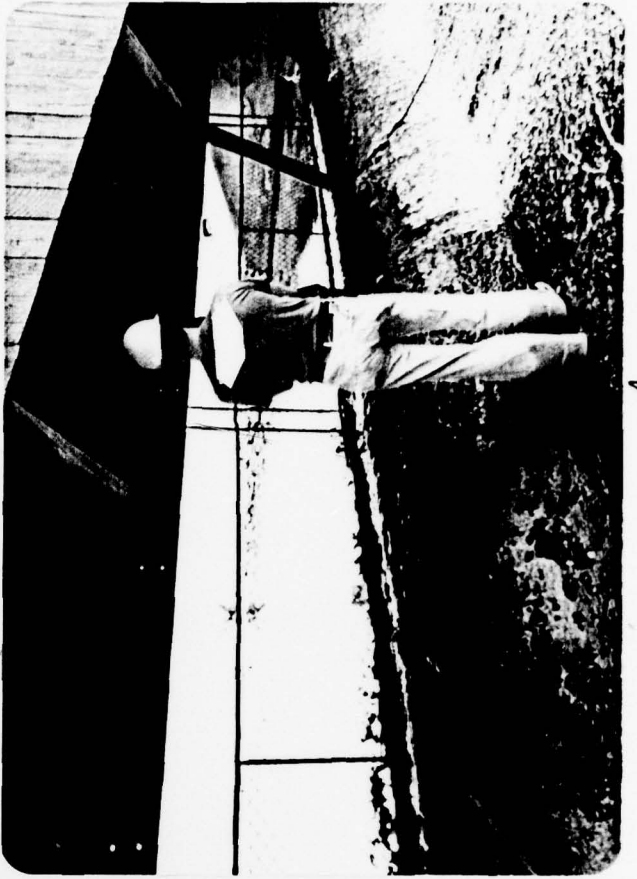
1. Spillway. The spillway structure was found to be in good condition with minor deficiencies that included scaling of the ogee-like weir crest (see Photograph 4) and minor cracking and spalling of the wingwalls. A 2.3-foot high chain link fish screen obstructs free flow over the weir crest; however, the Camp Director stated that the screen is removed under high flow conditions. In addition, temporary boat docks are located immediately upstream of the spillway approach channel entrance which could cause spillway blockage during major flooding.

1. Spillway. The spillway is in good condition and appears to be structurally stable. Minor deficiencies include scaling of the ogee-like crest section and some spalling of the concrete wingwalls.

PHOTOGRAPH 4 Close-up view of the scaled condition of the concrete spillway weir.

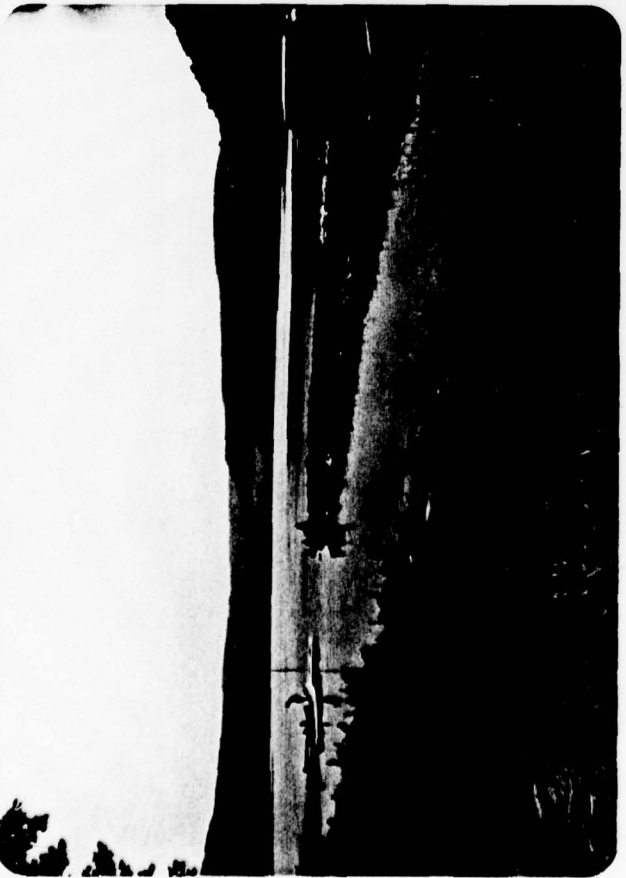
1

d. Reservoir Area. The reservoir is surrounded by steep slopes that are primarily heavily forested (see Photograph 1). No evidence of slope distress was observed in the surrounding area.

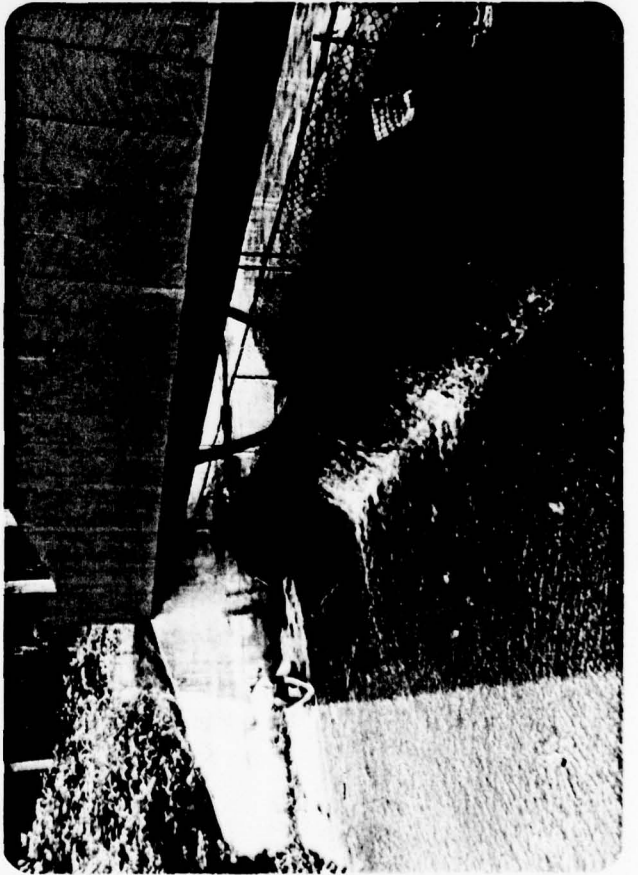
a) Spillway. The spillway is a concrete chute structure located at the right abutment. The crest consists of a 37-foot long ogee-like weir approximately 4 feet in height and 6.5 feet wide at its base (see Photographs 3 and 4). There reportedly is a cutoff wall under the weir founded in impervious material, extending about 9 feet into the right abutment, and tied into the original concrete cutoff wall within the embankment. The spillway walls are concrete sections 10 feet high with a maximum base

PHOTOGRAPH 3 View of the spillway located at the right abutment. Note the removable fish catch screen atop the overflow crest.

e. Develop a formal manual of operation and maintenance to insure the proper care and utilization of the facility. Included in the manual should be provisions for removing the fish screen from the spillway crest and securing or removing the temporary docks at the entrance to the spillway during periods of large flow.

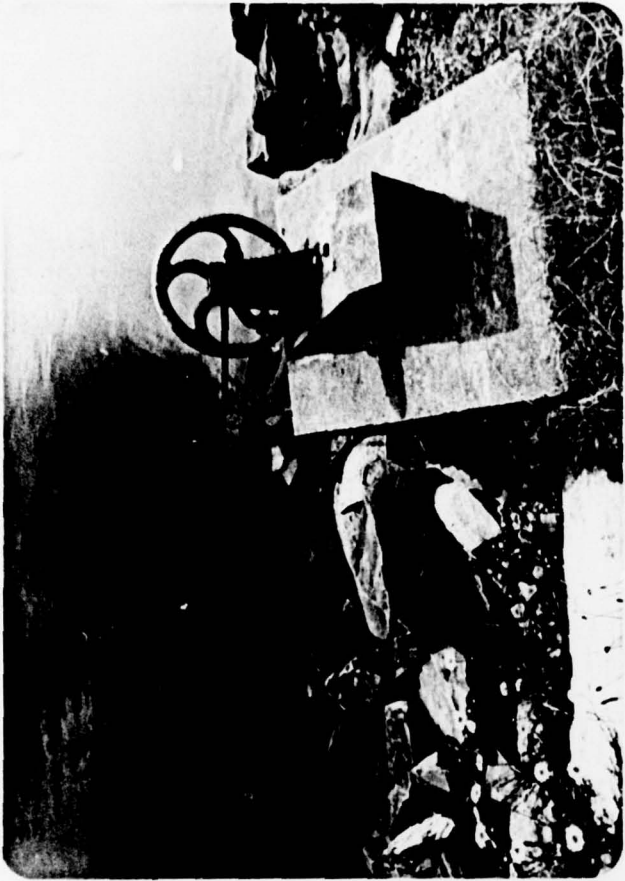
6

There are no formal maintenance procedures in effect for the spillway system or drawdown facility. The slide gate on the drawdown pipe has not been operated for years. The observed condition of the gate stem (see Photograph 6) indicates that it may be inoperable.

ITEM	OBSERVATIONS AND/OR REMARKS
INTAKE STRUCTURE	Submerged, not observed.
OUTLET CONDUIT (CRACKING AND SPALL- ING OF CONCRETE SURFACES)	Submerged, not observed.
OUTLET STRUCTURE	None observed.
OUTLET CHANNEL	Flat ponded area, poorly drained.
GATE(S) AND OPERA- TIONAL EQUIPMENT	Valve stem and wheel located along upstream face about 400 feet from right abutment. Stem is corroded and bent and of questionable operability.

d. Have the drawdown mechanism inspected to assess the condition of the slide gate and control rod and take remedial measures to restore the operability of the system.

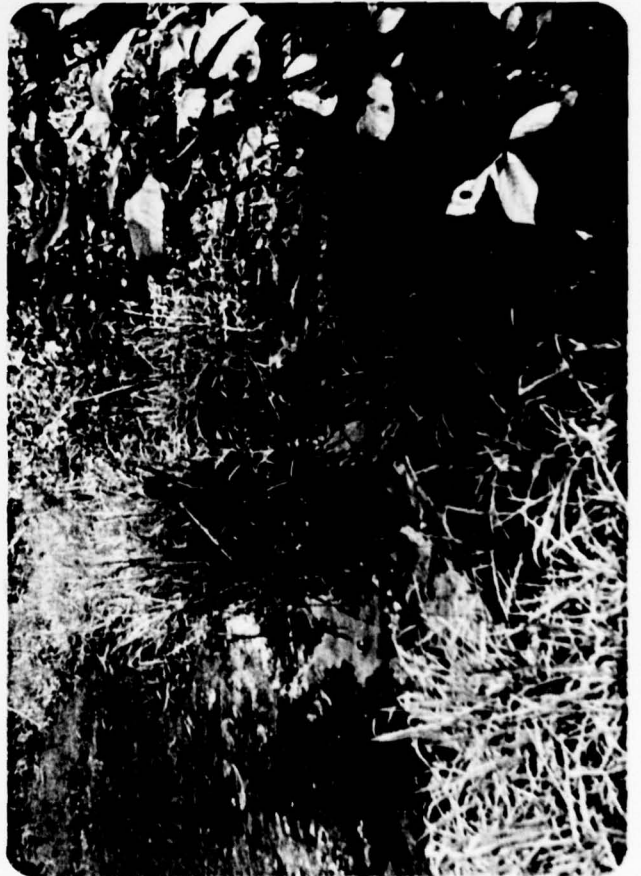
Seepage and ponding is evident at the toe of the embankment from the outlet conduit to about 100 feet from the left abutment. The amount of the seepage could not be ascertained with any certainty because of the dense vegetation and ponding; however, no seepage was observed through the face of the dam.

PHOTOGRAPH 7 Close-up view of the partially submerged discharge end of the outlet conduit located at the downstream embankment toe.

c. Take remedial measures to drain the ponded water along the downstream toe and install a weir or weirs under the direction of a registered professional engineer, experienced in the design of earth dams, to evaluate the seepage conditions.
