PENNSYLVANIA
HINCKSTON RUN DAM

NDS LD. No. PA - 00430
PENNDER LD. No. 11 - 9

PHASE I INSPECTION REPORT
NATIONAL DAM INSPECTION PROGRAM

SEPTEMBER 1979

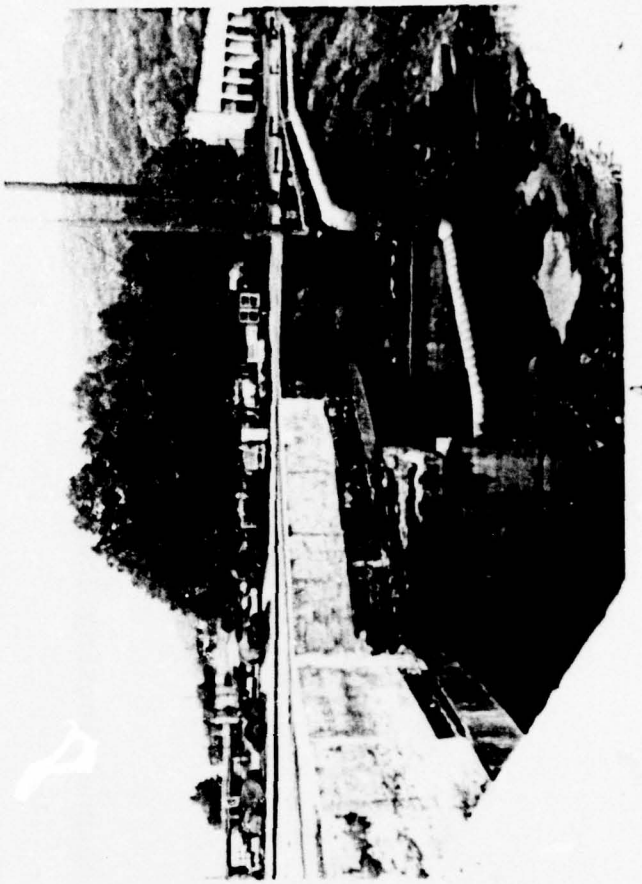
b. Embankment. Visual inspection indicated that the embankment is in good condition (see Photograph 1). The upstream slope is well-aligned and adequately protected by hand-placed sandstone riprap (see Photograph 3). The crest is grass covered and well maintained, and the downstream slope consists of a massive accumulation of dumped hot-poured slag.

PHOTOGRAPH 3 View showing upstream riprap and intake tower.
