PENNSYLVANIA
FOUR-MILE RUN DAM

NDS I.D. No. PA - 00457
PENNDER I.D. No. 65 - 126

PHASE I INSPECTION REPORT
NATIONAL DAM INSPECTION PROGRAM

AUGUST 1979

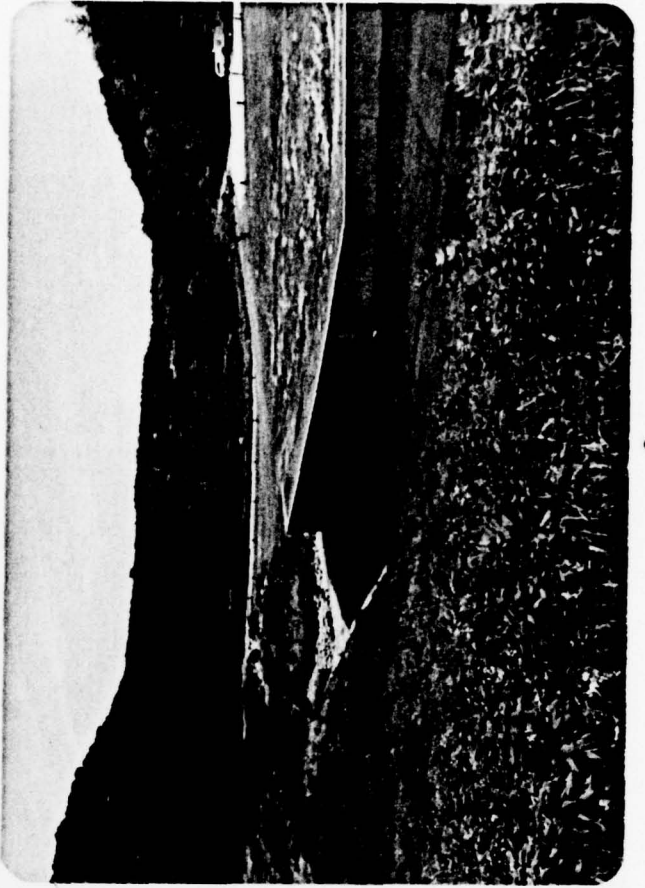
PHOTOGRAPH 8 View looking downstream from the crest of the dam.

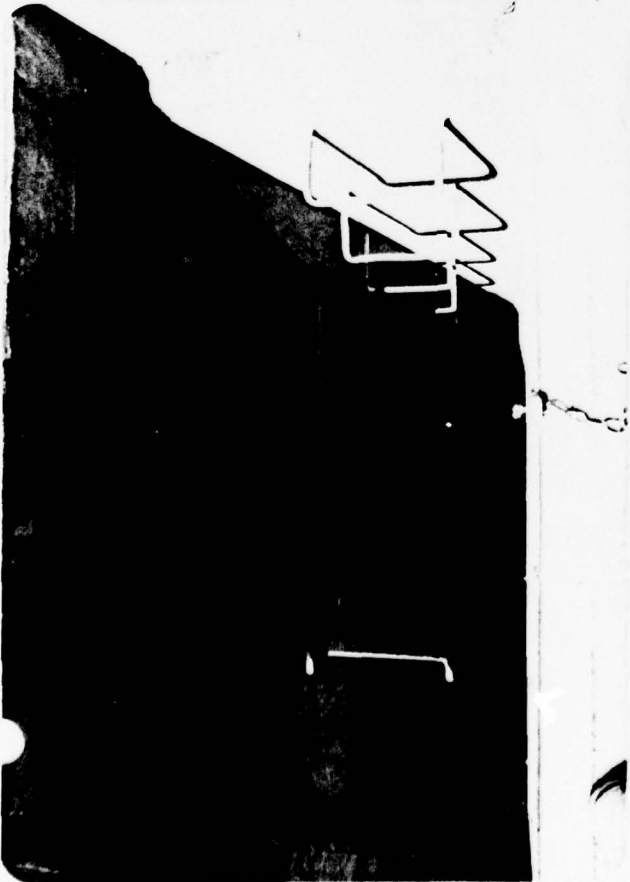
PHOTOGRAPH 5 Interior view of the outlet conduit control tower.
