PENNSYLVANIA  
VIRGIN RUN DAM

NDS I.D. No. PA - 00196  
PENNDER I.D. No. 26 - 85

PHASE I INSPECTION REPORT  
NATIONAL DAM INSPECTION PROGRAM

GAI CONSULTANTS, INC.  
570 BEATTY ROAD  
MONROEVILLE, PENNSYLVANIA 15146

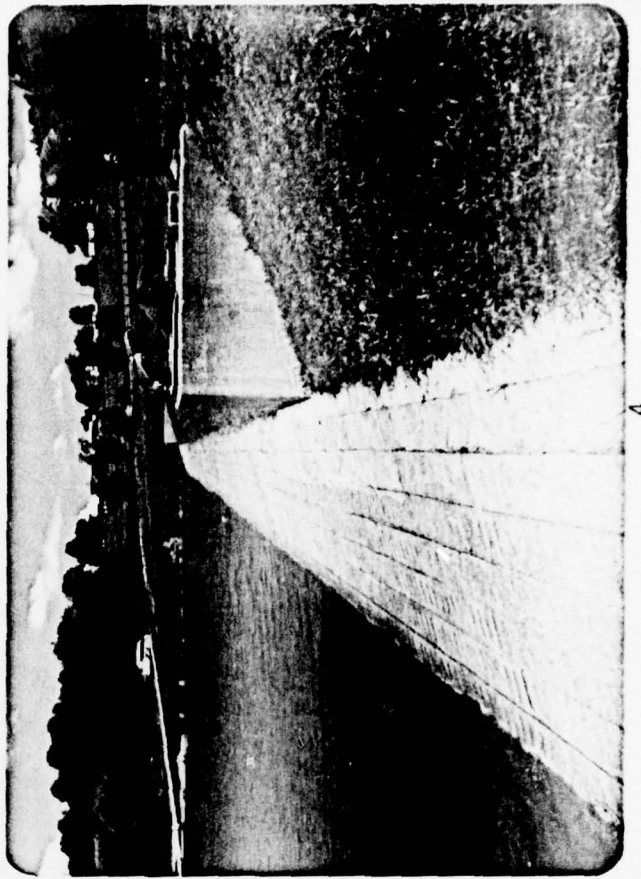
PHOTOGRAPH 4 View of the upstream embankment slope and control tower riser as seen from the right abutment.

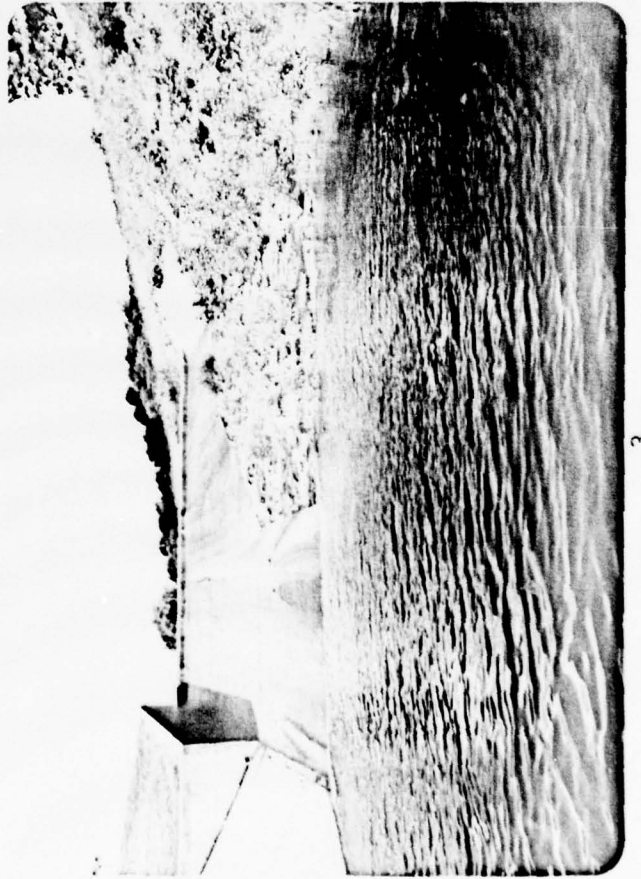
PHOTOGRAPH 3 View of the spillway channel as seen from the edge of the plunge pool.

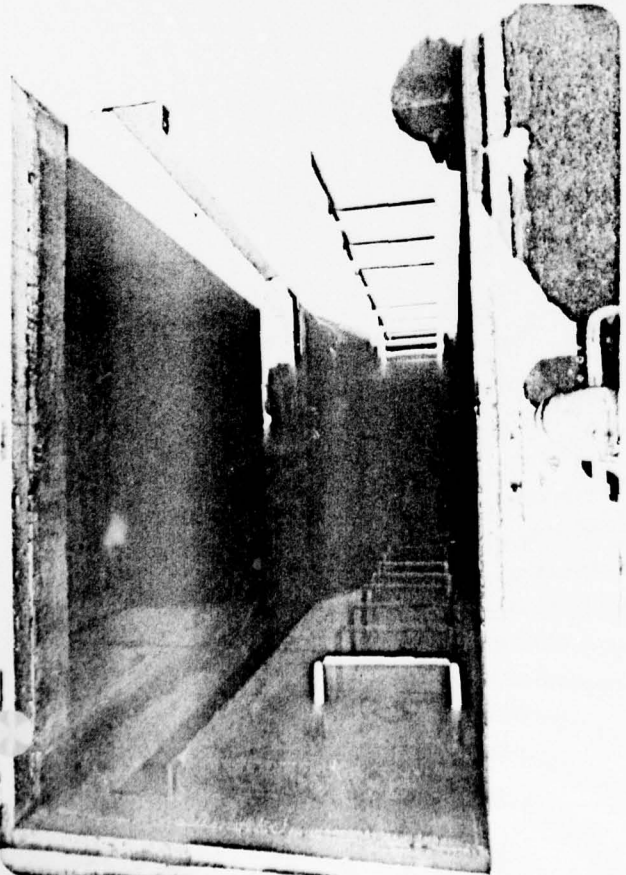
2. Outlet Works. The outlet works at Virgin Run Dam is in excellent condition. No signs of deterioration were observed on any of the visible exposed concrete surfaces, including a large portion of the interior of the control tower riser (see Photographs 4 and 5). The stop logs were in place although exhibiting some leakage. The 3-foot square discharge culvert could not be entered, however, due to tailwater and discharge through the stop logs (see Photograph 6).

PHOTOGRAPH 5 Close-up view of the interior of the control tower riser.

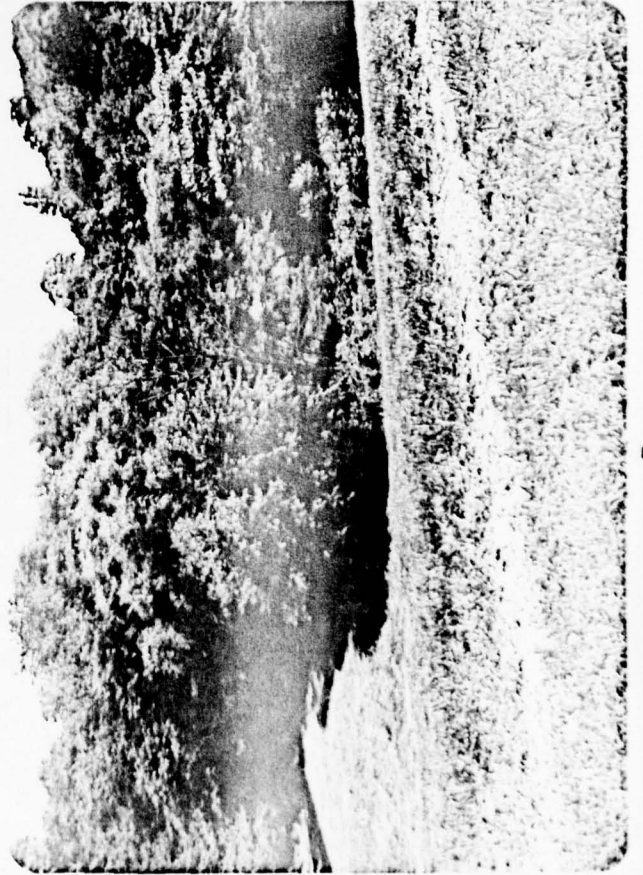
ITEM	OBSERVATIONS AND/OR REMARKS	NDI# PA - 196
DAMP AREAS IRREGULAR VEGETATION (LUSH OR DEAD PLANTS)	No damp areas were observed. Heavy overgrowth, including trees and high brush, covers the entire downstream embankment toe and extends a minimum of about 12 feet up the slope.	
ANY NOTICEABLE SEEPAGE	None observed through embankment or near toe.	
STAFF GAGE AND RECORDER	None.	
DRAINS	None observed.

PHOTOGRAPH 7 View of the overgrown downstream embankment toe as seen from the embankment crest.

- a. Clear the downstream embankment slope and toe area (to a distance at least 100 feet beyond the embankment toe) of all trees and overgrowth that hinder visual evaluation of the facility.
- b. Restore foundation support to the lower end of the right spillway endwall just beyond the plunge pool.
