LAKE FORECAST DAM

PHASE I INSPECTION REPORT
NATIONAL DAM INSPECTION PROGRAM

AUGUST 1979

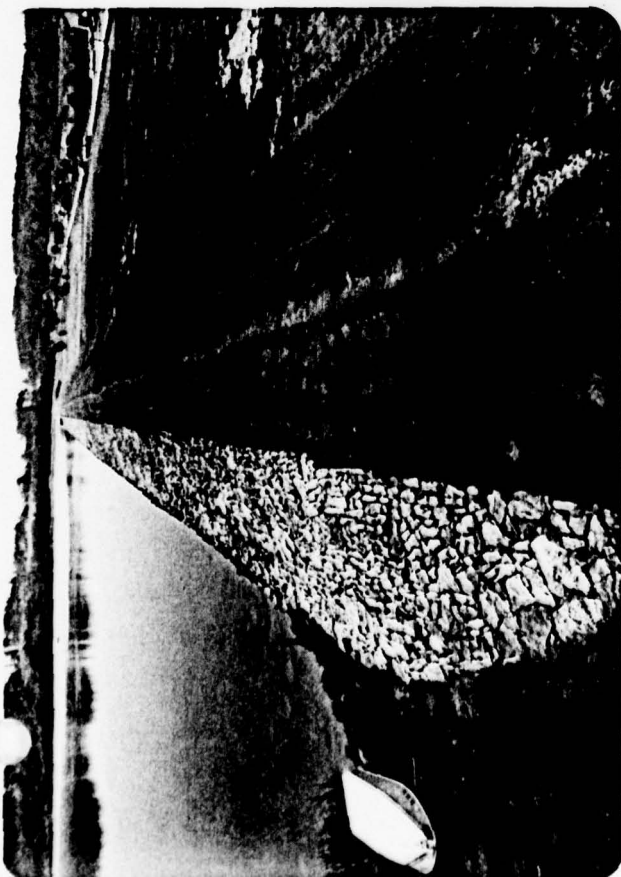
b. Embankment. The field inspection indicated that the embankment is well maintained (see Photographs 1 and 2), but, is considered to be in poor condition due to substantial seepage through its downstream face and in that area immediately downstream of the toe (see Photographs 3 and 4). An approximate mapping of the observed seepage is shown on Figure 1 and Photograph 3. As indicated, seepage through the embankment was evident along a line that was only about 6 feet below the pool level (normal pool) at the time of inspection. Discharge from the drains installed after reservoir filling and concentrated surface flow, all of which empty into the channel downstream of the outlet conduit, indicate clear seepage is in excess of 10 gallons per minute. No signs of instability (sloughing, and/or slumping of embankment slopes) were observed while the measured features generally conform to the design drawings.

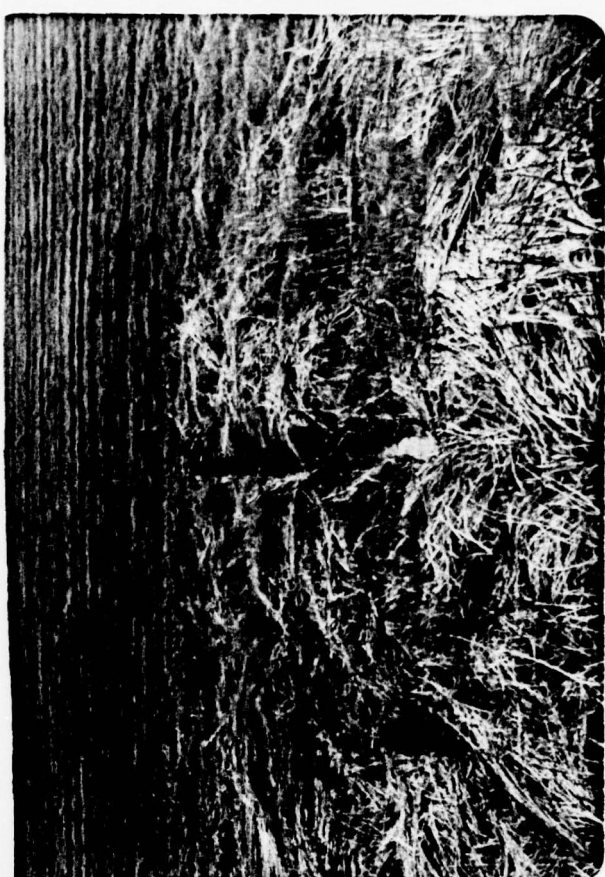
PHOTOGRAPH 4 View of a typical wet spot found along the downstream embankment toe to the right of the outlet conduit.

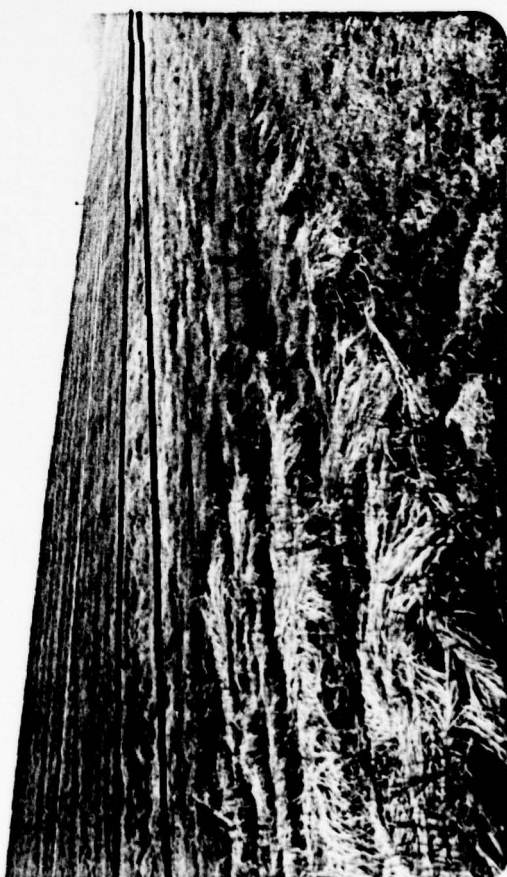
Observations made during the visual inspection suggest that the embankment may be structurally unsafe as extensive areas of seepage were noted on the downstream embankment slope and immediately below the toe area to the right of the outlet conduit. Seepage conditions became evident shortly after reservoir filling and have persisted in spite of the installation of a remedial sand drain system near the toe.

PHOTOGRAPH 3 View of the downstream embankment face to the right of the outlet conduit where seepage was observed. Two black lines attached to the photograph represent the base of the slope (bottom line) and top of observed seepage (top line), respectively.

a. Retain the services of a professional engineer, experienced in the design and construction of earth dams, to study the embankment and assess the effects of the seepage conditions on embankment stability under all possible operating conditions (including earthquake loading) and make remedial recommendations as deemed necessary. The study should include (but should not be limited to) drilling, soils testing to establish actual engineering properties, instrumentation, and an assessment of the effects of reservoir drawdown to a safe operating level which should be maintained until remedial studies and/or repairs are completed.

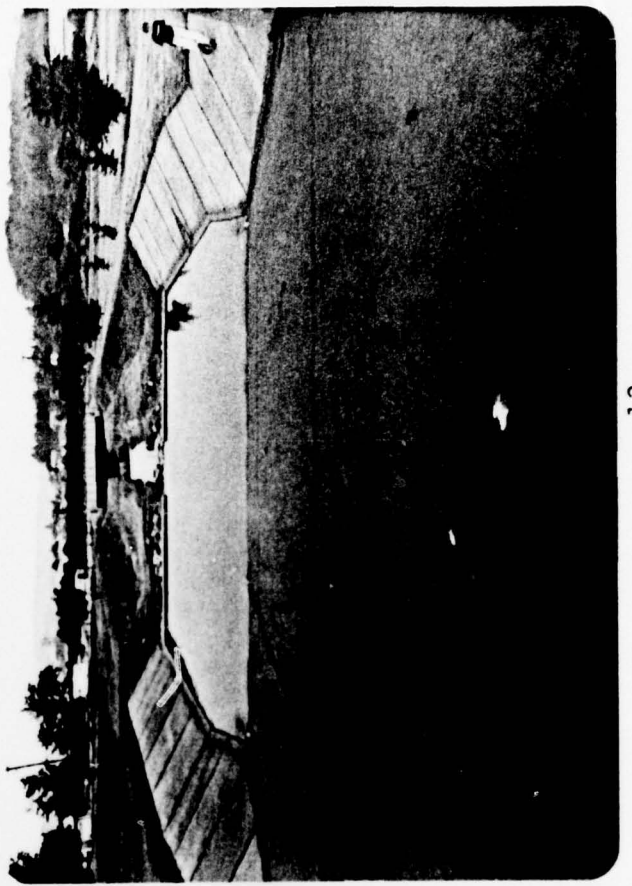
1. Spillway. The visual inspection revealed the spillway to be in good condition (see Photographs 11 and 12). Joints and minor structural cracks have been sealed with a bitumen filler.

PHOTOGRAPH 12 View looking downstream from the spillway crest.

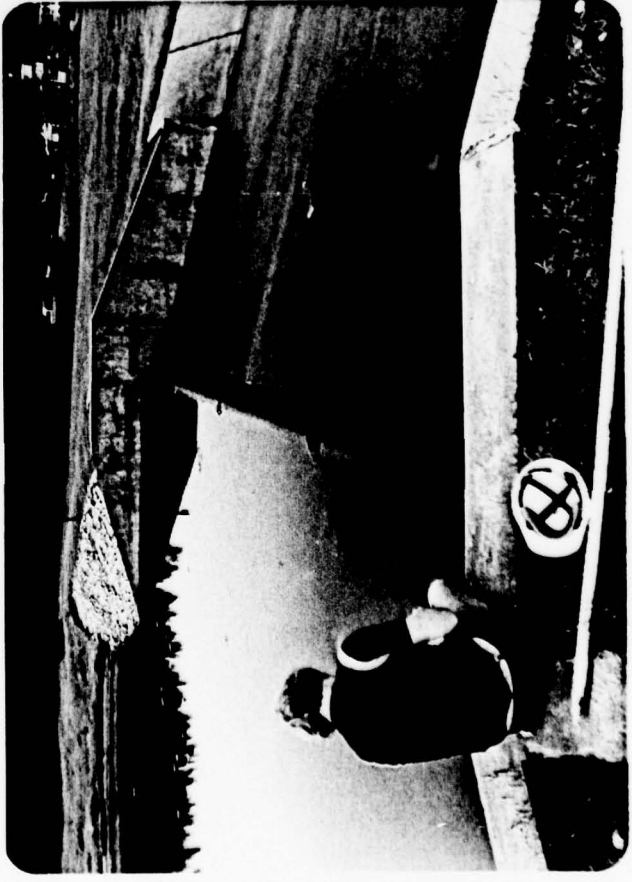
PHOTOGRAPH 11 View of the spillway overflow weir.

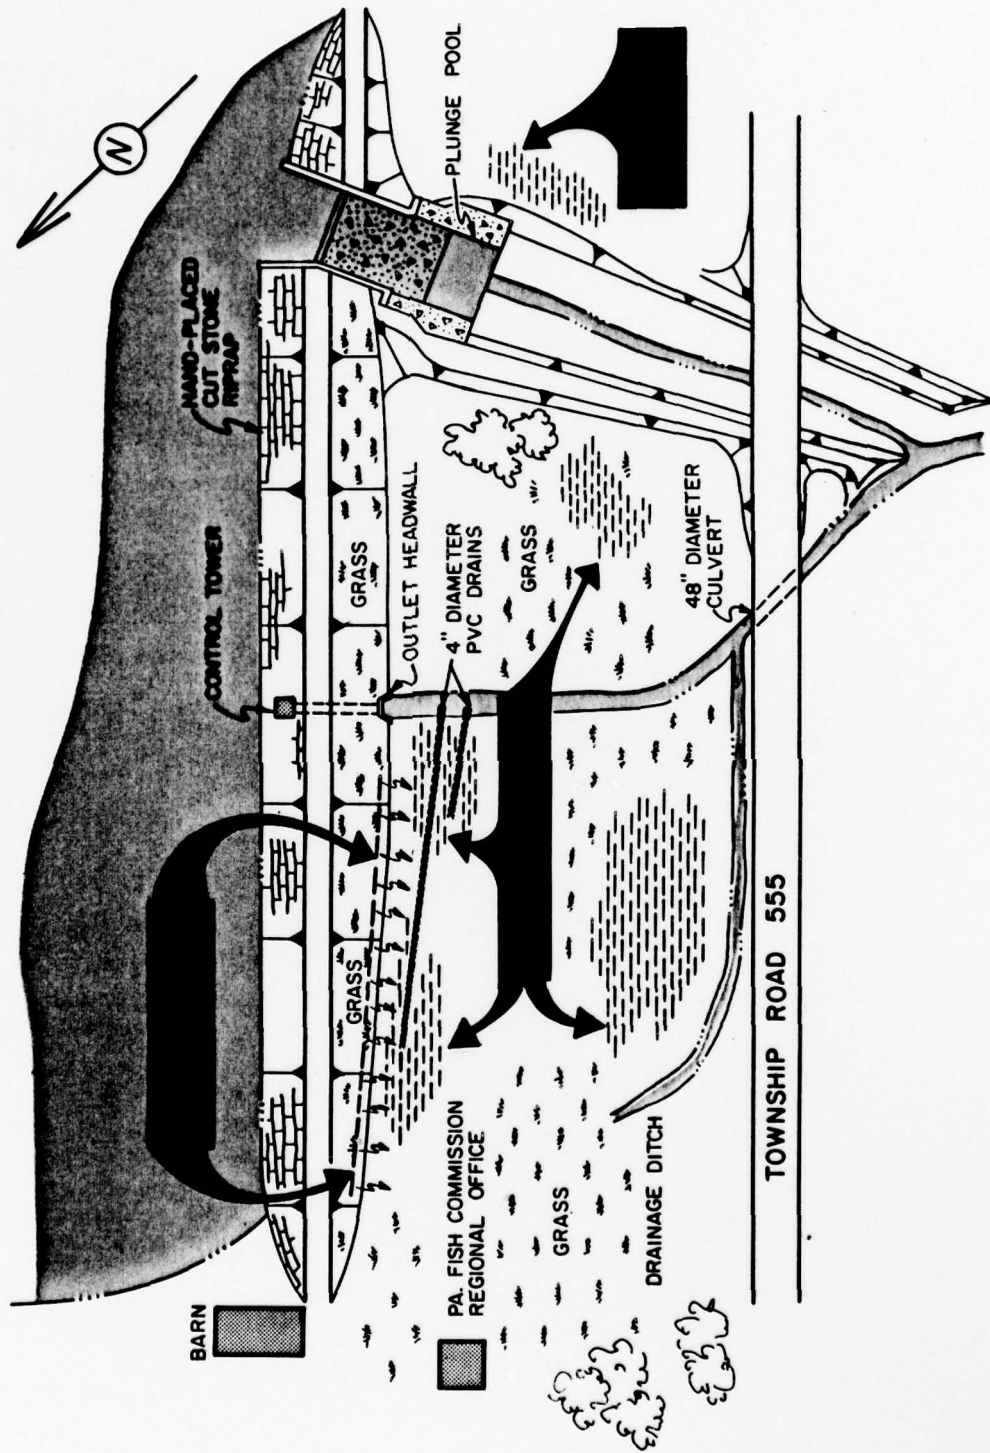
FIGURE 1 - LAKE SOMERSET DAM
 GENERAL PLAN : FIELD INSPECTION NOTES

ITEM	OBSERVATIONS AND/OR REMARKS
<p>DAMP AREAS IRREGULAR VEGETATION (LUSH OR DEAD PLANTS)</p>	<p>Extensive areas of saturation were noted in the flat area beyond the downstream embankment toe (see Figure 1, Appendix F).</p>
<p>ANY NOTICEABLE SEEPAGE</p>	<p>Substantial seepage was observed to be issuing through the downstream face of the embankment and through the flat area immediately downstream from the embankment toe. Wet or damp areas were found along the downstream face as high as elevations which were only 6' below the normal pool level. See Appendix F, Figure 1 for a field sketch which outlines the areas of concern.</p>
<p>STAFF GAGE AND RECORDER</p>	<p>None.</p>
<p>DRAINS</p>	<p>Two drains have been installed along the downstream toe to transport some of the seepage water to the outlet channel. Estimated discharge at the time of inspection was in excess of about 10 gallons per minute.</p>

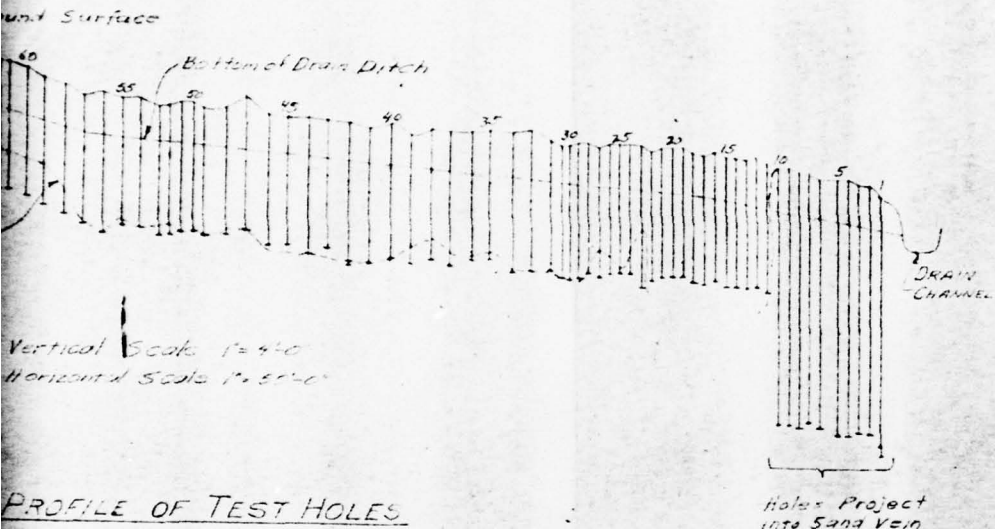
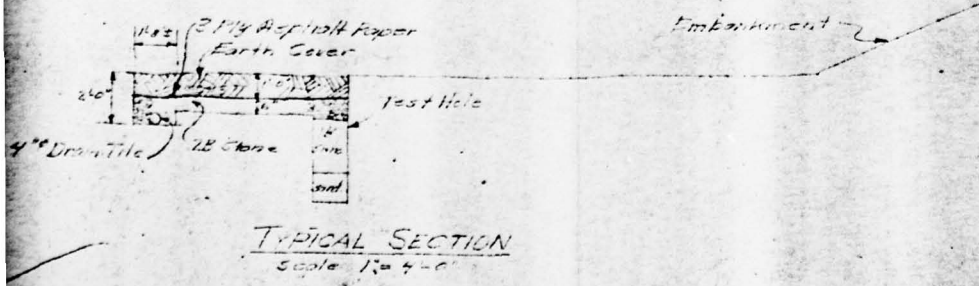
TEST HOLES & DRAINAGE DITCH

Ninety-five, 16-inch diameter, 5 and/or 10-foot deep test holes (sand drains) were installed after the dye test program to further assess the seepage and provide positive drainage of the area (see Figure 7). Details of the drilling and remedial work are contained in PFC files. Conditions observed during the field inspection indicate the drainage system is inadequate or ineffective.
