National Dam Inspection Program

MOOSE CREEK RESERVOIR DAM,

Susquehanna River Basin, Moose Creek  
Clearfield County, Pennsylvania.

PHASE I INSPECTION REPORT  
NATIONAL DAM INSPECTION PROGRAM

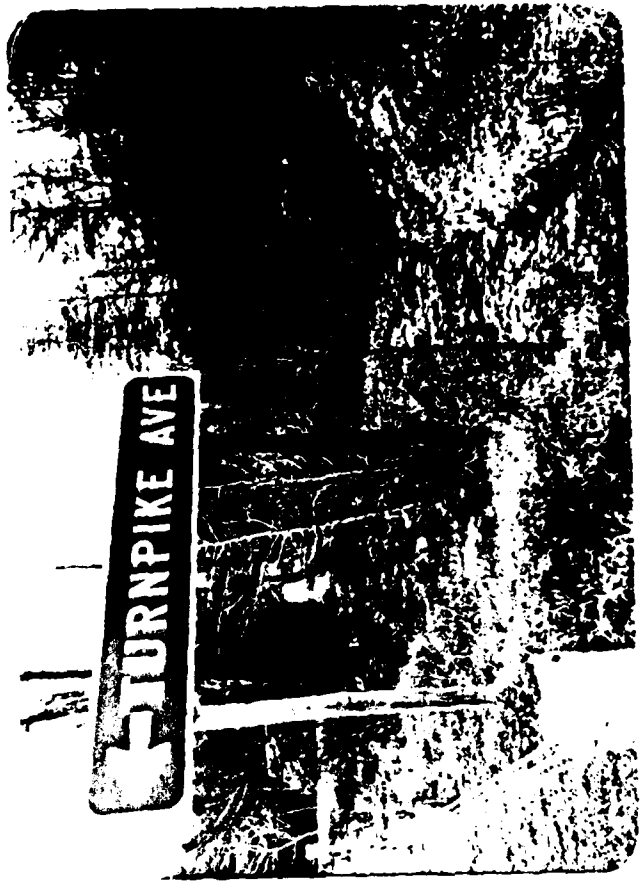
PHOTOGRAPH 10 View of Moose Creek at a point approximately 5,600 feet downstream of the dam. Note the dwelling near the left center portion of the photograph.
