MEADOW GROUNDS DAM,

Potomac River Basin, Roaring  
Run, Fulton County, Pennsylvania

PHASE I INSPECTION REPORT.

PHASE I INSPECTION REPORT  
NATIONAL DAM INSPECTION PROGRAM  
MEADOW GROUNDS DAM  
NDI# PA-185, PENNDE# 29-32

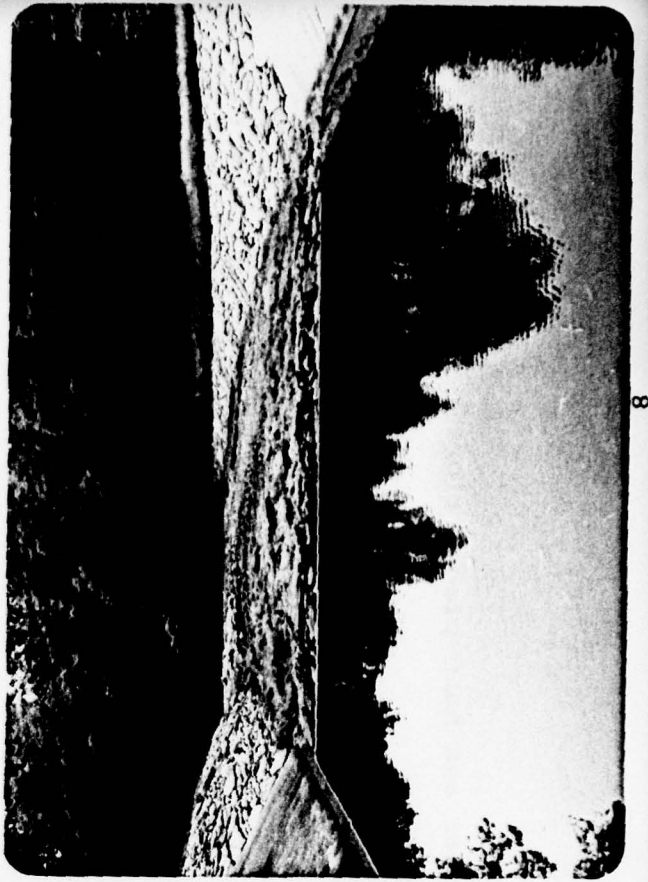
1. Spillway. Visual inspection revealed the spillway to be in good condition (see Photographs 6 and 7). No obstructions or concrete deterioration were observed. The channel immediately downstream of the stilling basin is adequately protected by hand-placed and/or dumped rock riprap (see Photograph 8).

PHOTOGRAPH 8 Downstream view of spillway channel from weir crest.

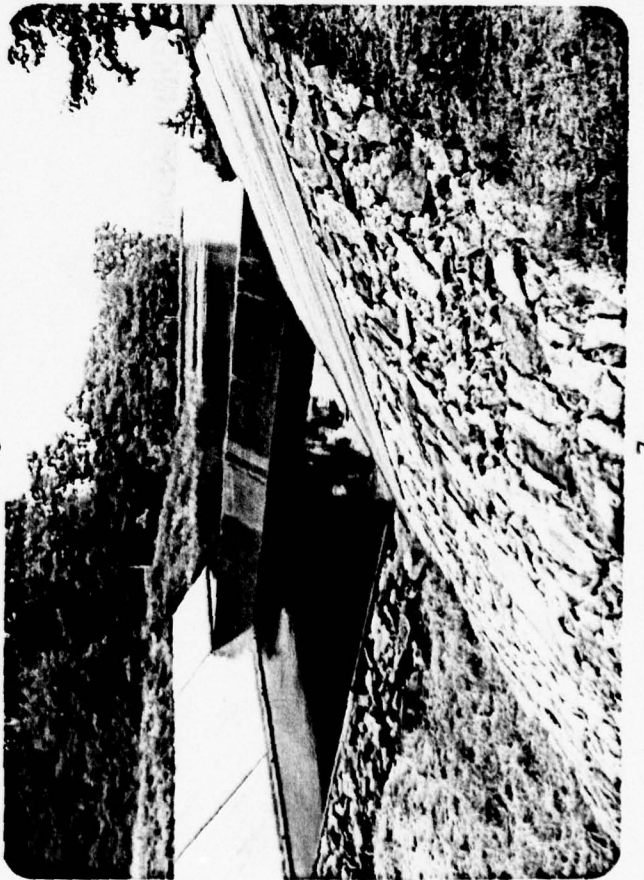
PHOTOGRAPH 7 View of spillway from downstream, left channel wall.

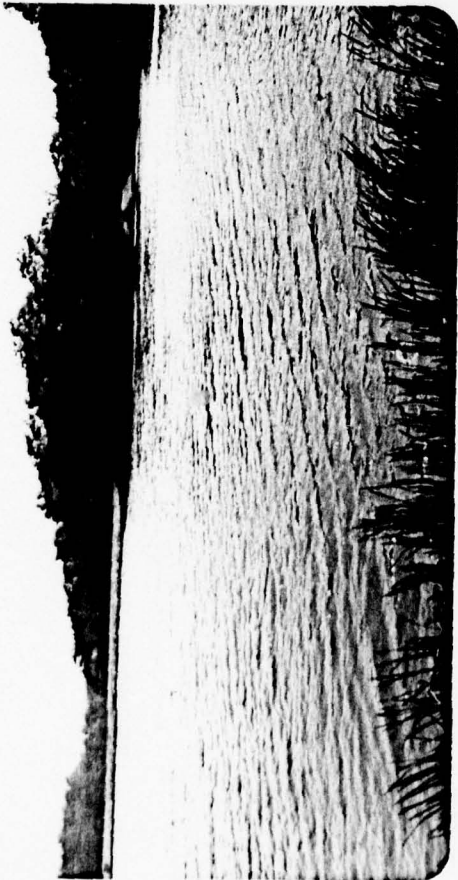
PHOTOGRAPH 5 View showing upstream slope (left of center) and spillway (extreme right).

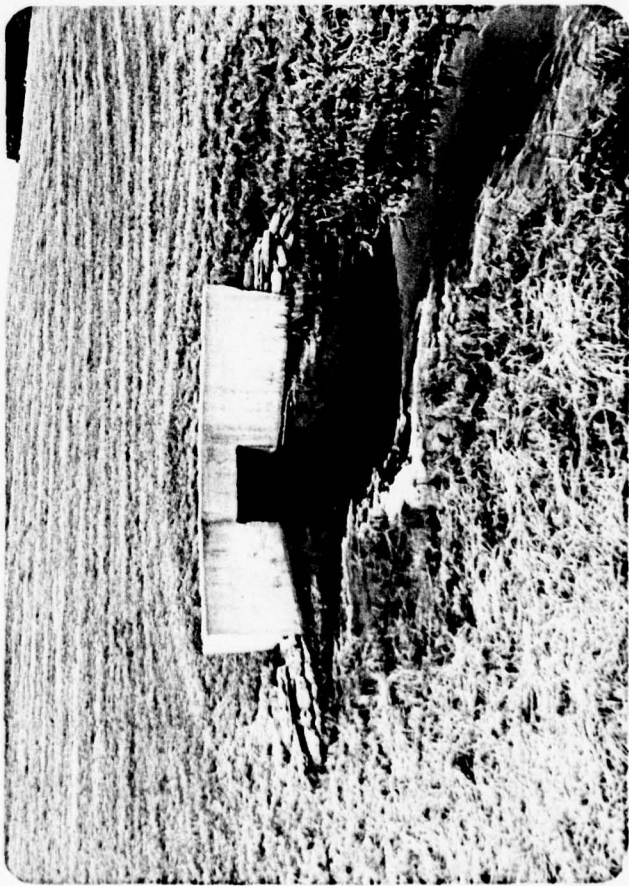
2. Outlet Works. Visible portions of the outlet works were found to be in good condition (see Photographs 9, 10, and 11). No concrete deterioration was noted on the control riser or outlet endwall. The interior of the outlet conduit was not inspected because of partial inundation and noxious conditions attributed to the stagnant pool at the outlet (see Photograph 11). The stoplogs were in place and functioning as designed.

2. Outlet Works. Visible portions of the intake tower and outlet conduit were found to be in good condition. The outlet conduit was not entered due to partial inundation and noxious conditions attributed to stagnant water ponded at the outlet.

PHOTOGRAPH 11 View of outlet endwall and stagnant pool.

a. Evaluate the outlet works channel and take necessary remedial measures to provide unimpeded discharge through the channel.
