GRAHAMVILLE RESERVOIR DAM

NDI No. PA 00020
PennDER No. 25-2

PHASE I INSPECTION REPORT NATIONAL DAM INSPECTION PROGRAM

Grahamville Reservoir Dam, Erie County, Pennsylvania
NDI No. 00020, PennDER No. 25-2
Sixteen Mile Creek
Inspected 16 November 1978 and 5 June 1979

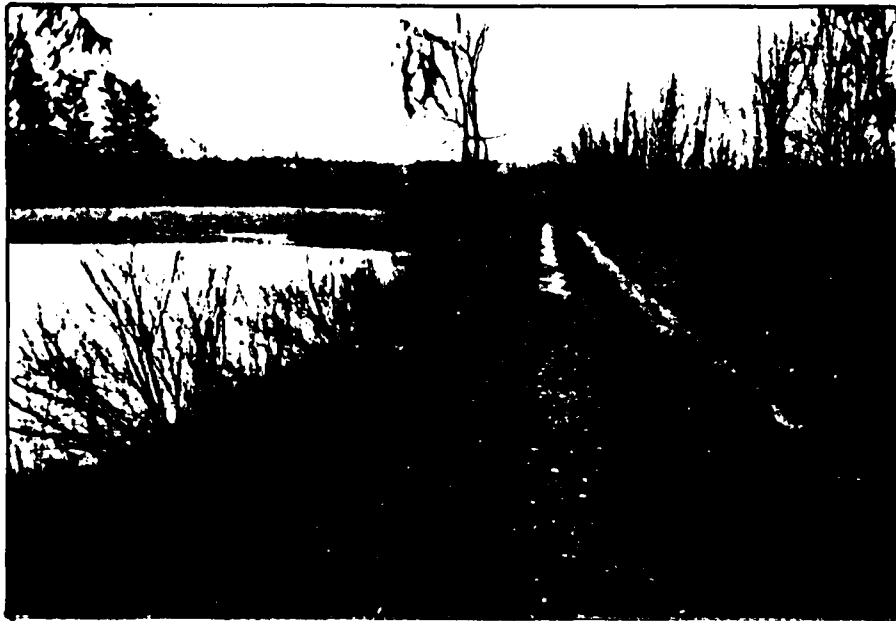
- b. Dam - Both the upstream and downstream faces of the embankment are covered with high grasses, bushes, and small trees. The upstream face has a 3 to 4 foot, near vertical drop-off at the normal pool elevation due to erosion of the embankment. Erosion was also noted approximately 200 feet from the right abutment on the downstream face. Some seepage was noted at the right abutment on the downstream side; however, due to the dense vegetative growth, an accurate assessment of the severity of the seepage could not be made, although no signs of piping were evident. Two large ruts have formed across the crest of the embankment due to vehicular traffic.

**PHOTO 4. Main Embankment from Right Abutment
(Note Ruts and Standing Water on Crest)**

- 4) Regrade and reseed the large ruts along the crest with an appropriate mixture to prevent erosion.
- 5) Repair the concrete on the outside of the gate valve house. Also, repair the head wall for the two 12 inch outlet pipes.

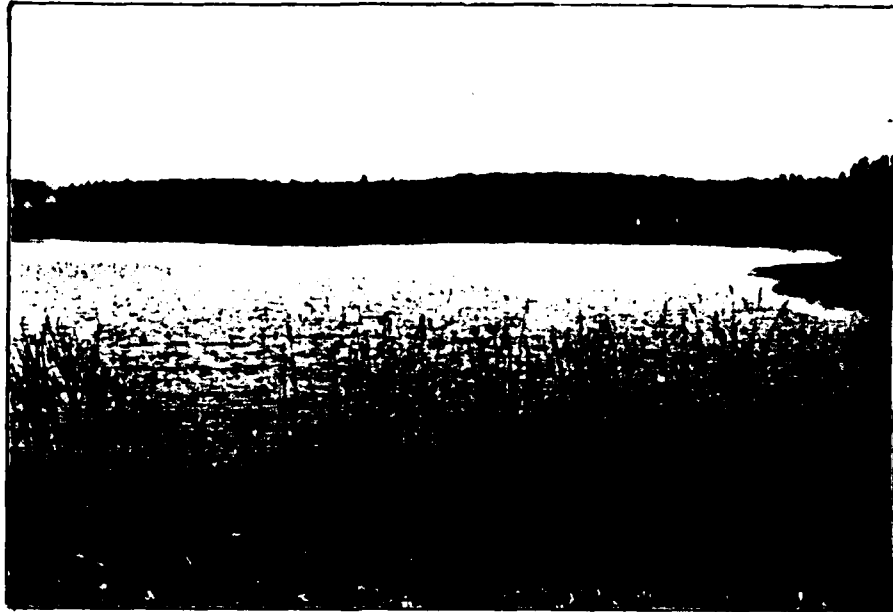
PHOTO 7. View of Reservoir from Crest

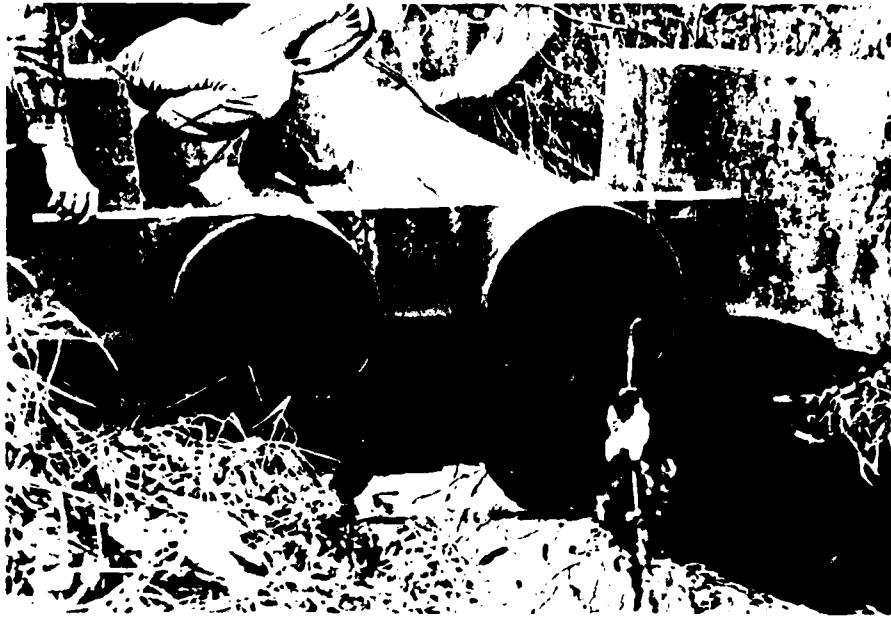
PHOTO 9. Inlet to Reservoir (Two 19 Inch Cast-Iron Pipes)
