# BRADYS LAKE DAM

## PHASE I INSPECTION REPORT NATIONAL DAM INSPECTION PROGRAM

BRADYS LAKE DAM, MONROE COUNTY  
PENNSYLVANIA

NDS I.D. NO. PA 00782  
DER I.D. NO. 45-8

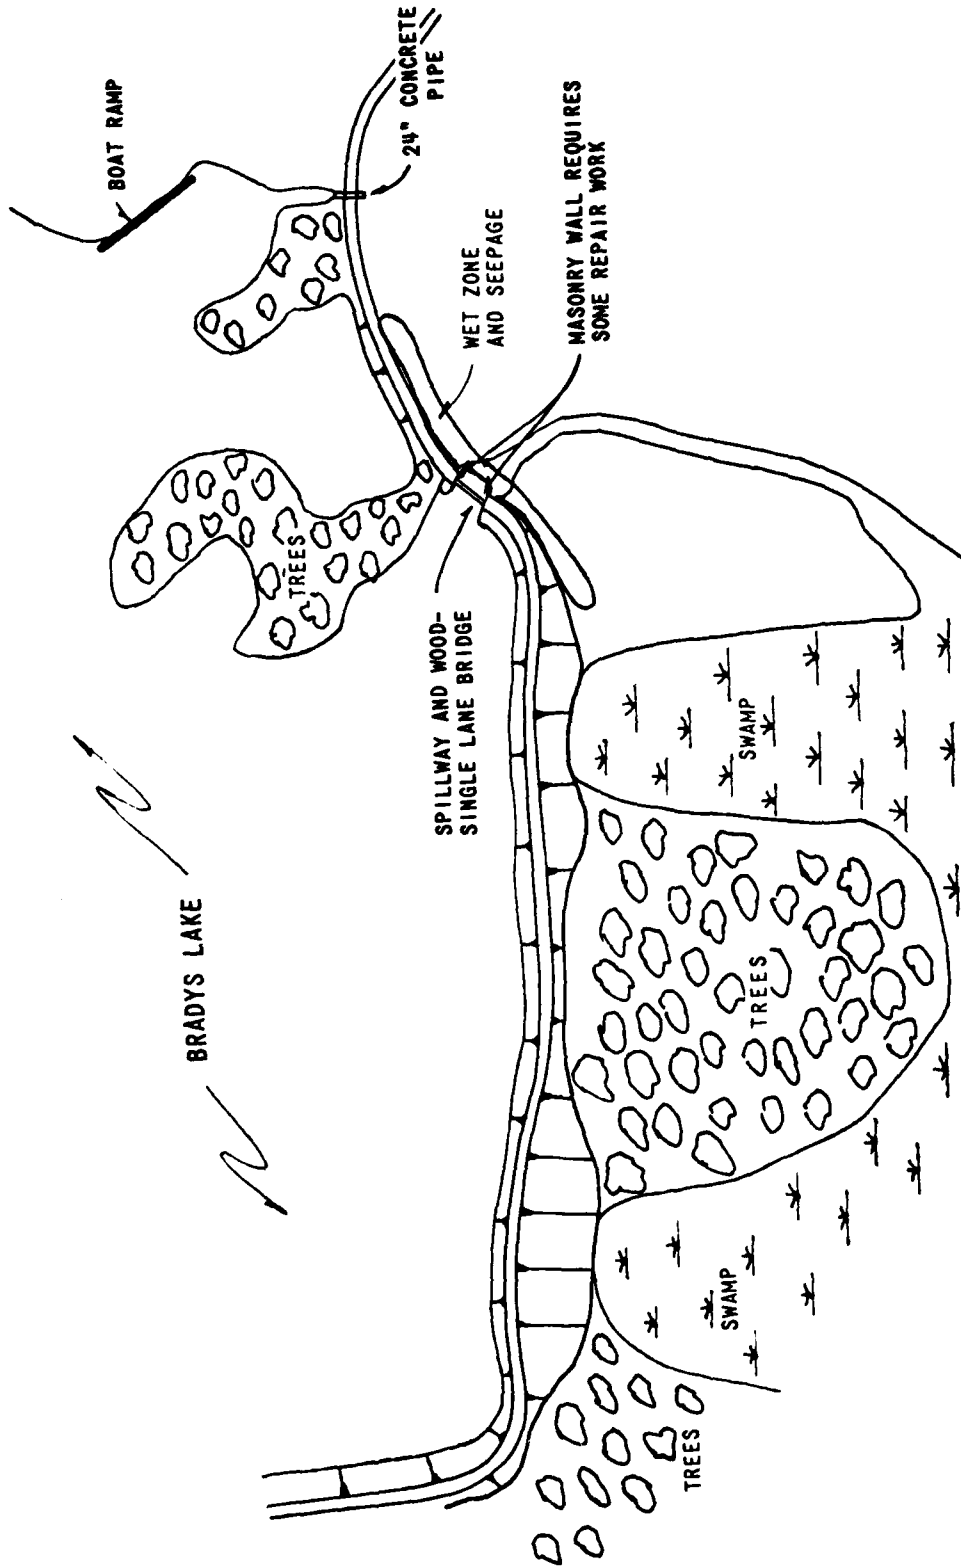
FIELD OBSERVATION PLAN  
 BRADYS LAKE DAM  
 SHEET 5A OF 11

Seepage was noted as shown on sheet 5a. All of this seepage was observed at the left end of the dam at the downstream toe between the 24-inch pipe and the spillway. This same seepage was noted in previous inspection reports, which date as far back as June 1934. Because of the backwater/swamp from the beaver dam, possible seepage under the right end of the dam may not be visible.

The wet areas, noted on sheet 5a, Appendix B, downstream of the embankment to the left of the spillway have been a source of seepage for more than 45 years. Based on available documentation, there has been no significant change in the rate of seepage for at least that period of time. Thus, it is judged that this seepage is in a reasonably stable condition, but does not discount the fact that it should be monitored.

*Yes. See Sheet 5a, all of the seepage was observed at the left end of the dam at the downstream toe between the 21 inch pipe and the spillway.*

2. Seepage at the downstream toe should be periodically monitored and checked, at least visually, for increases in rates or changes in turbidity.
3. The spillway should be rehabilitated to a good condition.
