MAY 1979

LAKE ALEEDA DAM

(NDI-ID No. V PA-00557)

PHASE I INSPECTION REPORT

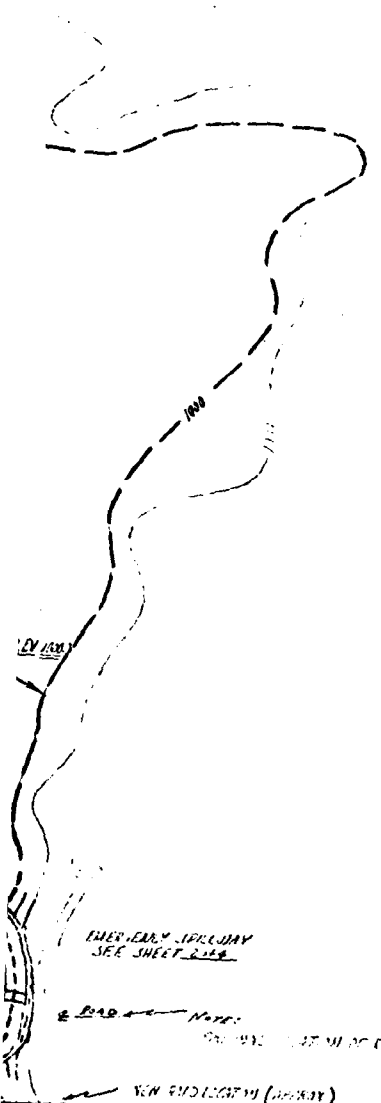
PHASE I INSPECTION REPORT  
 NATIONAL DAM INSPECTION PROGRAM  
 LAKE ALEEDA DAM  
 ALEEDA DEVELOPMENT CORPORATION, INC.  
 PLAN  
 MAY 1979  
 PLATE 2

c. Design Considerations. Plate 2 indicates that the cutoff trench only extends under the length of the embankment that is below normal pool elevation. Current standard practice would require that the cutoff trench extend under the entire embankment. Although the main spillway design has been used successfully by the SCS for many years, it appears that there is a potential to develop cavitation during certain flow conditions.

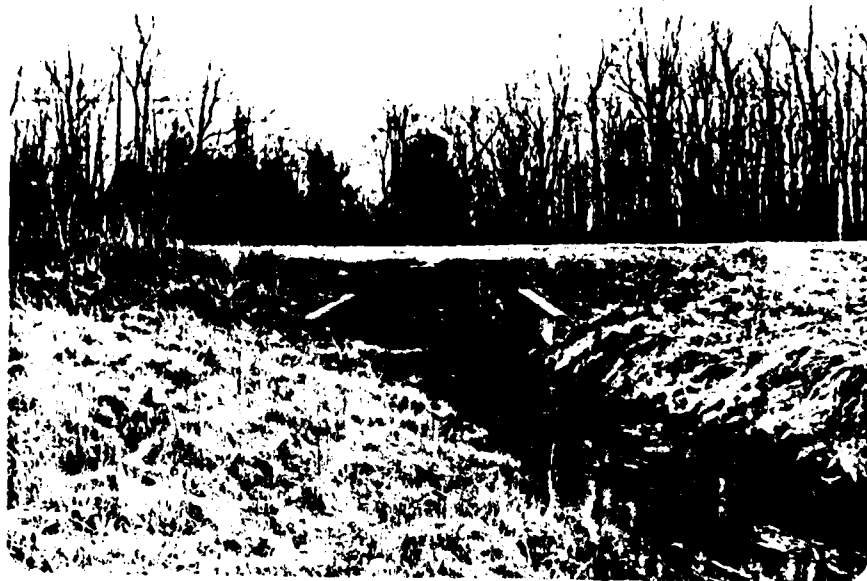
(5) Downstream Conditions. The roadway embankment immediately downstream from the dam will increase tailwater at the dam. This will decrease the main spillway capacity slightly but will have no effect on the auxiliary spillway capacity. The small size of the culverts are not considered to be a deficiency. The downstream conditions indicate the only hazard presented by the dam is to Bear Creek Lake Dam and its surrounding homes. A Phase I National Dam Inspection Report has previously been prepared for Bear Creek Lake Dam, which is a high hazard dam of small size with a seriously inadequate spillway. There are 8 dwellings that could be flooded by a failure of Bear Creek Lake Dam. Because the failure of Lake Aleeda Dam could cause the failure of Bear Creek Lake Dam, a high hazard classification is warranted for Lake Aleeda Dam.

E. Roadway Culverts Downstream of Dam

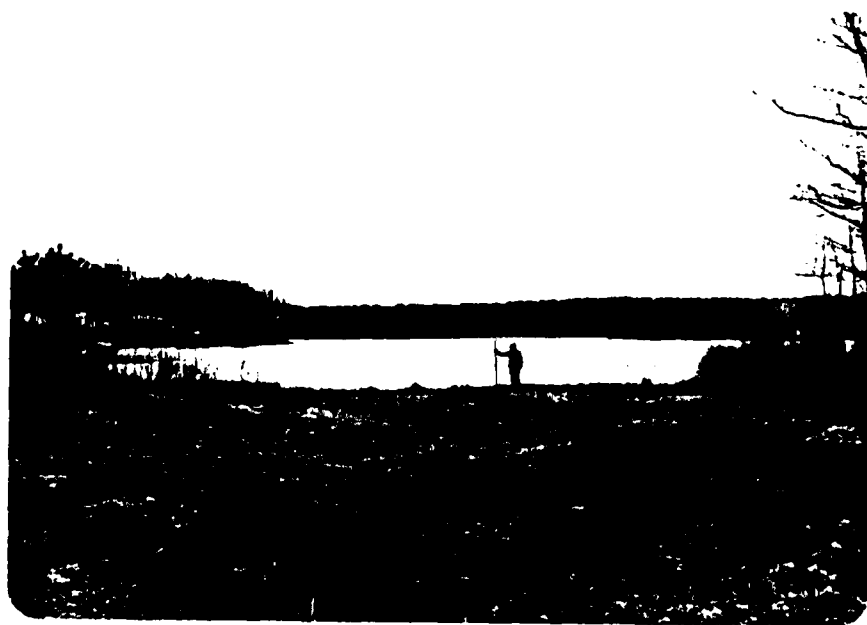
F. Auxiliary Spillway Approach Channel
