NO. 5 DAM
NDI ID NO. PA-00375
DER ID NO. 35-22

PENNSYLVANIA GAS AND WATER COMPANY

APRIL 1979

~~PENNSYLVANIA GAS AND WATER COMPANY,~~
Susquehanna River Basin, Stafford Meadow Brook
Lackawanna County, Pennsylvania.
PHASE I INSPECTION REPORT,
NATIONAL DAM INSPECTION PROGRAM

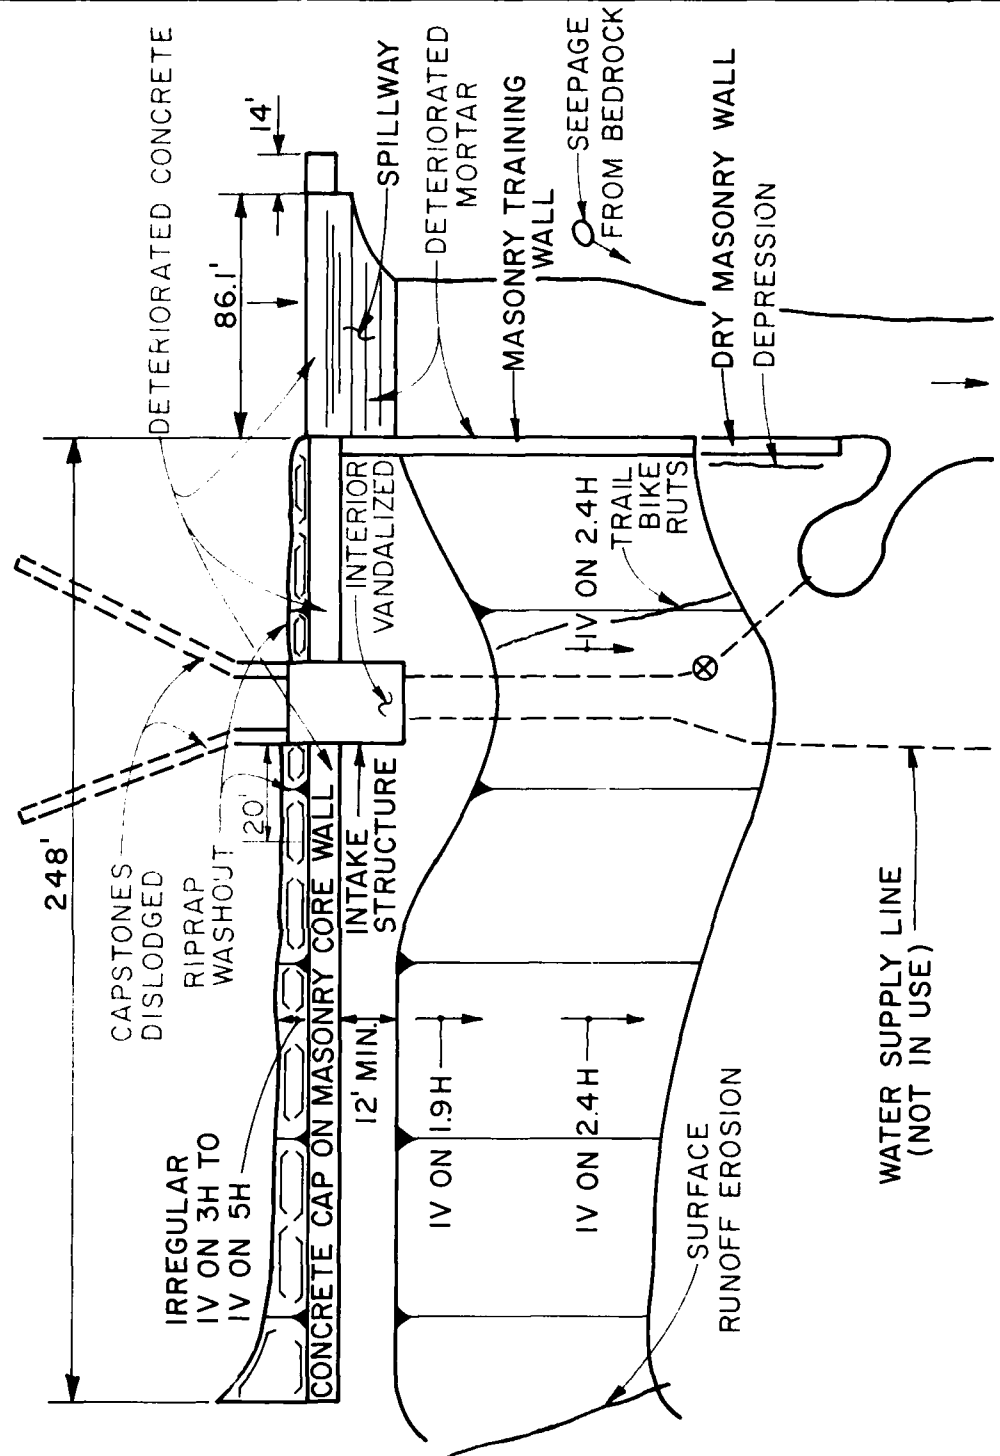
PHASE I INSPECTION REPORT
NATIONAL DAM INSPECTION PROGRAM
NO. 5 DAM
PENNSYLVANIA GAS AND WATER COMPANY
RESULTS OF VISUAL INSPECTION

a. General. The overall appearance of the dam is good. However, some deficiencies were observed as noted below. A sketch of the dam with the location of deficiencies is presented in Appendix B on Plate B-1. Survey information acquired for this report is summarized in Appendix B. On the day of the inspection, the pool was 0.1 foot above the spillway crest.
