OHIO RIVER BASIN
JACOBS CREEK, WESTMORELAND COUNTY, Pennsylvania

PA-657 DAM
(ACME DAM)

(NDI ID. PA-00828
PENNDER ID. 65-133)

PHASE I INSPECTION REPORT,
NATIONAL DAM INSPECTION PROGRAM

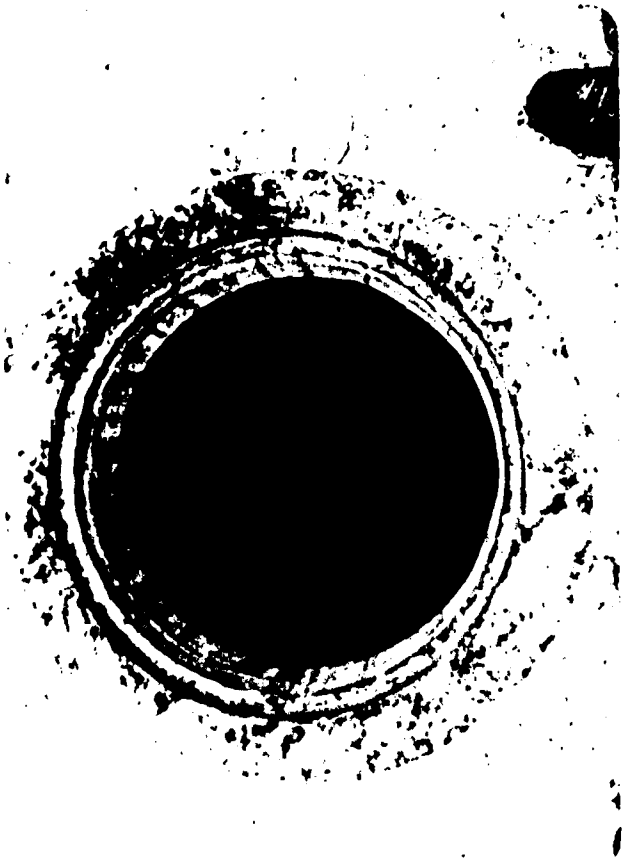
PHOTOGRAPH 5

View through the manhole opening of the interior of the service spillway riser. The manhole cover was missing on the day of the inspection.

a. Repair the damaged pond drain gate control and replace the missing manhole cover atop the service spillway riser. Consideration should be given to redesigning the gate control mechanism to protect it from future vandalism.
