DAM F  
NDI ID NO. PA-00642  
DER ID NO. 40-13

HAZLETON CITY AUTHORITY  
PHASE I INSPECTION REPORT  
NATIONAL DAM INSPECTION PROGRAM

DELAWARE RIVER BASIN,  
DRECK CREEK, LUZERNE COUNTY,  
PENNSYLVANIA.

PHASE I INSPECTION REPORT  
NATIONAL DAM INSPECTION PROGRAM

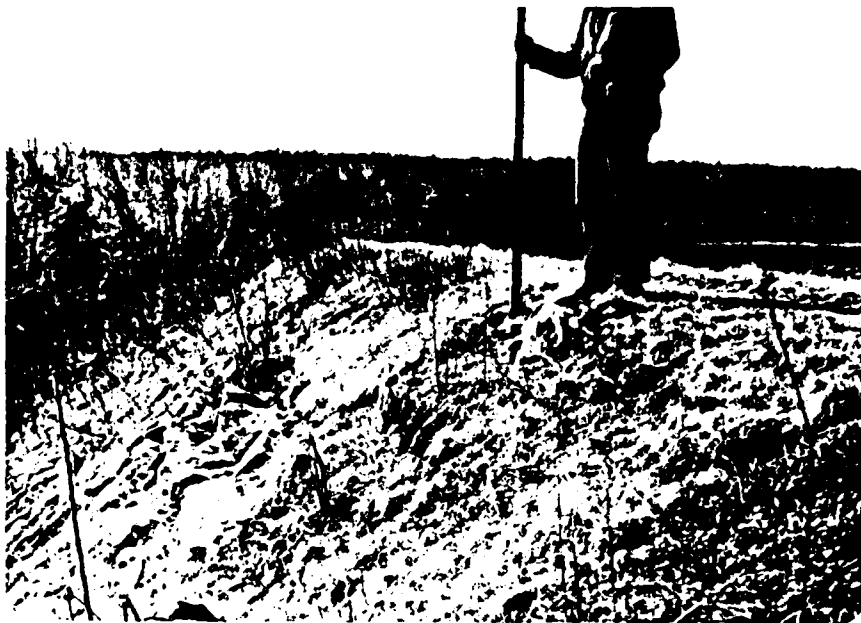
(2) Embankment. An inspection by the Commonwealth in 1928 noted that fill had recently been placed on the top of the dam. It is surmised that uncompacted soil was placed along the top of dam to fill in low areas and that an amount of overbuild was provided. This is probably the reason why the embankment is above its design elevation, minor sloughing occurred, and the existing top width varies. These conditions are not of particular concern. The brush on the slopes and the trees along the toe are undesirable. The bulges and heaves on the downstream slope are of concern. A 1928 inspection report by the Commonwealth noted that the paving on both slopes had just been relaid. The present bulges were first noted in an inspection by the Commonwealth in 1944. In that inspection report, the bulges were described as extending over a 50-foot length near the outlet works. Repairs were ordered, but apparently never accomplished. The present bulges are much more extensive. The heaves on the upstream slope are probably caused by poor construction grading; they are not of particular concern.

C. Sloughing at Top of Downstream Slope

(6) Monitor by any suitable means the scour, cracking, and deterioration of the concrete spillway walls, the sloughing near the top of the dam, and the heaves on the upstream slope. Take remedial action when needed.

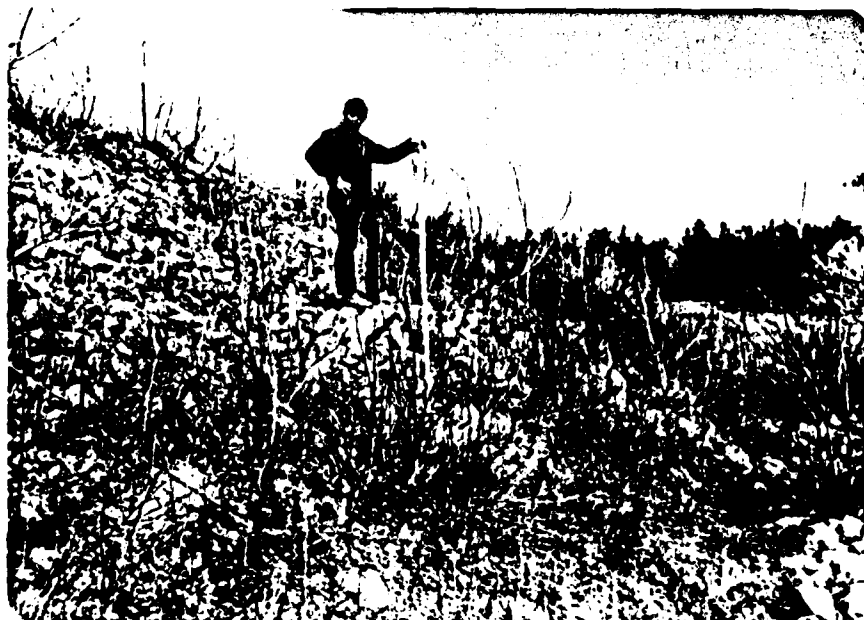
c. Operating Records. There are no formal records of operation. No evidence of instability on any feature of the dam has been noted, except for the bulges on the downstream embankment slope.

D. Bulges on Downstream Slope

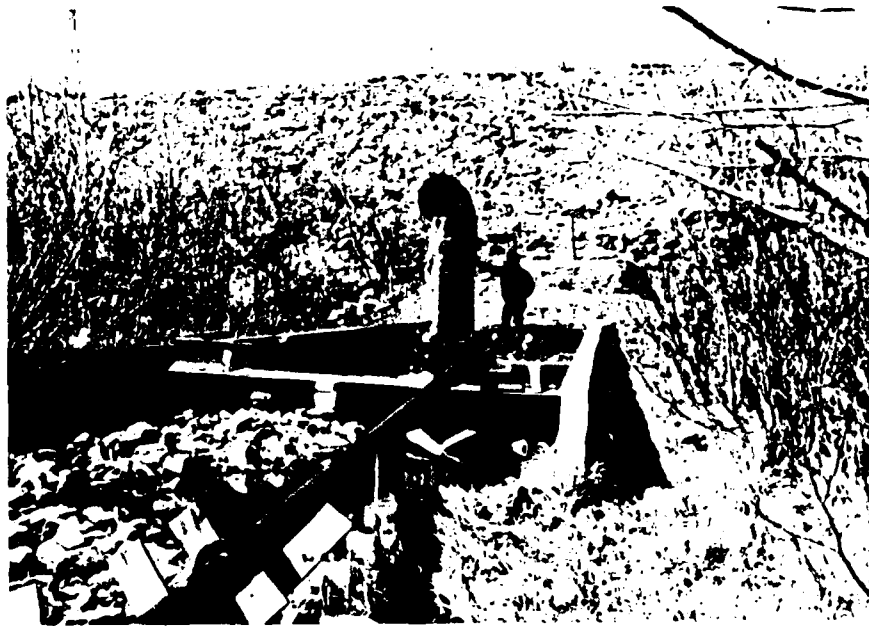
(3) Appurtenant Structures. Most of the conditions at the outlet works are assessed in Section 5. The deterioration of the valve house is probably caused by a poor mix of concrete and a lack of maintenance. The Owner reported that the reservoir water is very acid, which may be another contributing factor.

| VISUAL EXAMINATION OF | OBSERVATIONS | REMARKS OR RECOMMENDATIONS |
|---|---|---|
| OUTLET STRUCTURE VALVE HOUSE | ROOF NEAR COLLAPSE. CONCRETE VERY DETERIORATED | NO READY ACCESS TO RIGHT LINE VALVE |

F. Outlet Works
