PHOTOGRAPH THIS SHEET

AD A 081138

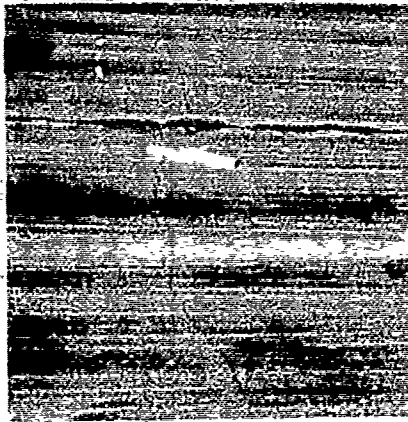
Photograph 1. Crack No. 1 on runway location prior to sealing. This was a very narrow, hairline-type crack.

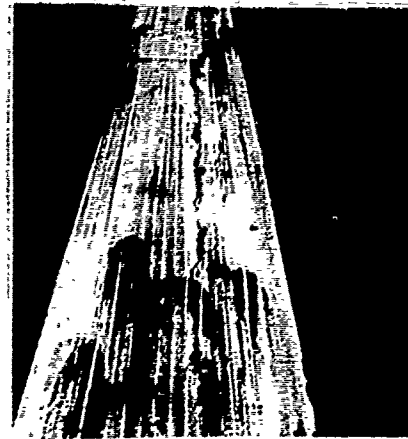
Photograph 2. Crack No. 3 on runway location prior to routing. This was a longitudinal crack on runway centerline $1/4$ in. or more in width.

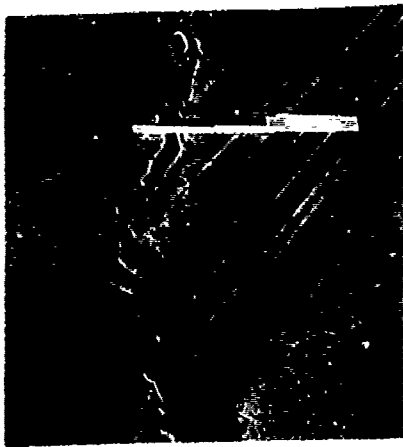
Photograph 3. Crack No. 4 on runway location showing previous sealing with AP-1.

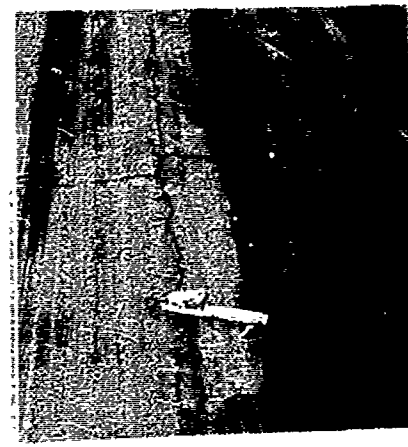
Photograph 4. Crack No. 5 on runway location prior to routing. This was a medium crack $1/3$ to $1/4$ in. in width.

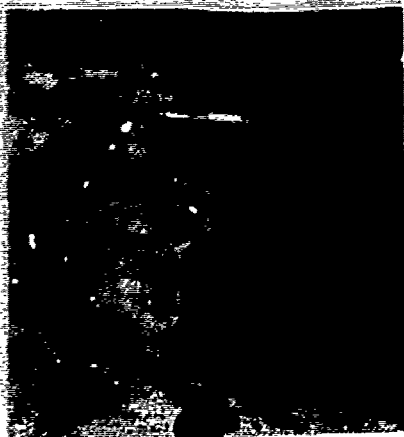
Photograph 5. Crack No. 13 on northeast warm-up apron location prior to routing. Crack was 1/2 in. wide and filled with old sealing material to within 3/4 in. of pavement surface.

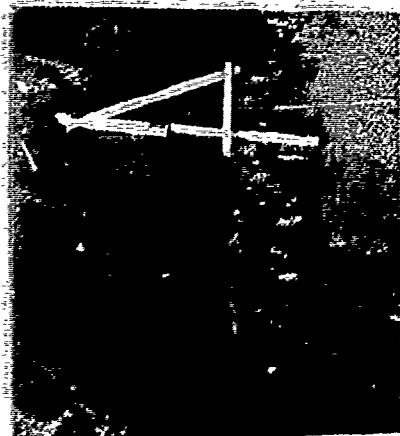
Photograph 6. Crack No. 16 on northeast warm-up apron prior to routing. Crack contained a considerable amount of water from previous rain.

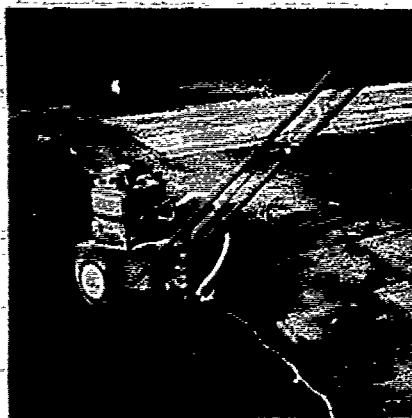
Photograph 7. Windsor router machine used in preparation of cracks for sealing.

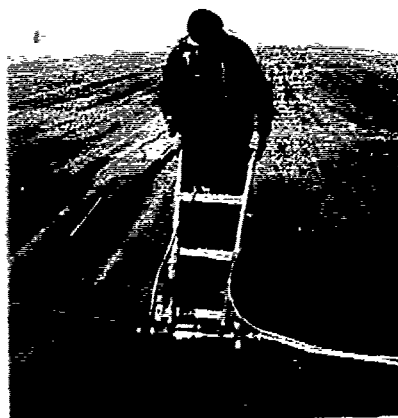
Photograph 8. Wire brush apparatus fabricated on site to clean cracks prior to sealing.

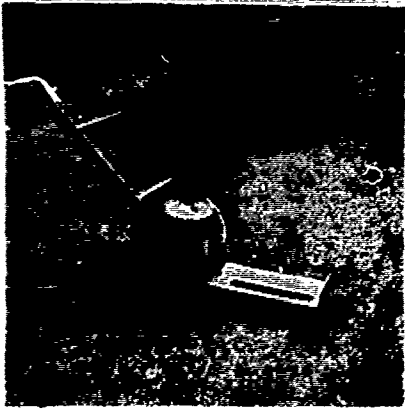
Photograph 9. Infrared heater used for heating interior of prepared groove and surrounding pavement prior to pouring of the sealing materials.

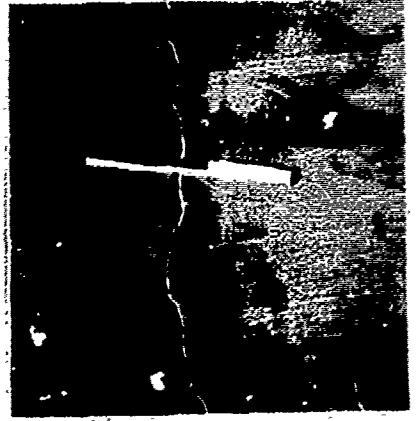
Photograph 10. Crack No. 1 on runway location after routing with 1/2-in.-diameter bit.

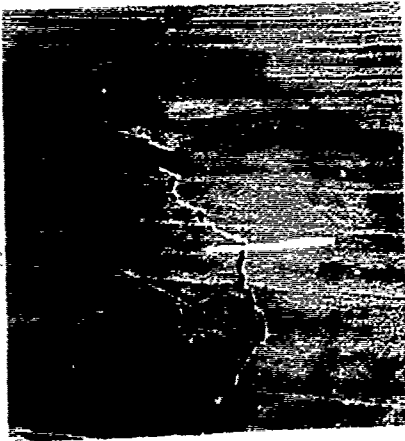
Photograph 11. Crack No. 2 on runway location after routing with 1/2-in.-diameter bit.

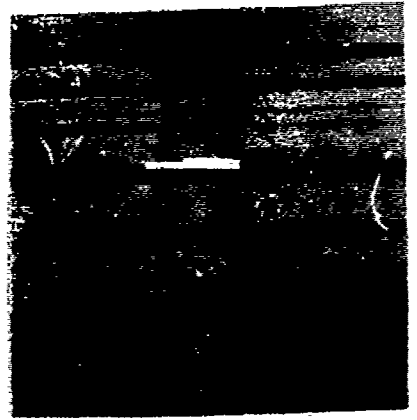
Photograph 12. Crack No. 8 on runway location routed with one pass of 1-in.-diameter bit.

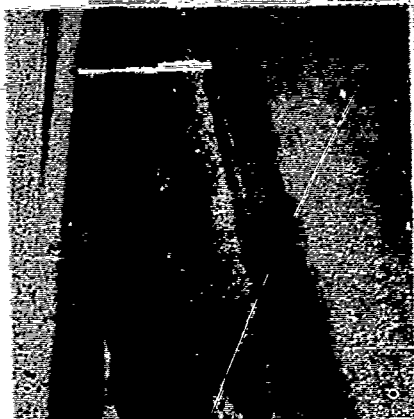
Photograph 13. Crack No. 6 on runway location routed with two passes of 1-in.-diameter bit. Note previous heavy application of AP-1 asphalt cement sealer.

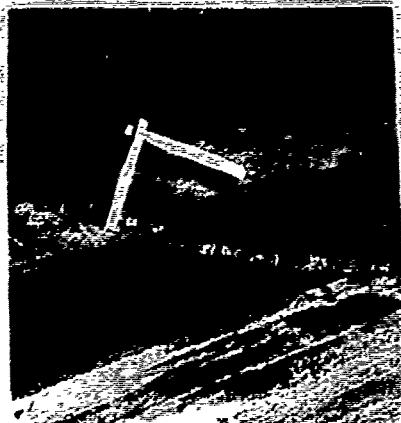
Photograph 14. Crack No. 3 on runway location showing depth of portion routed with three passes of 1-in.-diameter bit.

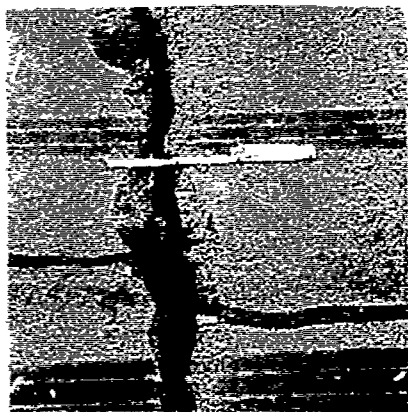
Photograph 15. Crack No. 6 on runway location before routing showing extent of previously applied sealing material.

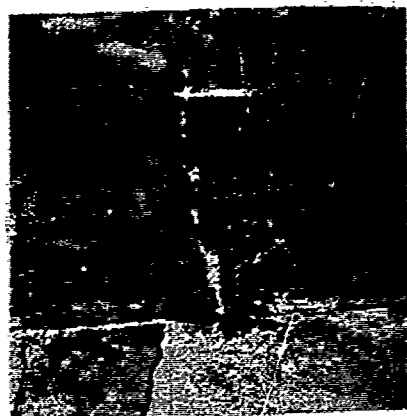
Photograph 16. Crack previously sealed with AP-1 asphalt cement prior to use of infrared heater.

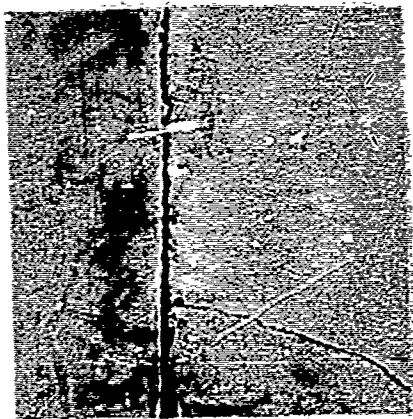
Photograph 17. Typical condition of crack, previously filled, prior to use of infrared heater.

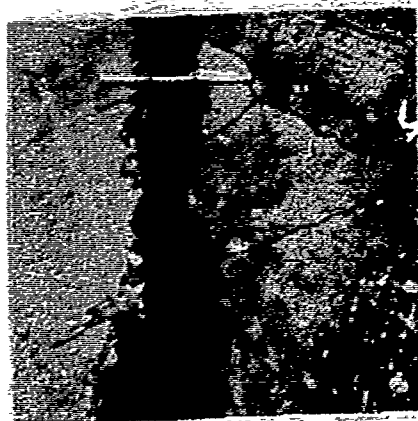
Photograph 18. Effect of infrared heater on old cracks previously sealed with AP-1 asphalt cement.

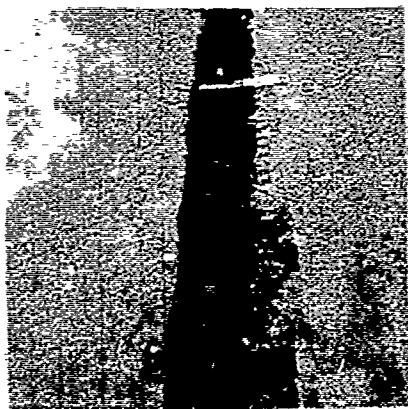
Photograph 19. Previously sealed crack after use of infrared heater.

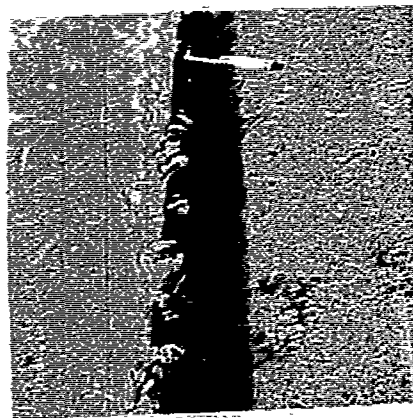
Photograph 20. Unprepared crack, previously filled, heated with infrared heater and sealed with Allied material.

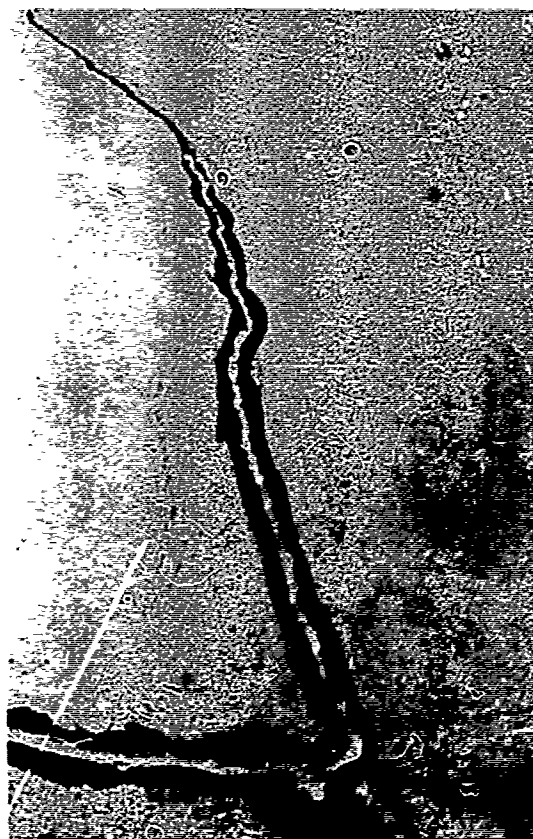
Photo 99. Crack No. 12 on northeast
corner of wall.

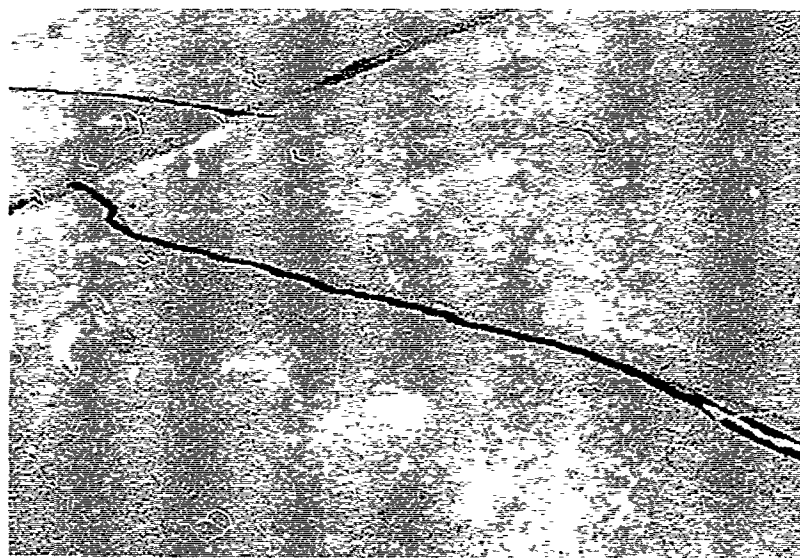
Photo 100. Crack No. 13 on northeast
corner of wall.

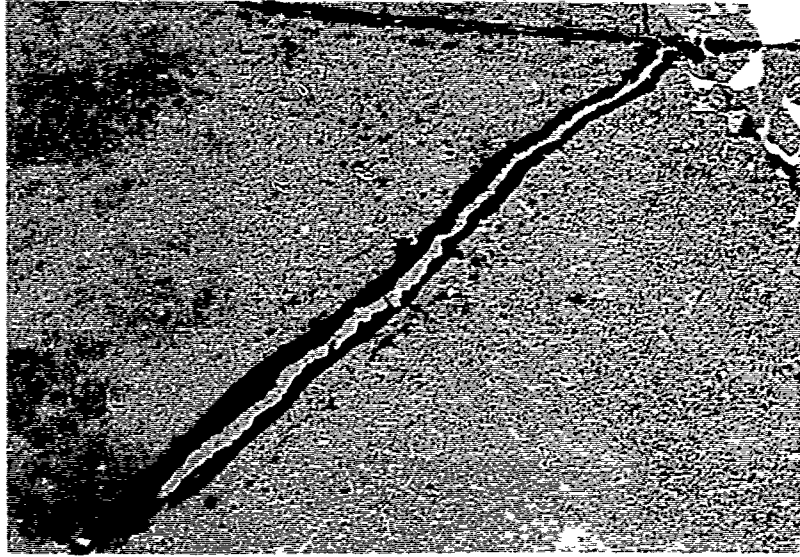
Figure 1. Topographic map of the study area.

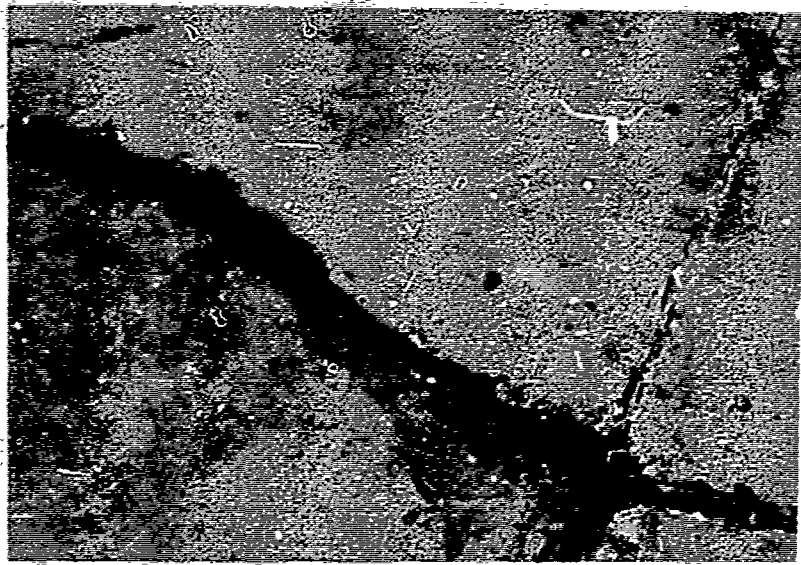
Photograph 25. Allied material in crack No. 1 on
northeast walk-up apron.

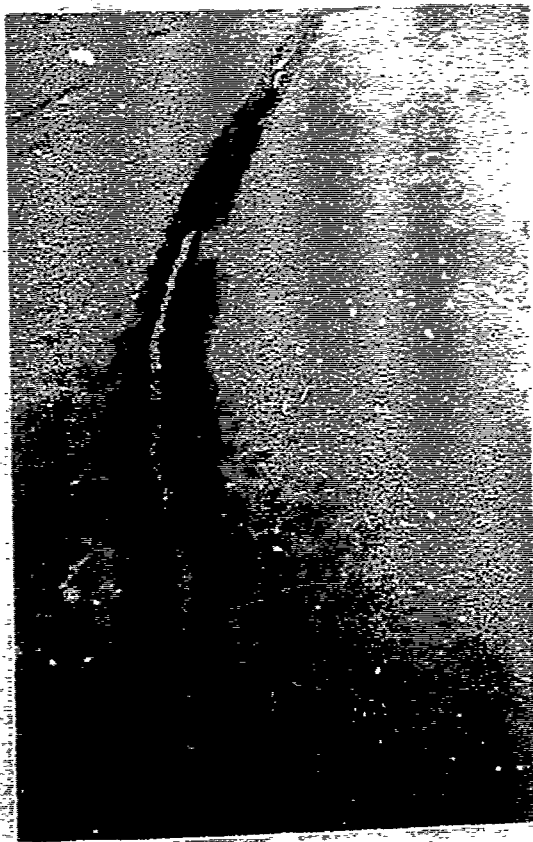
Photograph 26. Coast Pro-
Sent in crack No. 16 on
northeast walk-up apron.

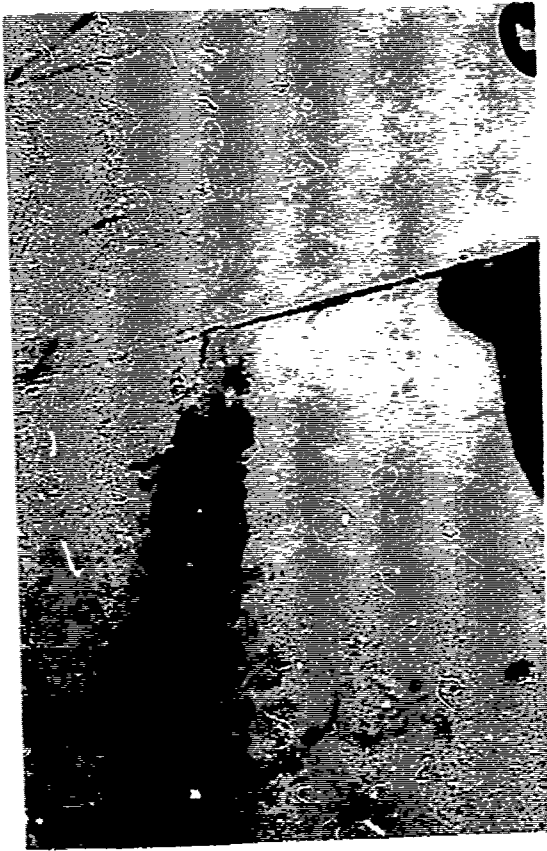
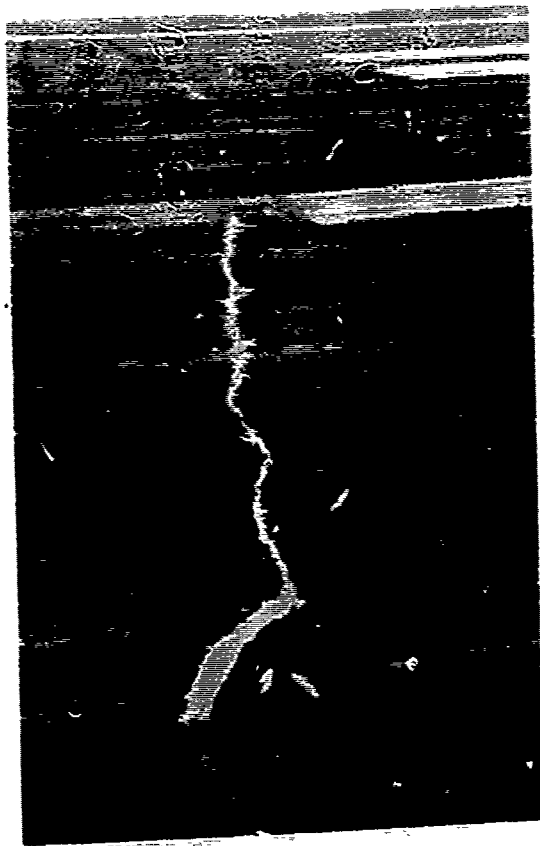
1950
1951
1952
1953
1954
1955
1956
1957
1958
1959
1960
1961
1962
1963
1964
1965
1966
1967
1968
1969
1970
1971
1972
1973
1974
1975
1976
1977
1978
1979
1980
1981
1982
1983
1984
1985
1986
1987
1988
1989
1990
1991
1992
1993
1994
1995
1996
1997
1998
1999
2000
2001
2002
2003
2004
2005
2006
2007
2008
2009
2010
2011
2012
2013
2014
2015
2016
2017
2018
2019
2020
2021
2022
2023
2024
2025

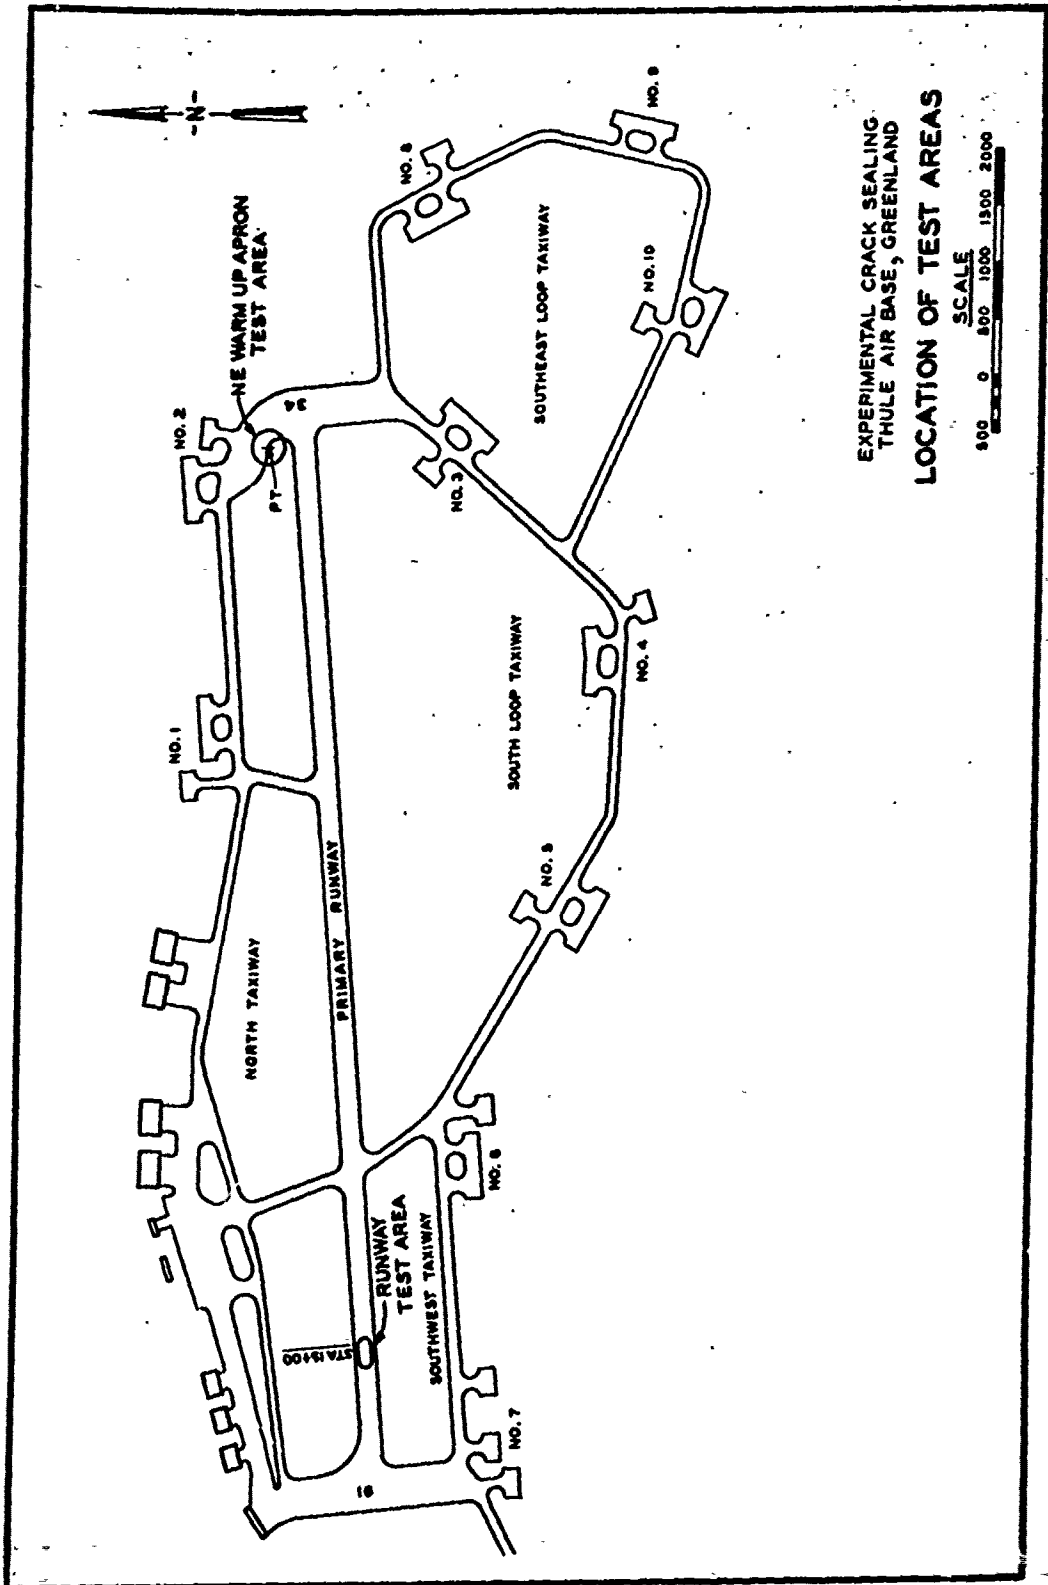
EXPERIMENTAL CRACK SEALING
 THULE AIR BASE, GREENLAND
LOCATION OF TEST AREAS

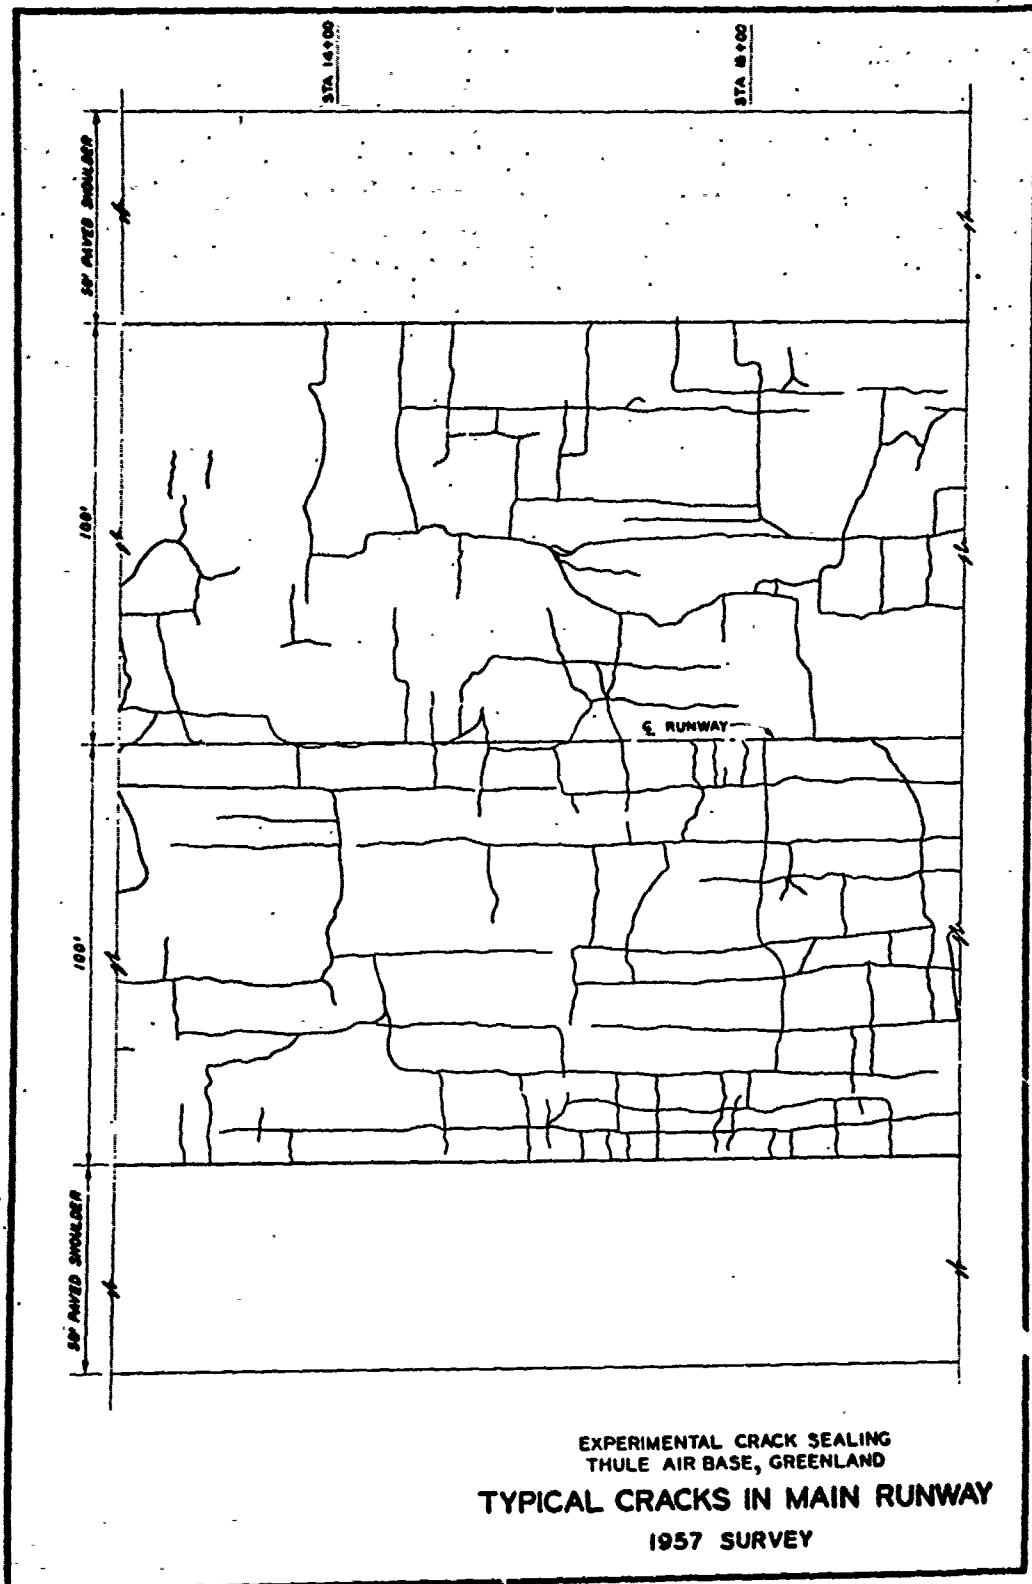
SCALE
 0 500 1000 1500 2000

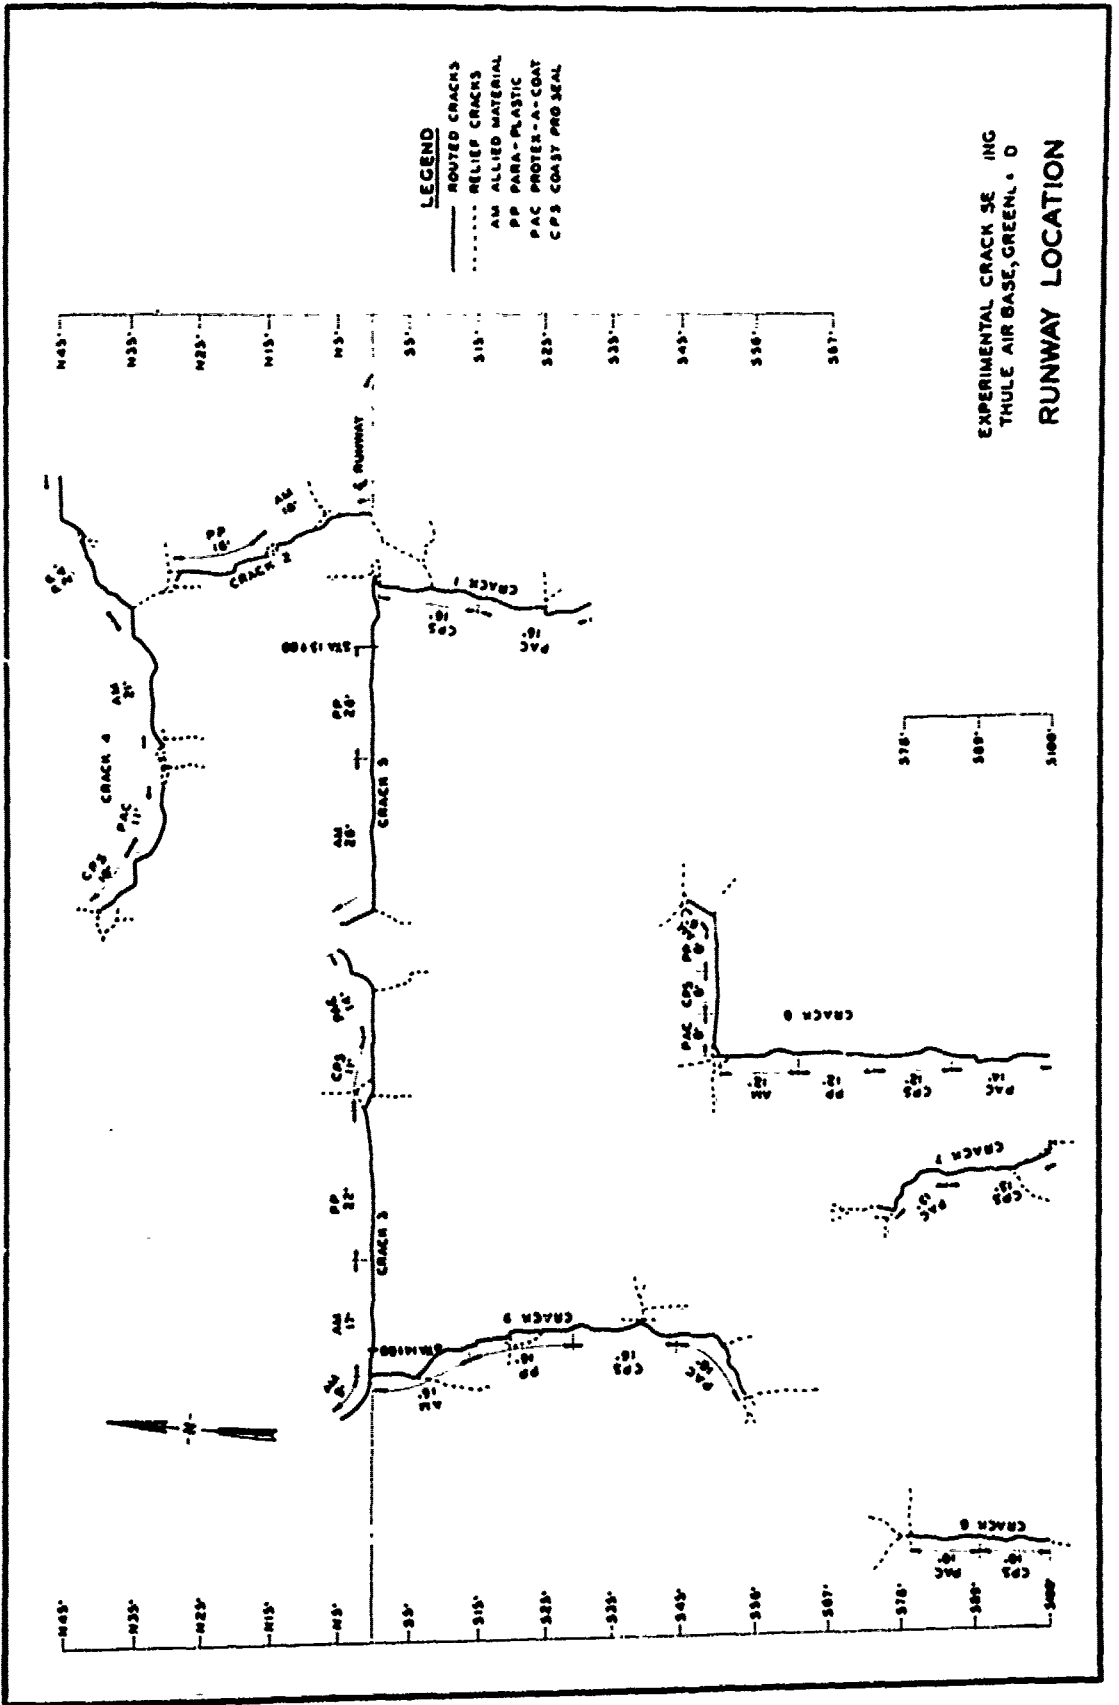
EXPERIMENTAL CRACK SEALING
THULE AIR BASE, GREENLAND
NE WARM UP APRON LOCATION

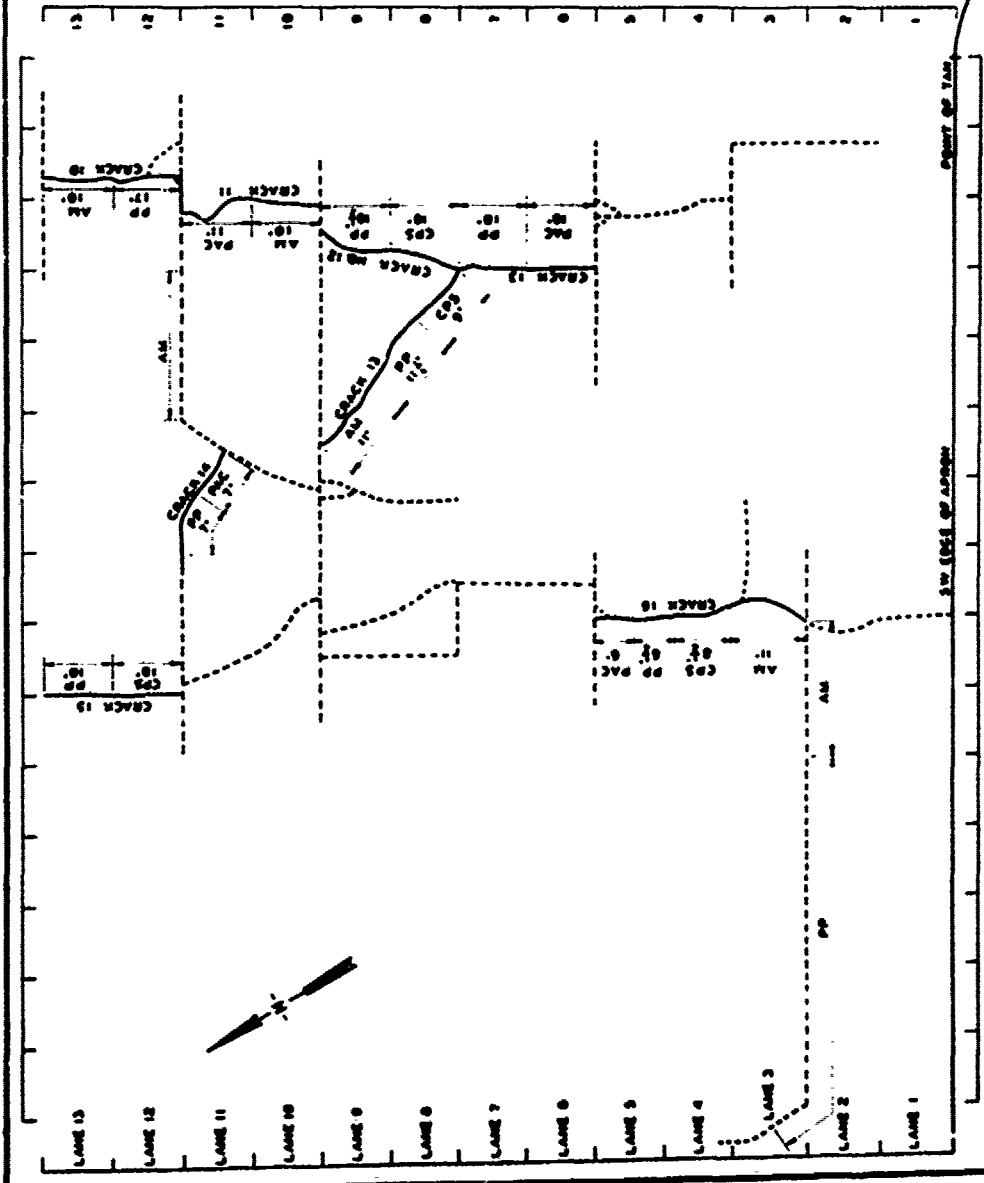
- LEGEND**
- ROUTED CRACKS
 - HELIED CRACKS
 - AM ALLIED MATERIAL
 - PP PARA-PLASTIC
 - PAC PROTER-A-COAT
 - CPS COAST PRO SEAL
