AN ARCHITECTURAL STUDY OF SOME LOG STRUCTURES IN THE AREA OF TH--ETC(U)

JUL 78 R C CARLISLE, A FERENCI

huntington district  
u. s. army corps of engineers  
September 1978

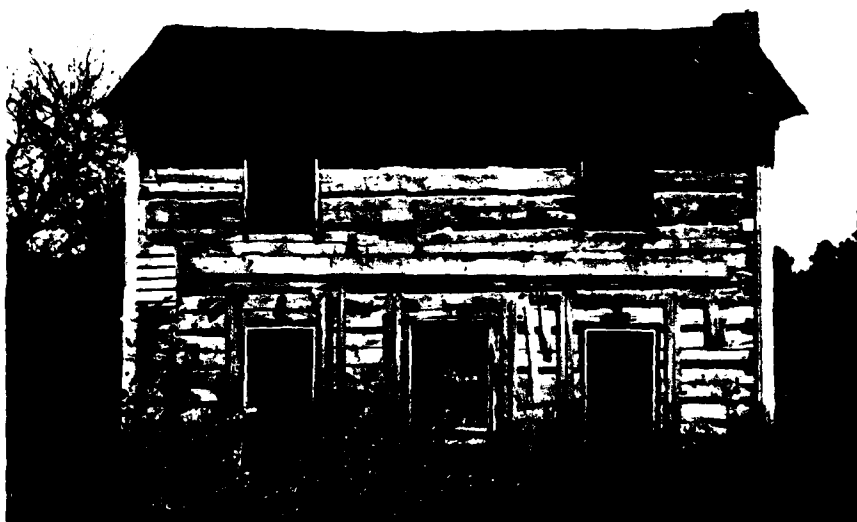
Fig. 21: Main entrance to log home on Tract 239 in southwest wall.  
Note original door width and remnants of frame siding.

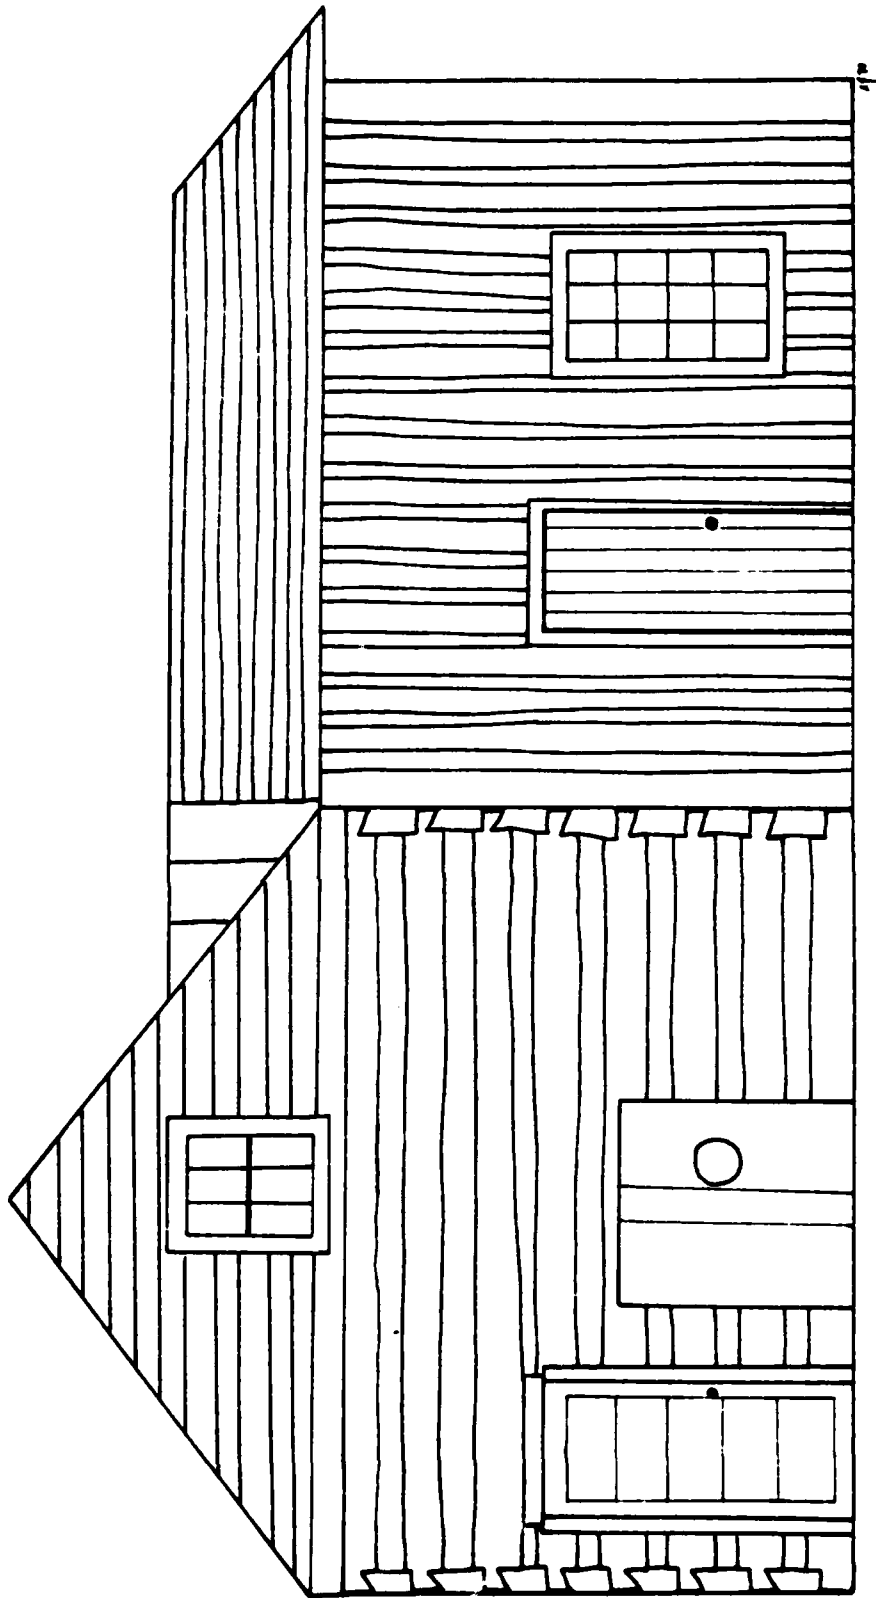
Fig. 87: Drawing of northwest wall of dwelling on Tract 1014. Note removal of chimney.

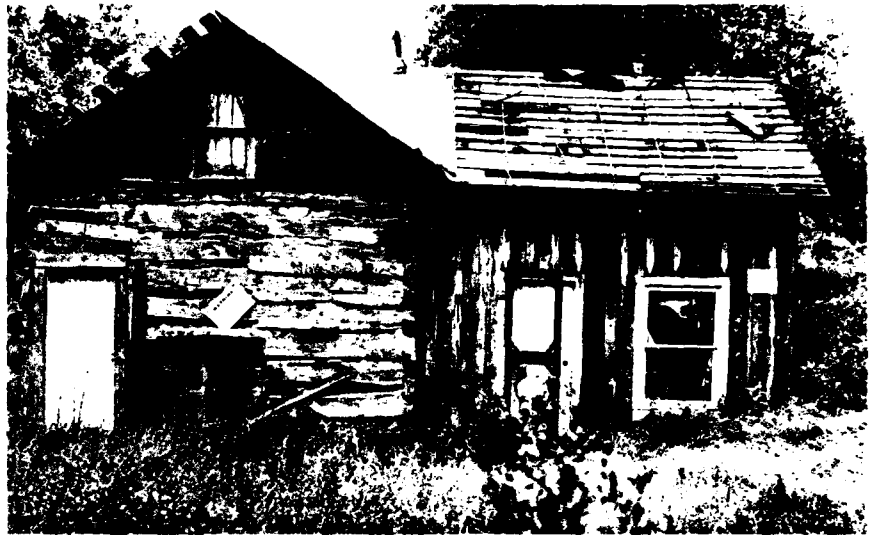
Fig. 92: Northwest wall of log portion of dwelling on Tract 1014. Note former chimney opening and use of riven weatherboards over interstices of some of the logs. Gable is assembled with cut nails.
