PHASE I REPORT  
NATIONAL DAM INSPECTION PROGRAM.

NAME OF DAM: Milburn Spring Dam  
 STATE LOCATED: Pennsylvania  
 COUNTY LOCATED: Bedford  
 STREAM: Unnamed tributary of Cumberland Valley Run  
 SIZE CLASSIFICATION: Small  
 HAZARD CLASSIFICATION: High  
 OWNER: Borough of Bedford  
 DATE OF INSPECTION: November 19 and December 12, 1979

(NLI ID Number P1 0023,  
 DEF ID Number 57)  
 Susquehanna River Basin, Unnamed  
 Tributaries of Cumberland Valley  
 Run, Bedford County  
 Pennsylvania, Phase I  
 Inspection Report

PHASE I REPORT  
NATIONAL DAM INSPECTION PROGRAM  
MILBURN SPRING DAM  
NDI I.D. PA-239  
DER I.D. 5-7

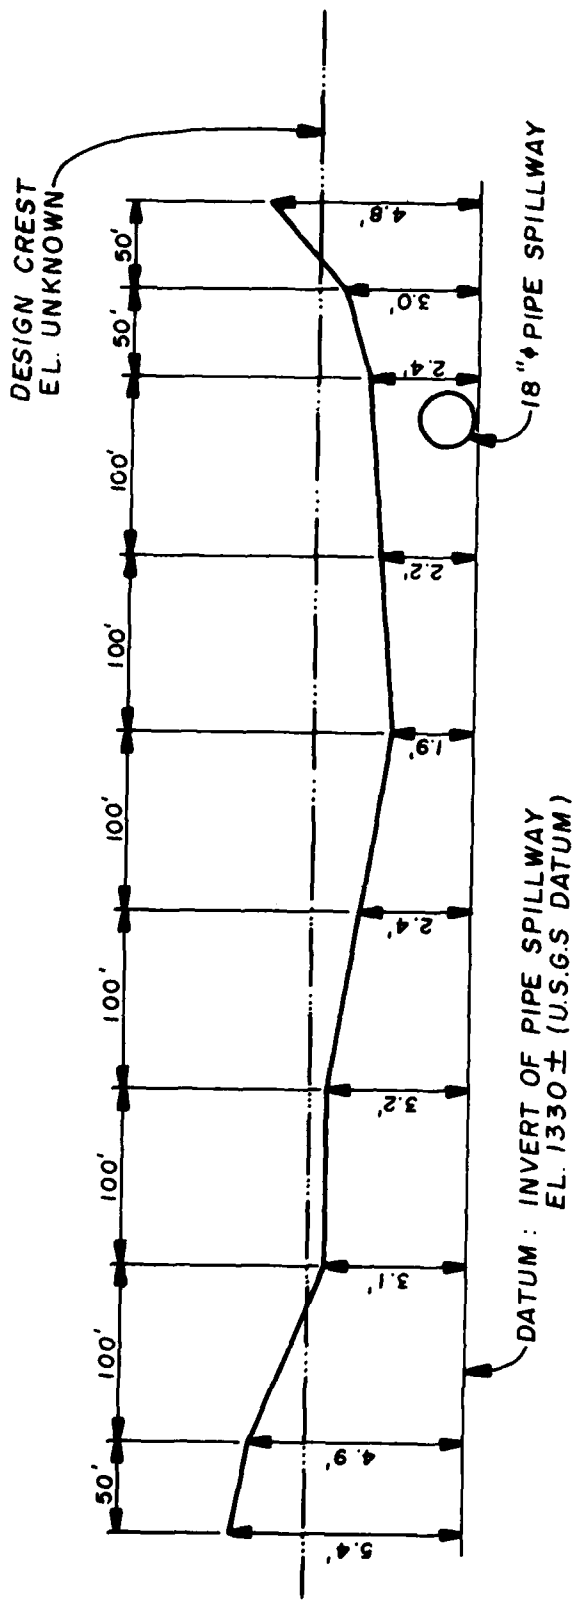
DAM CREST PROFILE  
(LOOKING DOWNSTREAM)

The crest of the dam was surveyed relative to the intake invert elevation of the outflow pipe. The freeboard was found to range from 1.9 feet near the northern corner of the reservoir to 5.4 feet on the left abutment. The dam crest profile is illustrated in Plate 5.
