TODD SPRING RESERVOIR

(NDI ID # PA-00241)

Susquehanna River Basin,  
Unnamed Tributary of Raystown Branch  
Juniata River, Bedford County, Pennsylvania.  
PHASE I INSPECTION REPORT

**NAME OF DAM:** Todd Spring Dam  
**STATE LOCATED:** Pennsylvania  
**COUNTY LOCATED:** Bedford  
**STREAM:** Unnamed tributary of the Raystown Branch of the Juniata River  
**SIZE CLASSIFICATION:** Small  
**HAZARD CLASSIFICATION:** High  
**OWNER:** Borough of Bedford  
**DATE OF INSPECTION:** November 19 and December 12, 1979

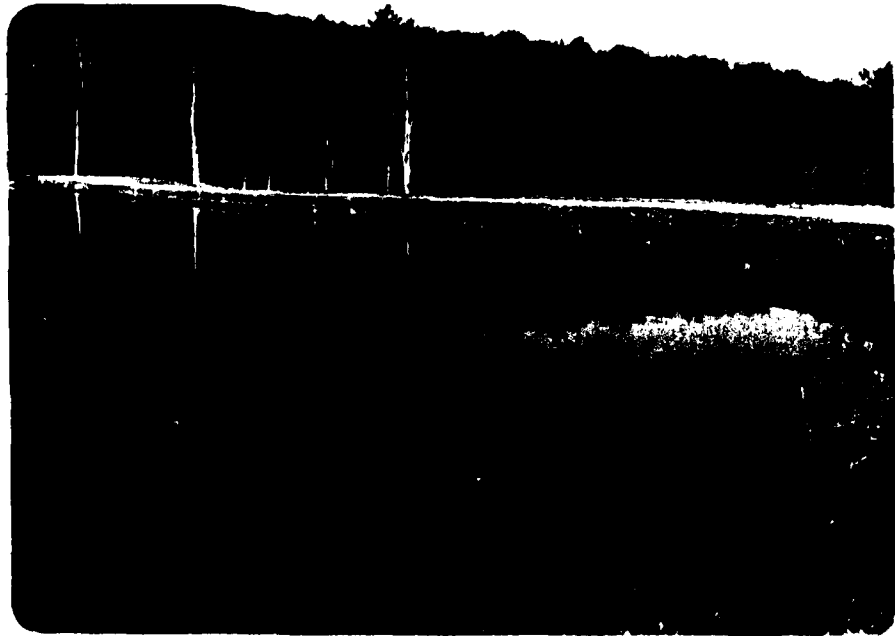
Upstream Face

| VISUAL EXAMINATION OF | OBSERVATIONS | REMARKS OR RECOMMENDATIONS |
|---|---|---|
| RIPRAP FAILURES | There is no erosion protection on the upstream side of the dam. | The owner should evaluate the need for providing erosion protection. |

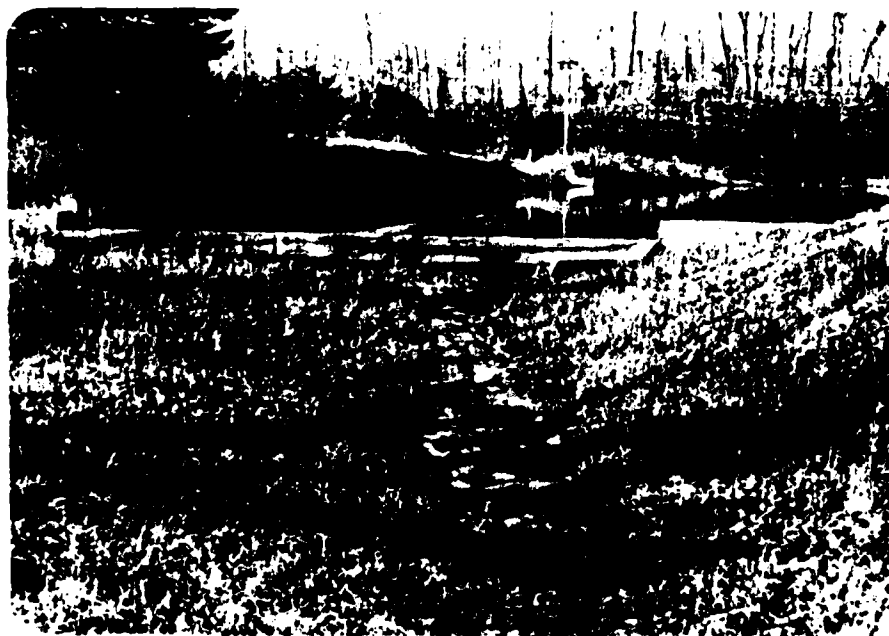
Photograph No. 3  
Spillway discharge channel, looking upstream.

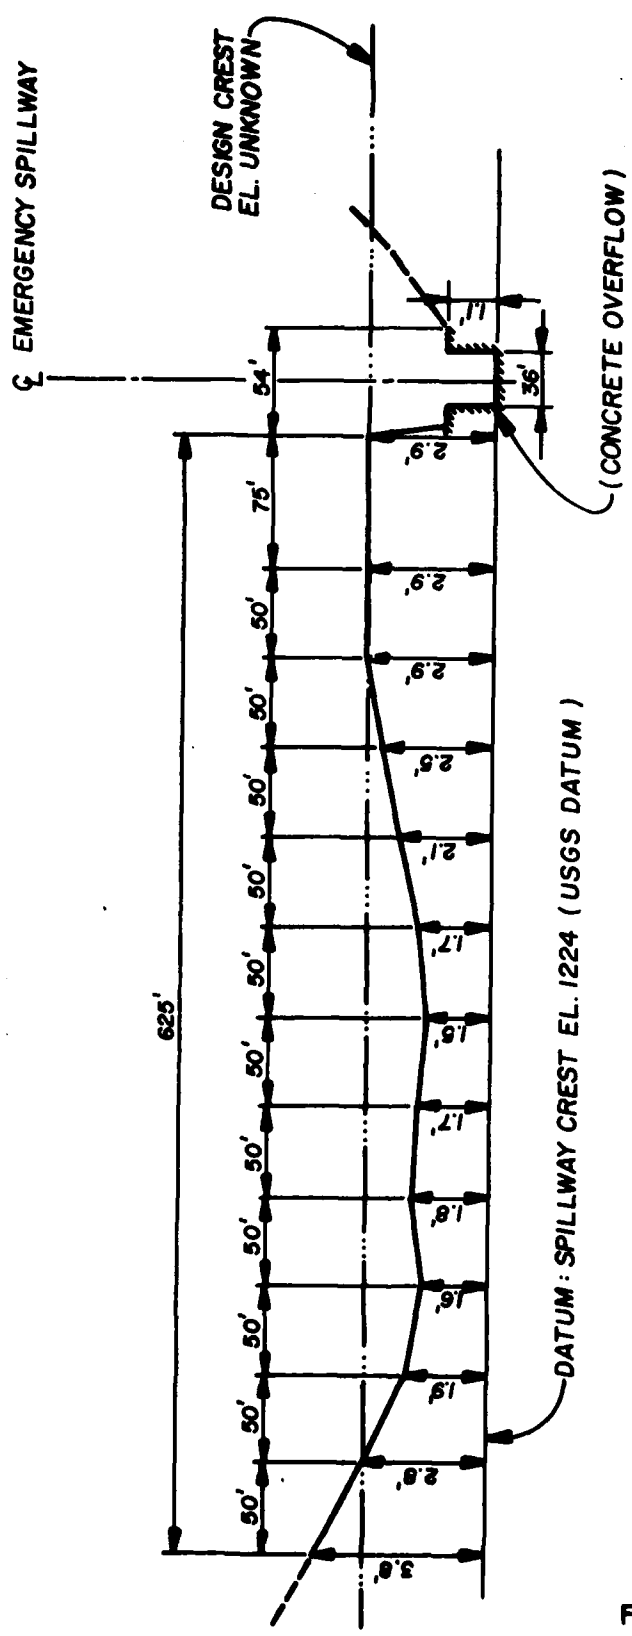
# **DAM CREST PROFILE** (LOOKING DOWNSTREAM)

The crest of the dam was surveyed relative to the spillway crest elevation and it was found that the middle one-third of the embankment is approximately 1.5 feet below the crest level near the abutment. The dam crest profile is illustrated in Plate 4.

| VISUAL EXAMINATION OF | OBSERVATIONS | REMARKS OR RECOMMENDATIONS |
|---|---|---|
| VERTICAL AND HORIZONTAL ALIGNMENT OF THE CREST | Middle one third of the embankment was found to be approximately 1.5 feet lower than the abutments. See Plate 4 for the dam crest profile. | |
