6 National Dam Inspection Program.
 White Oak Pond Dam (NDI Number
 PA-00147, DER Number 64-12),
 Delaware River Basin, Wayne
 County, Pennsylvania. Phase I
 Inspection Report. ~~REDACTED~~

PHASE I REPORT
NATIONAL DAM INSPECTION PROGRAM

Name of Dam: WHITE OAK POND, NDI NO. PA-00147
State & State No.: PENNSYLVANIA, 64-12
County: WAYNE
Stream: TRIBUTARY OF WEST BRANCH LACKAWAXEN RIVER
Date of Inspection: October 24, 1979

WHITE OAK POND DAM

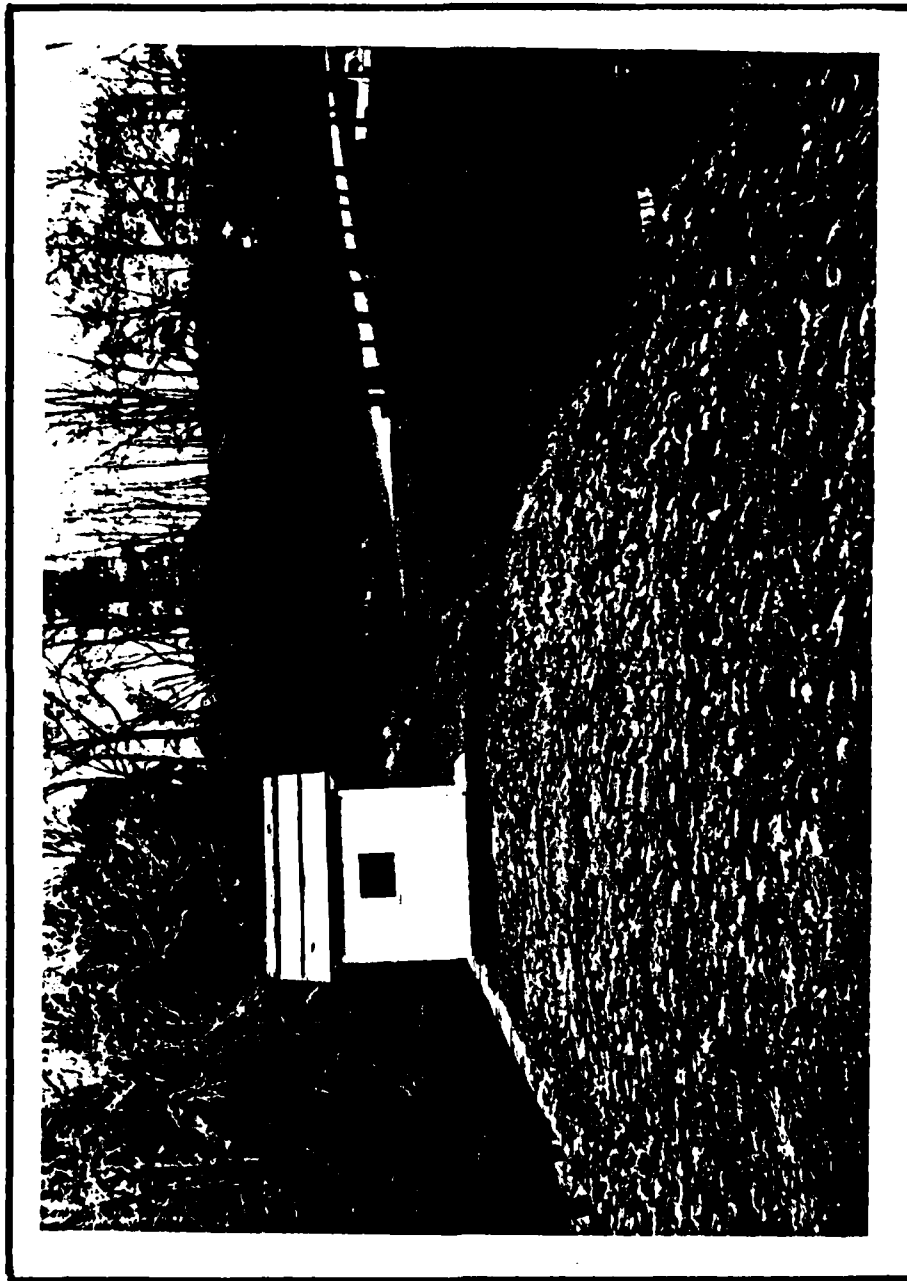
OVERVIEW
WHITE OAK POND DAM
Photograph No. 1

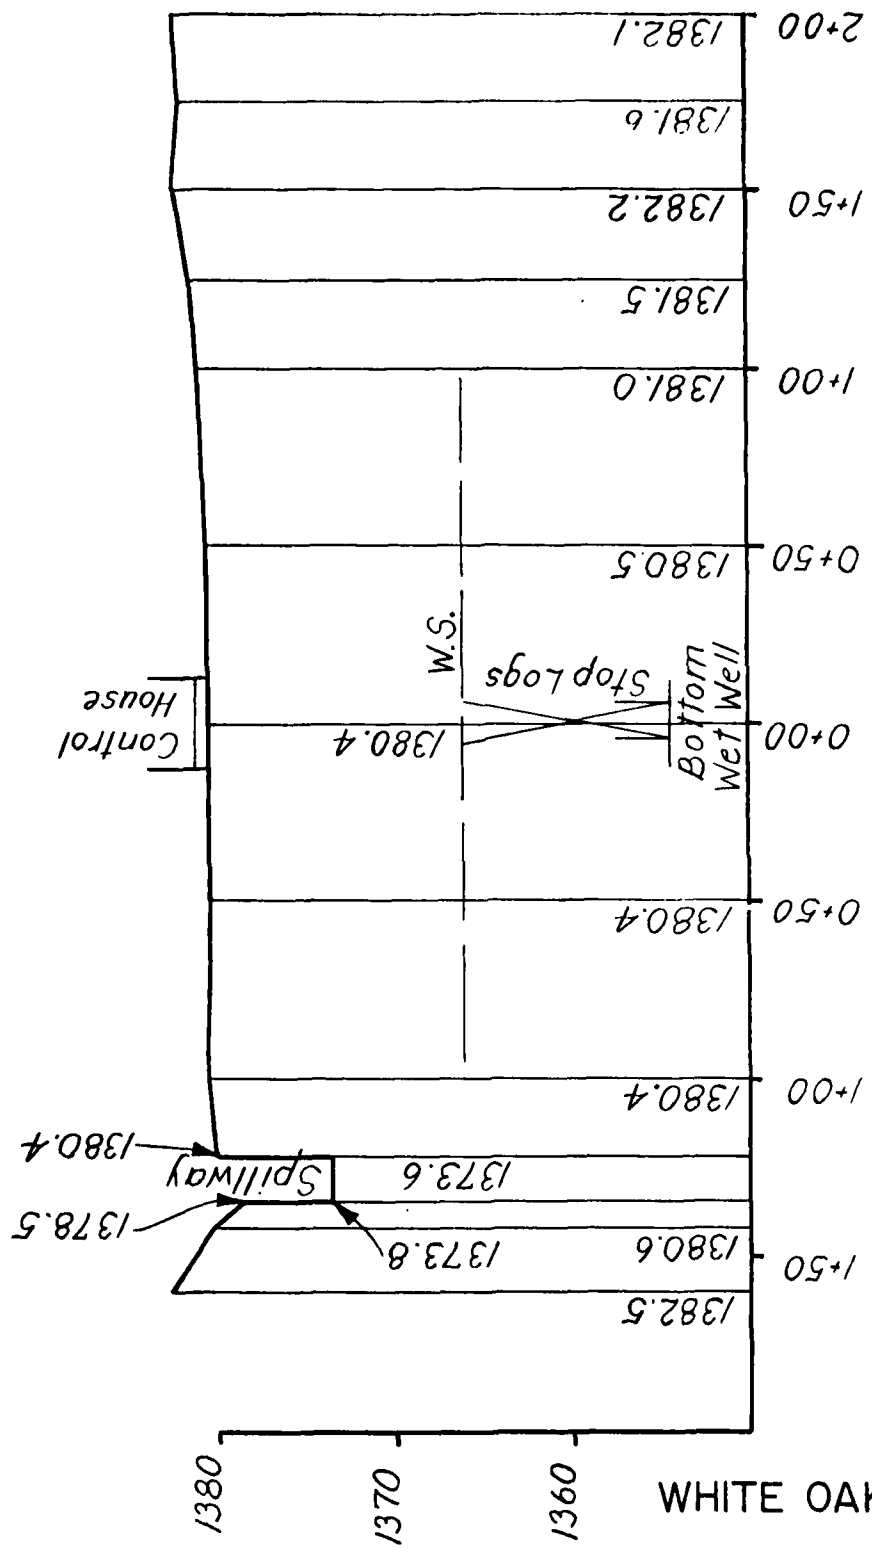
WHITE OAK POND DAM
PA.-00147
INSPECTION SURVEY
PLATE A-II

The breast of the dam is curved and is covered with a well maintained grass mat. The profile indicates a fairly level surface (Plate A-II). A wooden framed shed is located on the embankment over the wetwell. The downstream slope has a slightly battered wall formed with loose handlaid stone. This wall projects about nine feet downstream over the outlet structure. Although most of its surface was smooth and in one plane, a small area at the bottom of the wall bulges on both sides of the outlet structure. These "bulges" appear to be part of the original construction. It appears that the wall was built slightly wider at these locations, due to its height.

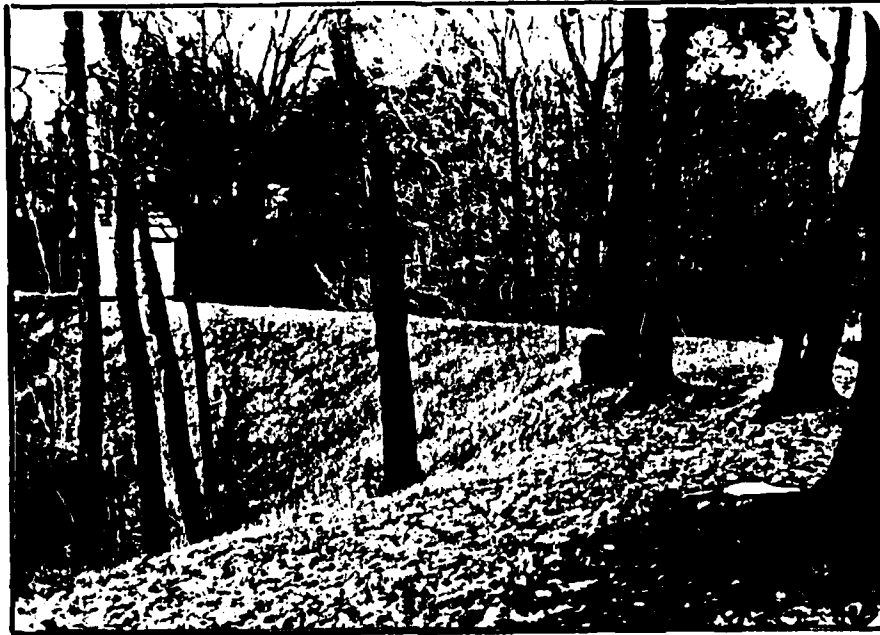
RIGHT END OF EMBANKMENT - NO. 2

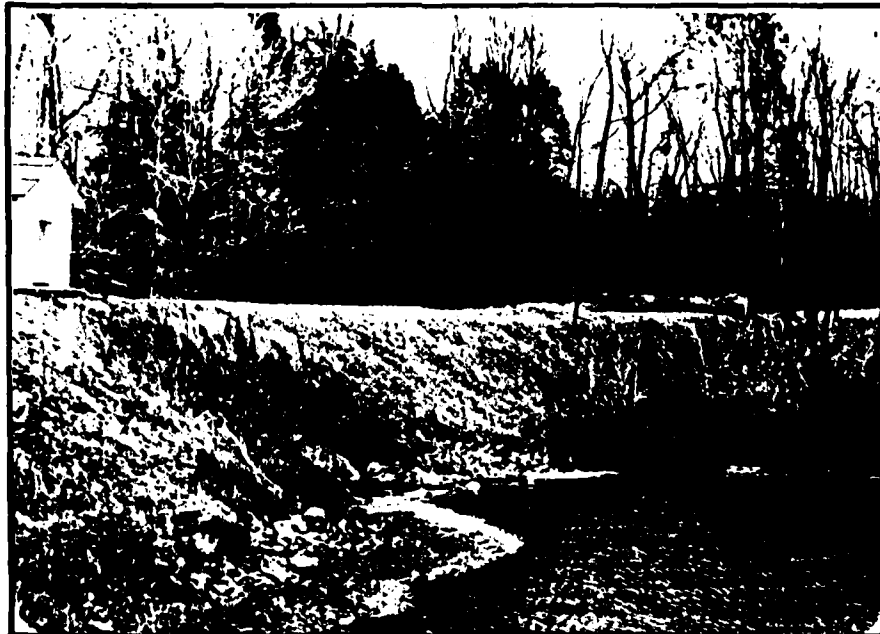
The dam was constructed along a horizontal curve. The alignment appeared to be good along this curve. The upstream slope is rather steep, but no slope failures were detected. Riprap is present near the entrance to the underwater intake to the wetwell. Some brush was on the upstream slope. This growth should be controlled by regular cutting. Trees growing near the left abutment are not considered a danger to the structure due to the width of the dam breast at this point and the relatively flat slopes.

UPSTREAM SLOPE OF EMBANKMENT - NO. 3

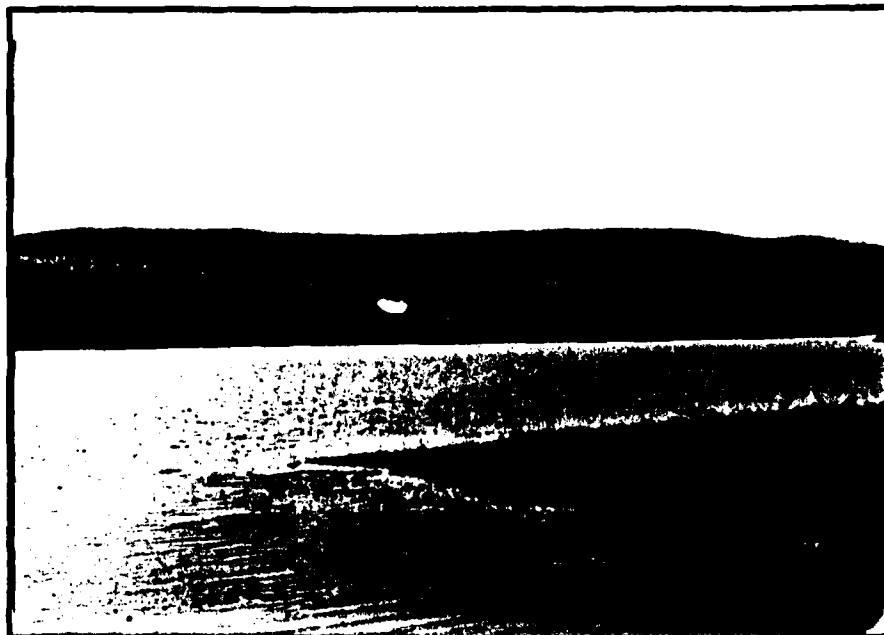
RESERVOIR AREA - NO. 5

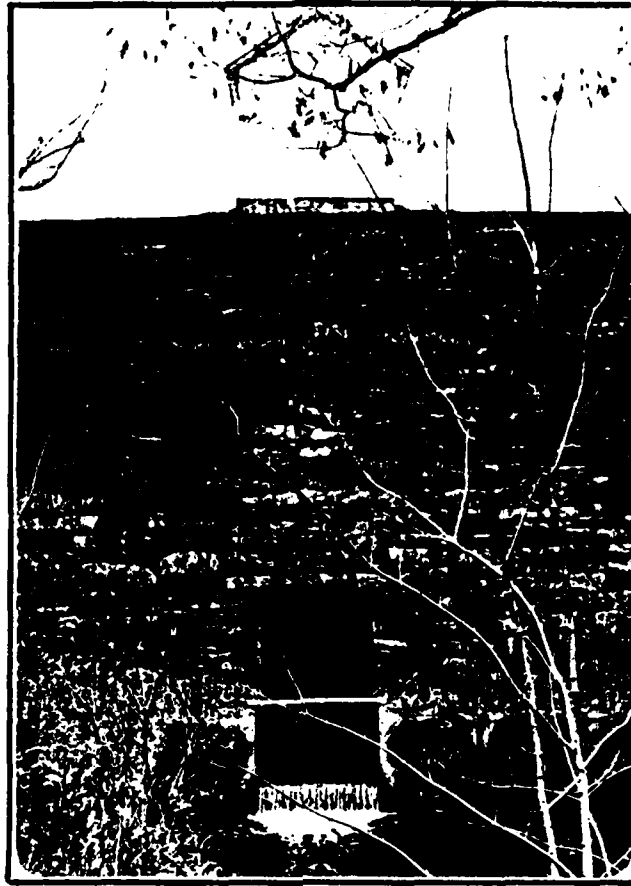
The wetwell is constructed of loose stone walls and the only apparent concrete was for support of the stoplog slot. The well and the stoplogs appear to be in good condition. The upstream conduit is under water and was not inspected. The downstream conduit was in good condition.

DOWNSTREAM CONDUIT OUTLET - NO. 8

4. That the downstream section of the outlet conduit be inspected on an annual basis for possible deterioration of concrete floor.
5. That a formal surveillance and downstream warning system be developed to be used during periods of heavy or prolonged precipitation.
6. That a program be developed for regular inspection and maintenance.

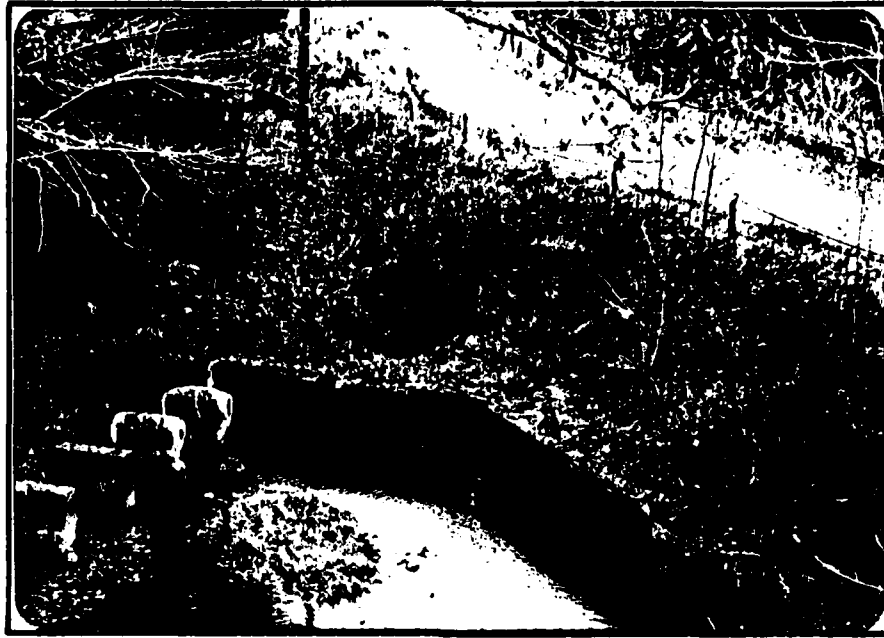
DOWNSTREAM CHANNEL WITH CATCHBASIN - NO. 10
