LAKE LADORE DAM

NDI NO. PA-00091

WAYNE COUNTY, PENNSYLVANIA

## PHASE I INSPECTION REPORT NATIONAL DAM INSPECTION PROGRAM

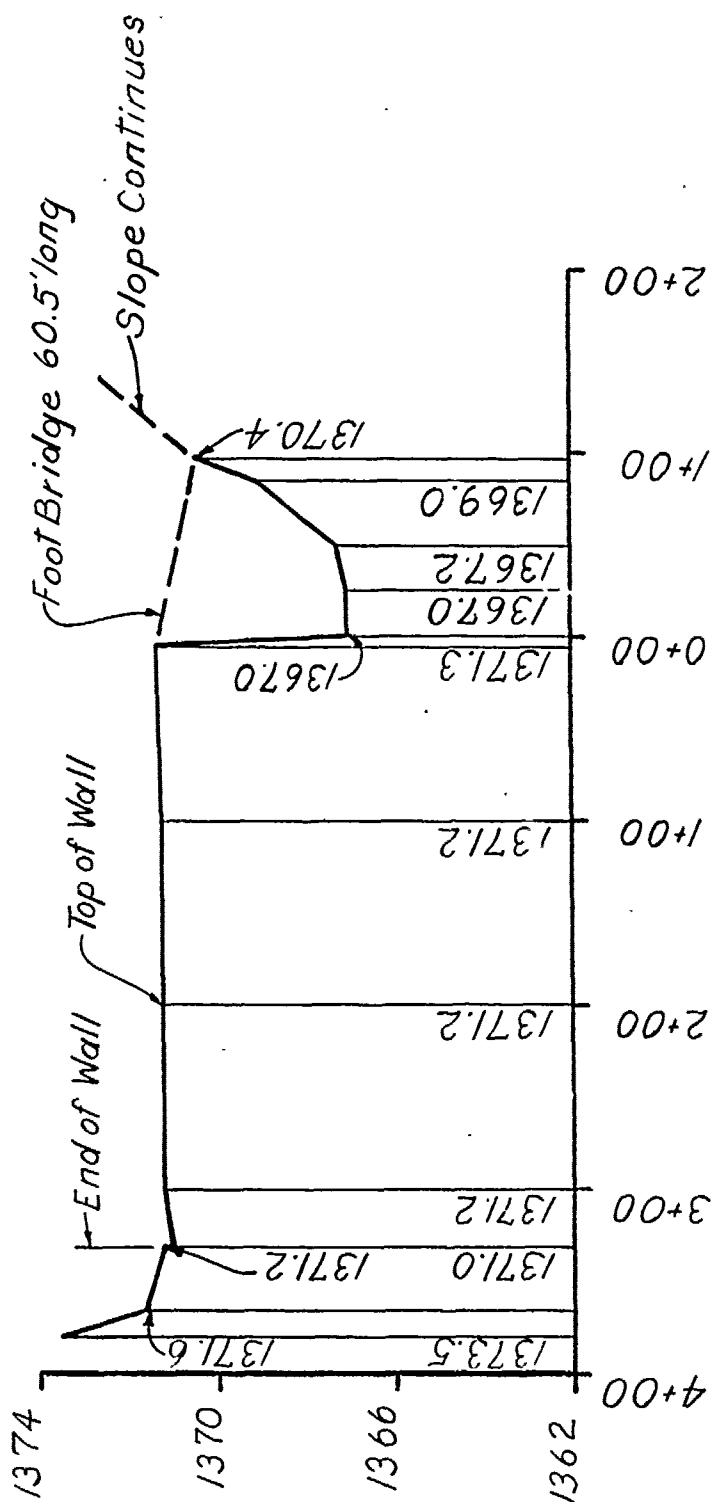
PLATE A-I

The general appearance of the Lake Ladore Dam is fair. The dam has a long history of changes and additions and is a mixture of several different types of construction. Although the upstream portion of the embankment and the top of the dam has a good appearance, the downstream side of the dam, formed by a concrete wall, shows a poor quality of concrete surface and some deterioration. Several weepholes extending through the wall are active, indicating a high phreatic line. The toe below the wall is wet and a steady flow of water was apparent at two locations (Appendix A, Plate A-I).

The ground surface at the toe of the wall is saturated between the added buttress and the old spillway buttress (See Plate A-I, Appendix A) and two streams of steady flow were apparent at the corners of the buttresses. The concrete of one buttress has spalled exposing the reinforcing steel.
