HANKINS POND DAM

NDI NO. PA-00169

WAYNE COUNTY, PENNSYLVANIA

**PHASE I INSPECTION REPORT
NATIONAL DAM INSPECTION PROGRAM**

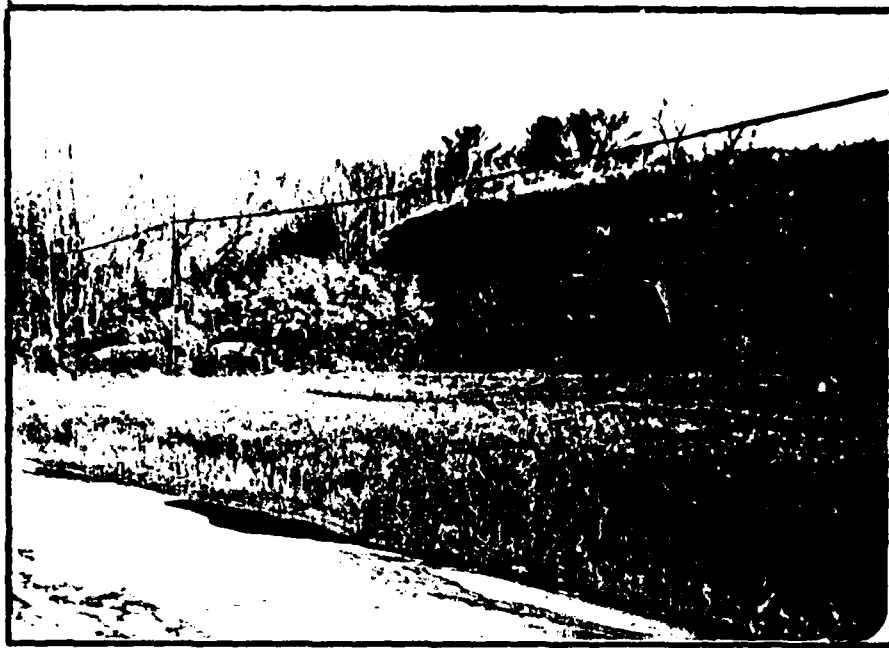
The downstream masonry wall of this 150 year old dam is in excellent condition. No distortions are noticeable and no movements have taken place. It was reported that some seepage or leakage is occurring at the toe of the wall in the catch-basin when the reservoir is full. There are no reasons for concern if the discharge is small and has no turbidity.

DOWNSTREAM DRY STONE WALL - NO. 4

1. Observe the seepage discharge from the toe of the wall on a regular basis. Note clarity of water and flow rate. If color appears or if flow increases, take immediate steps to determine cause and implement remedial action.
2. Remove screens in the spillway opening.
3. Remove all trees and brush on the embankment and implement an annual maintenance program for the removal of weed and brush growth on embankment and along downstream toe.

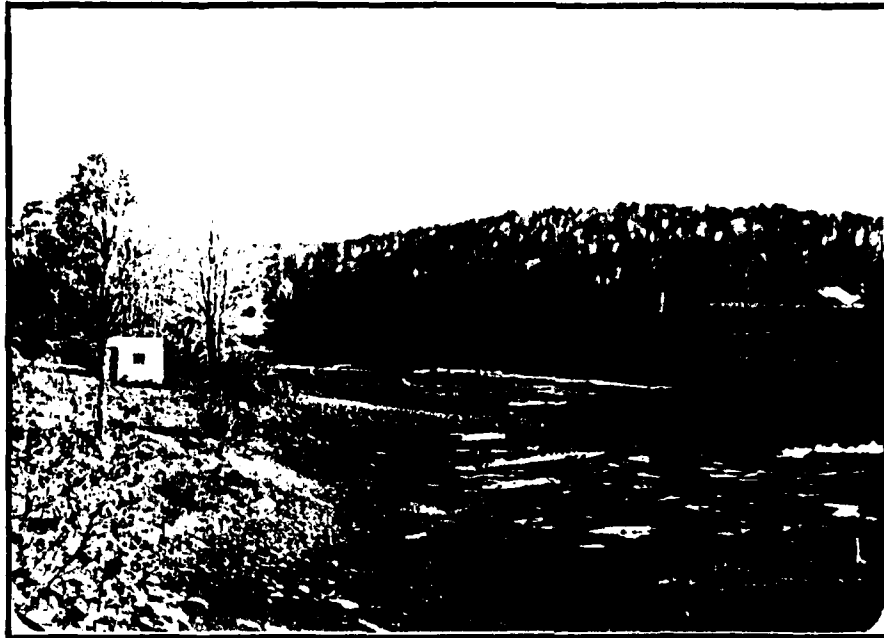
The typical dam section of Hankins Pond Dam consists of an upstream embankment and a downstream handlaid dry stone wall. The upstream slope is relatively steep (1.77H to 1V), but apparently stable. Although very little riprap was present, no wave damage was detected during the inspection.

RESERVOIR IN DRAWDOWN CONDITION - NO. 3

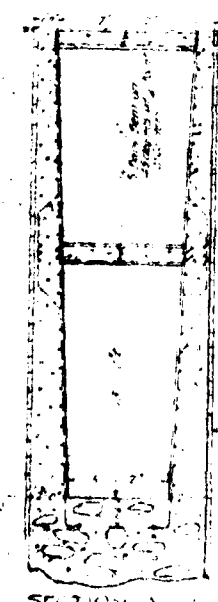
ELEVATION
 COMMONWEALTH OF PENNSYLVANIA
 DEPARTMENT OF FISHERIES
 PLAN OF
 IMPROVEMENTS
 TO
 WASTEWAY OF HANKINS POND DAM
 ANNE CO PA

Note: Drawing Plate III, Appendix E, indicates a 12-inch pipe below bottom slab of spillway with an upstream slide gate.

In 1923, a modification was made to the spillway consisting of concrete walls at the upstream end and concrete facing of the downstream end (Plate III, Appendix E).
