MIDDLE DAM

NDI ID NO. PA-00256  
DER ID NO. 45-3

PHASE I INSPECTION REPORT  
NATIONAL DAM INSPECTION PROGRAM

JANUARY 1980

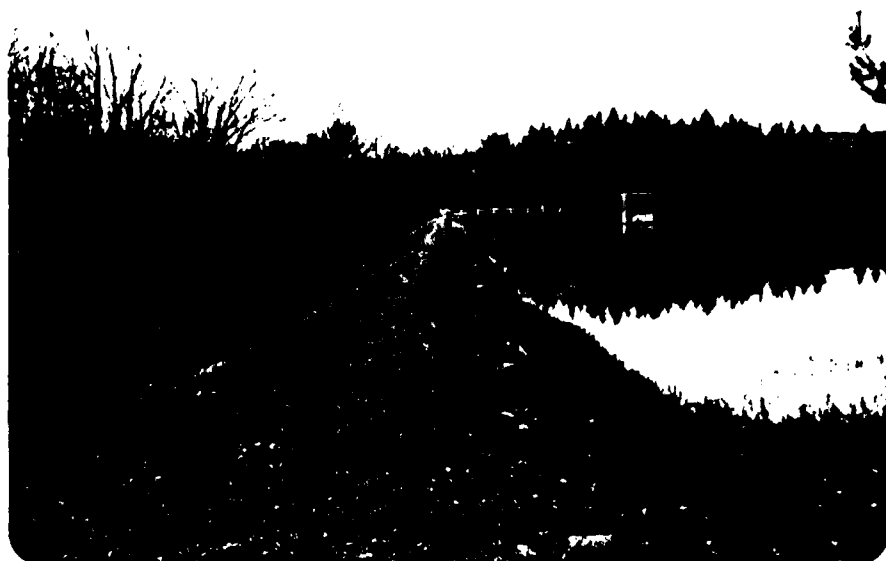
The downstream slope of the dam is covered with grass and is generally in good condition (Photographs B and C). One bare area about 500 square feet in size exists near the left abutment (Photograph D). The Owner stated that the area was disturbed in 1964 when the intake structure was constructed. No erosion has occurred at the bare area. Two burrowing animal holes are located on the downstream slope.

C. Embankment. View from Left Abutment.

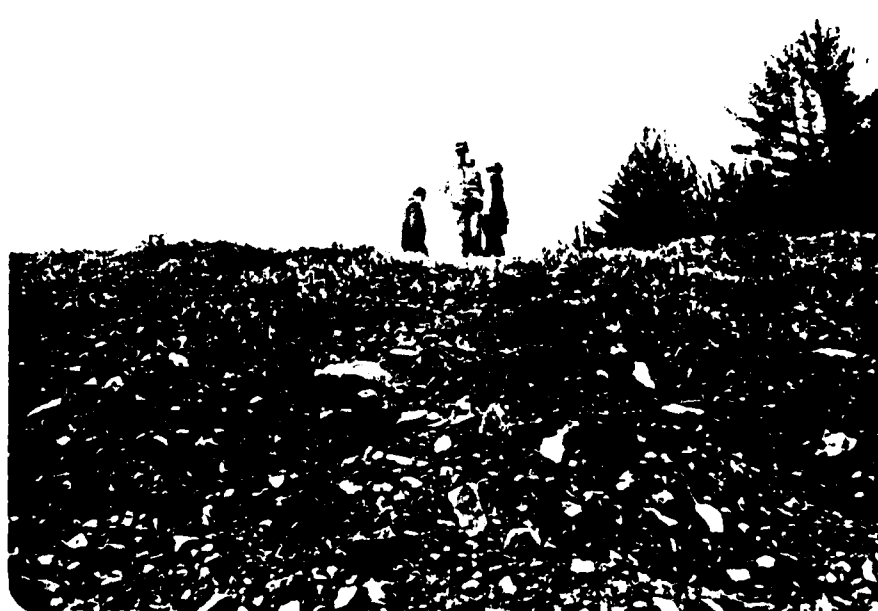
| VISUAL EXAMINATION OF | OBSERVATIONS | REMARKS OR RECOMMENDATIONS |
|---|---|---|
| SLOUGHING OR EROSION:<br>Embankment Slopes<br>Abutment Slopes | None observed. | One area on downstream slope near left abutment is bare. Approx. 500 SF. area. |

D. Downstream Slope Near Left Abutment.

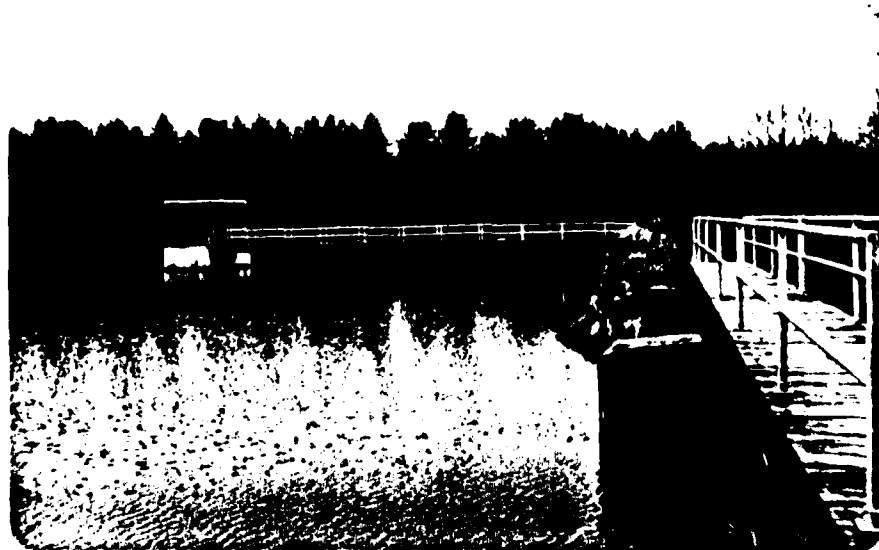
The intake structure located in the reservoir is in good condition (Photograph H). The Superintendent of Public Utilities stated that the three slide gates in the intake structure are all in good working order. Since there are no outlets at the dam, it was not requested that the gates be operated for this inspection. An examination was made of the valve chamber located along the downstream side of the corewall. Standing water about 12 inches deep and mud were present in the tunnel (Photograph I) and valve chamber. The two gate valves were nearly submerged. The source of the water could not be determined. The exposed portion of the corewall in the valve chamber is in good condition. It was damp at several locations, but there were no leaks.

| VISUAL EXAMINATION OF | OBSERVATIONS | REMARKS OR RECOMMENDATIONS |
|---|---|---|
| INTAKE STRUCTURE | Good condition - no deficiencies. | |

H. Intake Structure.

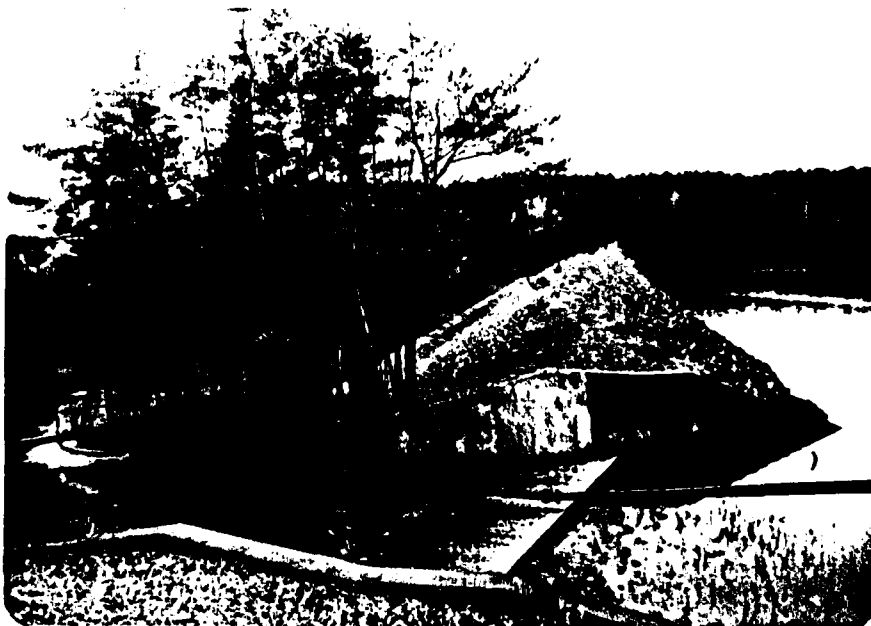
J. East Stroudsburg Dam. Located  
1.3 Miles Upstream.
