SHAWNEE DAM

NDI ID NO. PA-00629

PHASE I INSPECTION REPORT  
NATIONAL DAM INSPECTION PROGRAM

JANUARY 1980

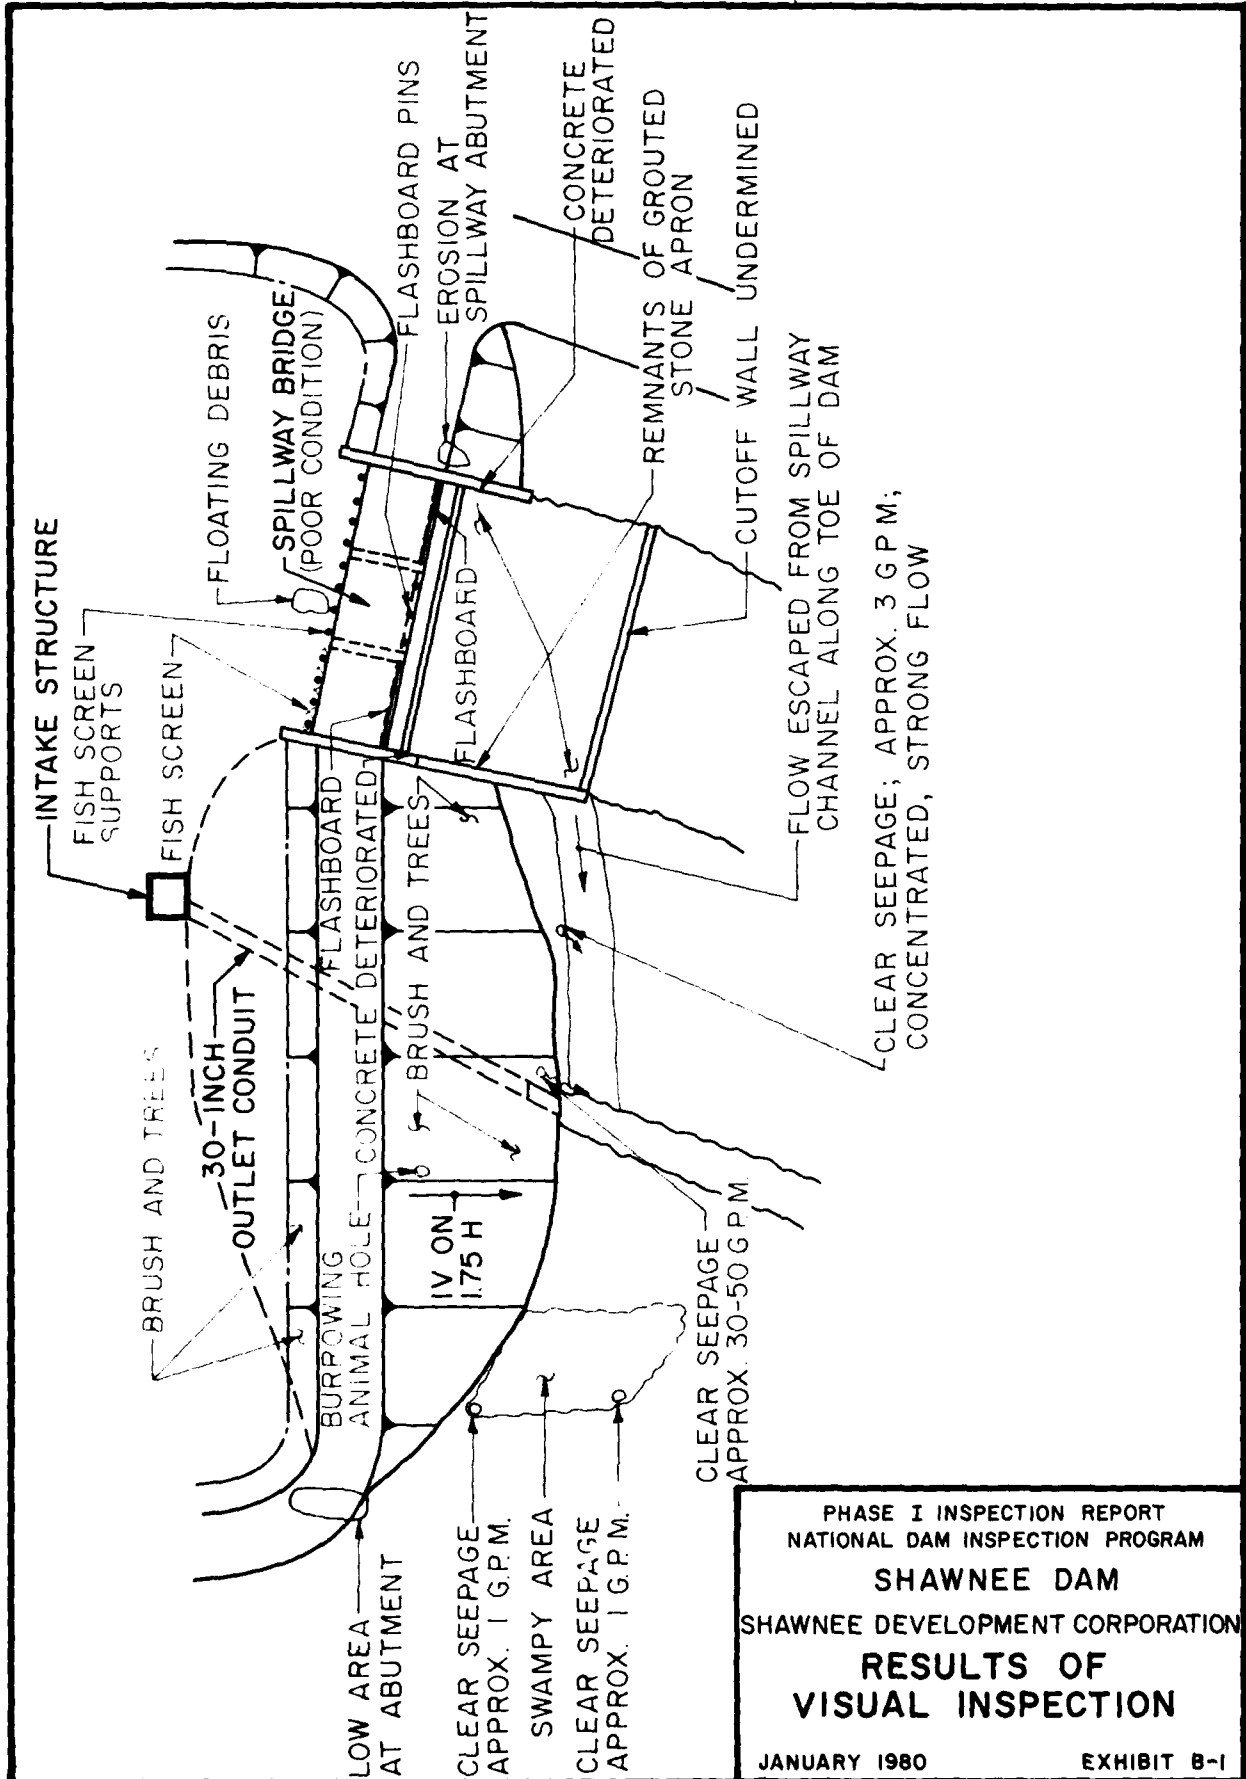
PHASE I INSPECTION REPORT  
NATIONAL DAM INSPECTION PROGRAM  
**SHAWNEE DAM**  
SHAWNEE DEVELOPMENT CORPORATION  
**RESULTS OF  
VISUAL INSPECTION**  
JANUARY 1980 EXHIBIT B-1

a. General. The overall appearance of the dam is poor. Deficiencies were observed as noted below. A sketch of the dam with the locations of deficiencies is presented on Exhibit B-1 in Appendix B. Survey information acquired for this report is summarized in Appendix B. On the day of the inspection, the pool was 0.1 foot above spillway crest.

| VISUAL EXAMINATION OF | OBSERVATIONS | REMARKS OR RECOMMENDATIONS |
|---|---|---|
| ANY NOTICEABLE SEEPAGE | See Exhibit B-1 for<br>locations and quantities of<br>seepage. | All observed seepage was<br>clear but some points<br>were discharging forcefully. |

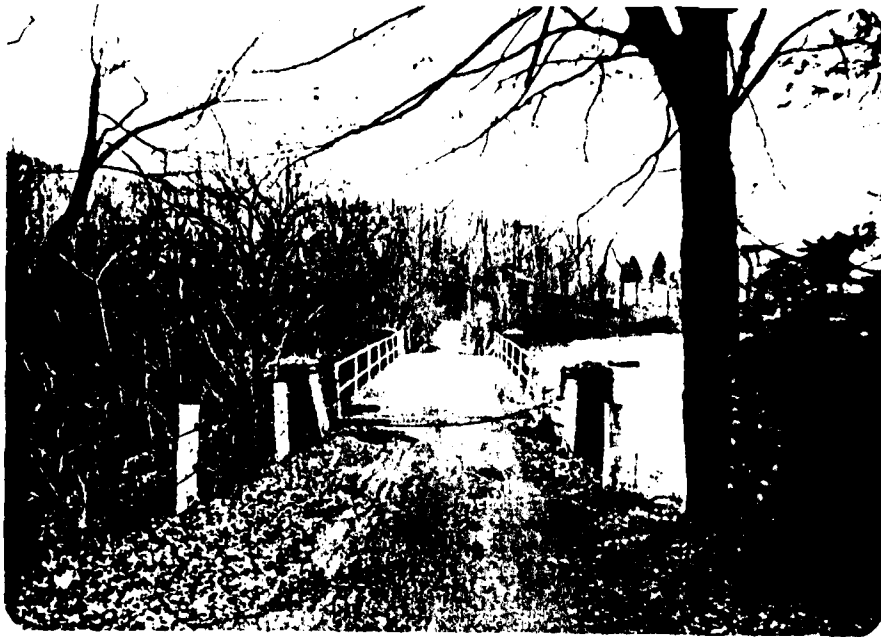
b. Embankment. The top of the dam is paved and used as an access road (Photograph A). The measured average topwidth is 10.5 feet. A low area, 0.3 foot below design level for top of dam, is located at the right abutment. All other portions of the embankment are at or above the design elevation. One area was observed on the top of the dam that has undergone erosion (Photograph B). It is on the downstream side of the dam adjacent to the left abutment of the spillway.

A. Top of Dam. View from Left Abutment.

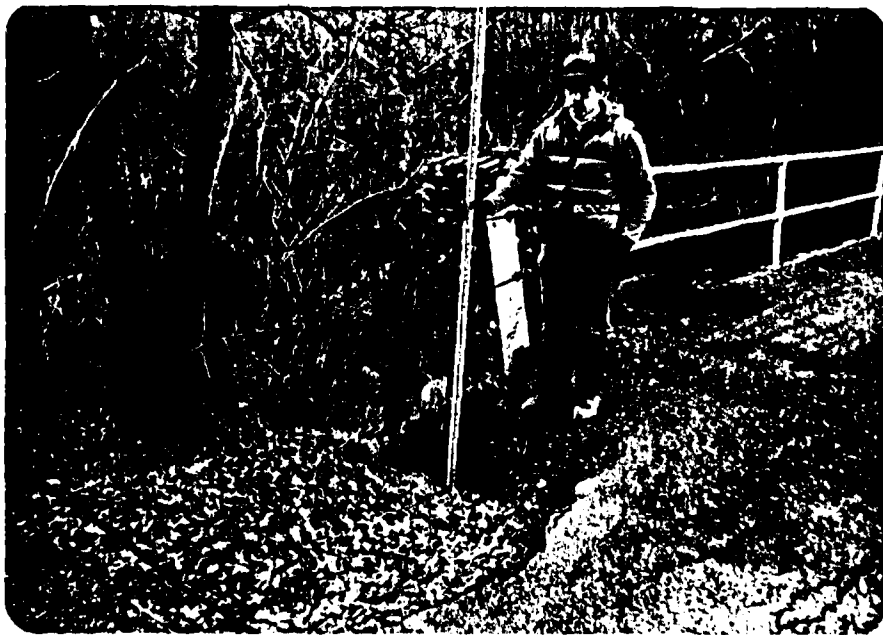
(2) Embankment. The eroded area on the downstream side of the top of the dam was not a serious hazard at the time of the inspection, but continued erosion is likely. As shown on the surveyed section in Appendix B, a portion of the upstream slope above the normal pool level is very steep (2V on 1H). Although it could not be verified by survey, records indicate that the submerged portion of the slope was constructed to the approved design slope of 1V on 2H. Provided that the record data are accurate, the small section of steep slope would not cause serious hazard to the safety of the embankment. Any failure that might occur would probably be a shallow slough that would not extend across the top of the dam. No evidence of sloughing or cracking along the upstream slope was apparent during the visual inspection. Although riprap does not extend to the top of the dam, there were no areas of wave erosion. Vegetation above the riprap has apparently provided adequate slope protection.

B. Eroded Area Adjacent to Spillway.

(7) Fill low area at top of dam, repair eroded area at top of dam, fill burrowing animal hole, and make repairs to spillway bridge.

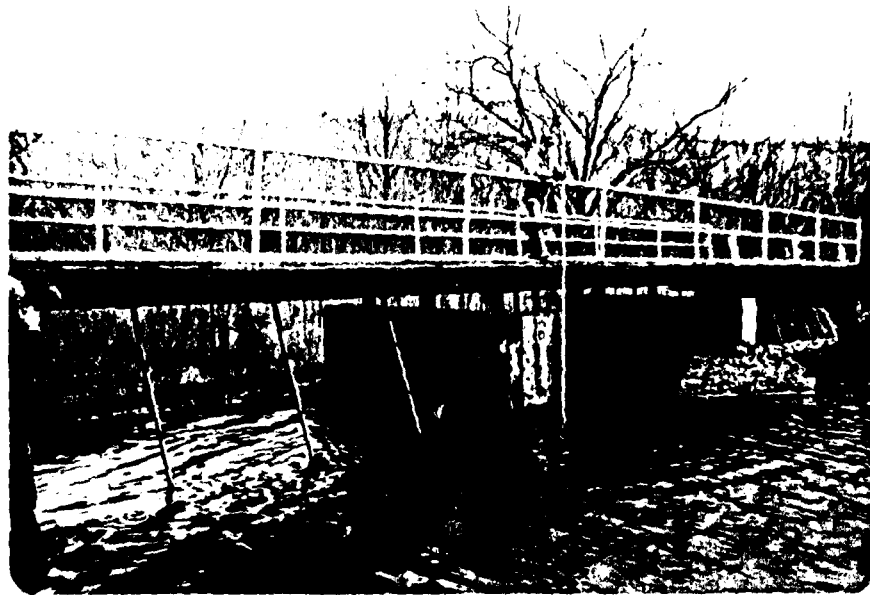
c. Appurtenant Structures. The spillway approach channel was obstructed by a fish screen and by the supports for the fish screen (Photograph E). Some floating debris was present. Flashboard pins were in place in all three bays of the spillway. A 6-inch high flashboard was in place in the right bay, and a partially displaced flashboard was in the left bay (Photographs E and F). The concrete of the spillway structures is in fair condition, with local areas of cracking and disintegration at the ends of the piers and sidewalls (Photographs F and G). The concrete weir is in good condition. The wood decking of the spillway bridge is rotted at various locations. The underside of the spillway bridge was determined to be at Elevation 439.2, which is 0.1 foot above the existing top of the dam and 0.2 foot below the design top of the dam. Only remnants of the grouted stone apron are visible (Photographs G and H). Erosion at the toe of the spillway weir is severe (Photographs F and G). The apron, which was once grouted, consists now of mostly large, loose rock. A cutoff wall located at the downstream end of the apron is badly undermined.

(3) Appurtenant Structures. The fish screens and fish screen supports are serious obstructions that could catch debris and significantly reduce spillway capacity. The flashboards serve no useful purpose, and they obstruct the spillway. The underside of the spillway bridge was found to be lower than the design elevation, which might cause pressure flow. Discharges under pressure flow would be less than under a free overfall condition. In computing the existing spillway capacity and in evaluating the spillway adequacy, none of the effects of the above deficiencies were included. The spillway capacity computed and used in this Report assumes that all flashboards, fish screens, and fish screen supports were removed.

E. Spillway Approach Channel.

- (1) Remove flashboards, flashboard pins, fish screens, and fish screen supports from the spillway.
- (2) Perform investigations and studies as required to assess the cause and hazard potential of the seepage areas. Take appropriate action as required.

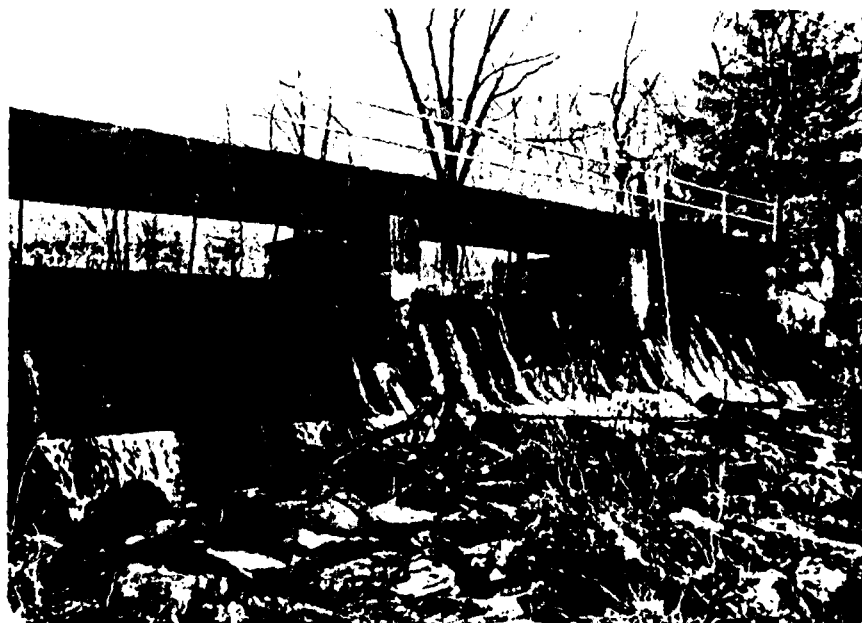
(3) Appurtenant Structures. Erosion of the grouted stone apron downstream from the spillway weir apparently began shortly after the dam was completed. There are no records of repairs. The existing condition is probably the result of progressive deterioration and

erosion over the last 52 years. The existing condition is potentially hazardous. The loss of material at the downstream toe of the weir adversely affects the stability of that structure. The spillway outlet channel does not adequately confine even small spillway discharge. Flow that escapes and flows along the toe of the embankment obscures seepage and creates an erosion hazard.

F. Spillway Weir and Apron.

(4) Perform additional investigations and studies to more accurately ascertain the structural stability of the spillway weir as well as the nature and extent of measures required to provide adequate factors of safety for structural stability under all loading conditions. Take appropriate action as required.

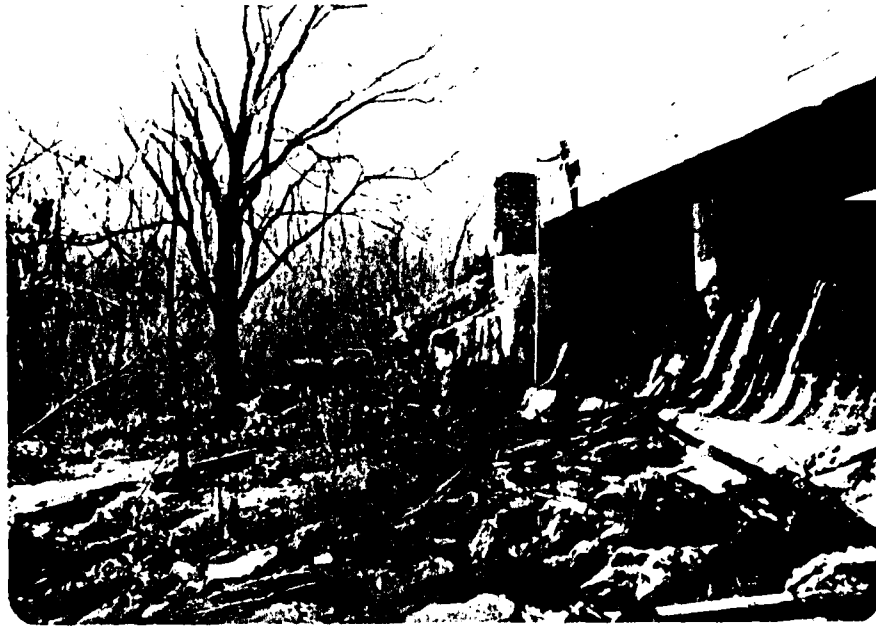
G. Spillway Weir and Apron.

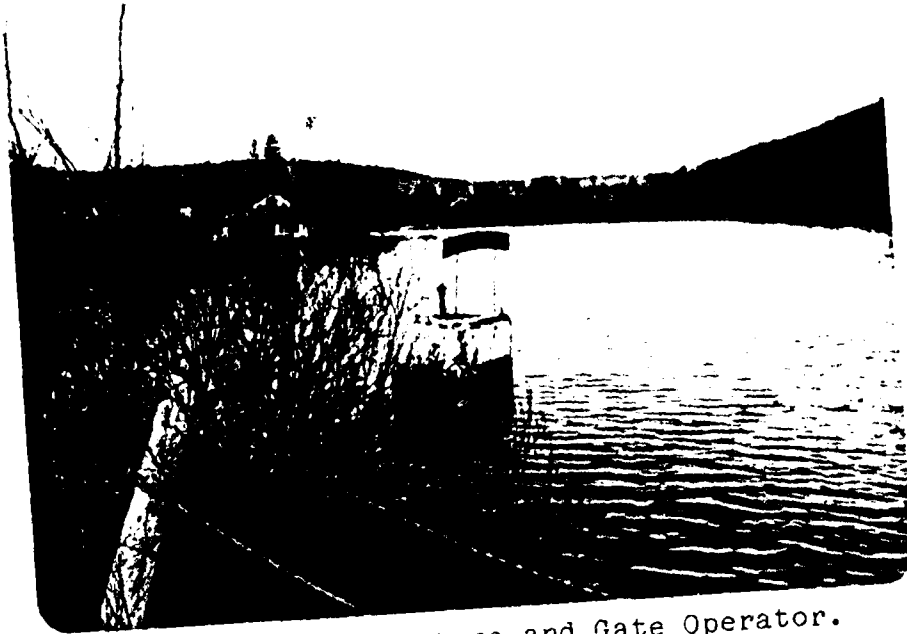
| VISUAL EXAMINATION OF | OBSERVATIONS | REMARKS OR RECOMMENDATIONS |
|---|---|---|
| INTAKE STRUCTURE | Located in reservoir area; access only by boat. | Could not inspect. Some external deterioration visible from top of dam. |

I. Intake Structure and Gate Operator.

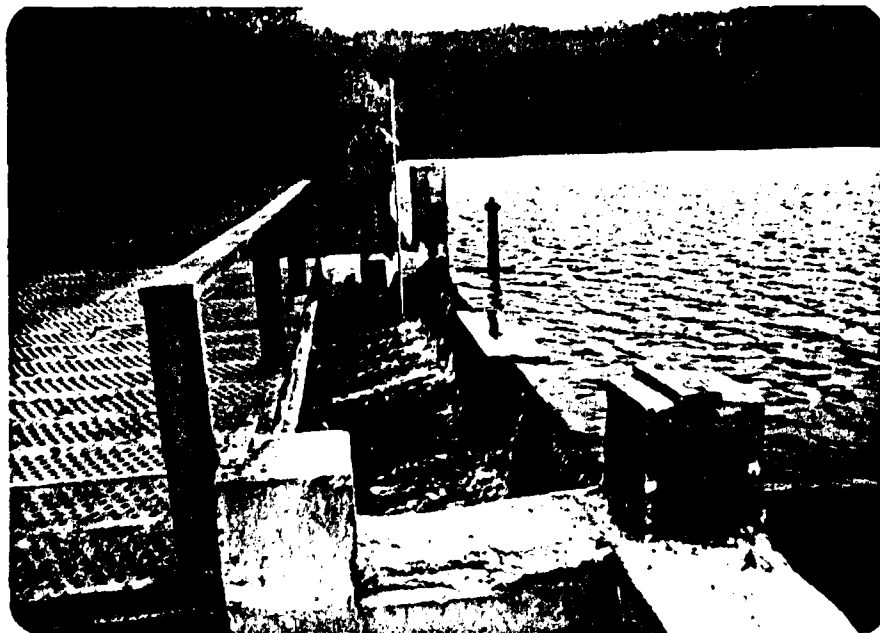
K. Main Spillway of Camp Sun Mountain Lake Dam (Located 0.45 Mile Upstream from Shawnee Dam).

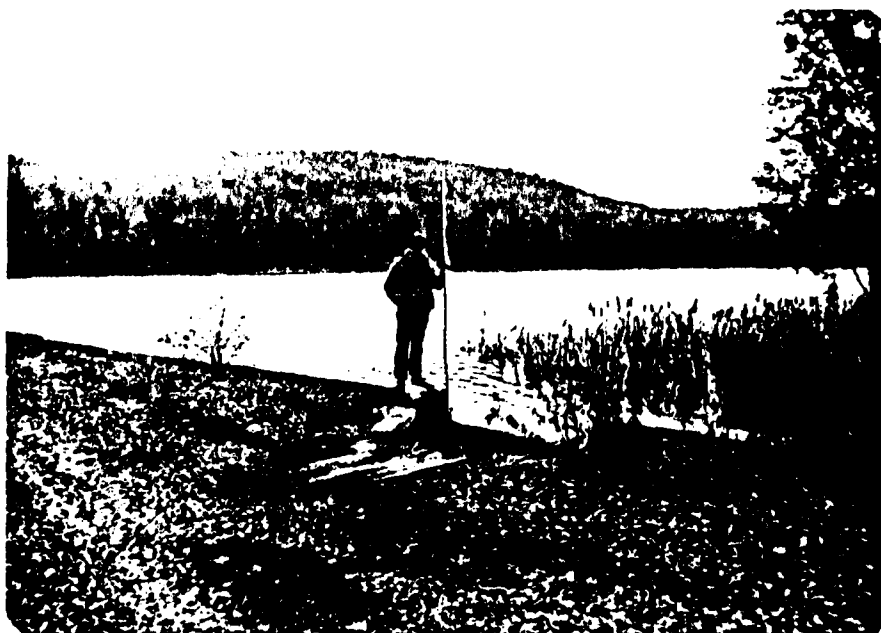
L. Auxiliary Spillway of Camp Sun Mountain Lake Dam (Located 0.45 Mile Upstream from Shawnee Dam).
